Mercury Alert

“Silent Switch”

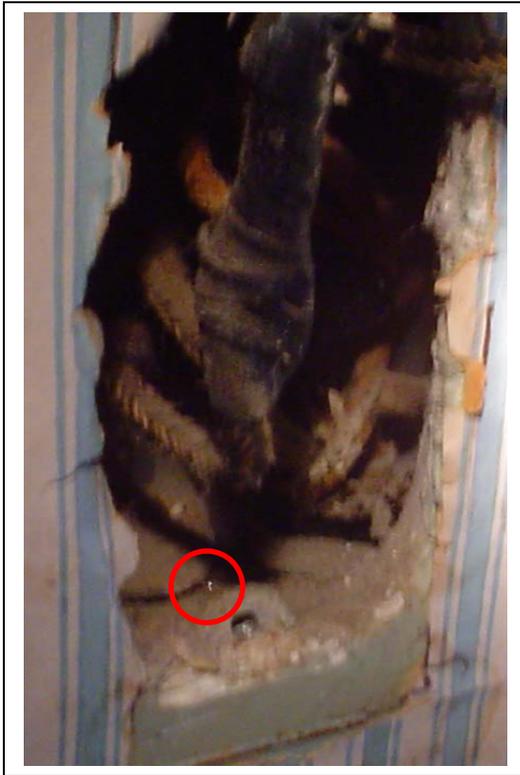
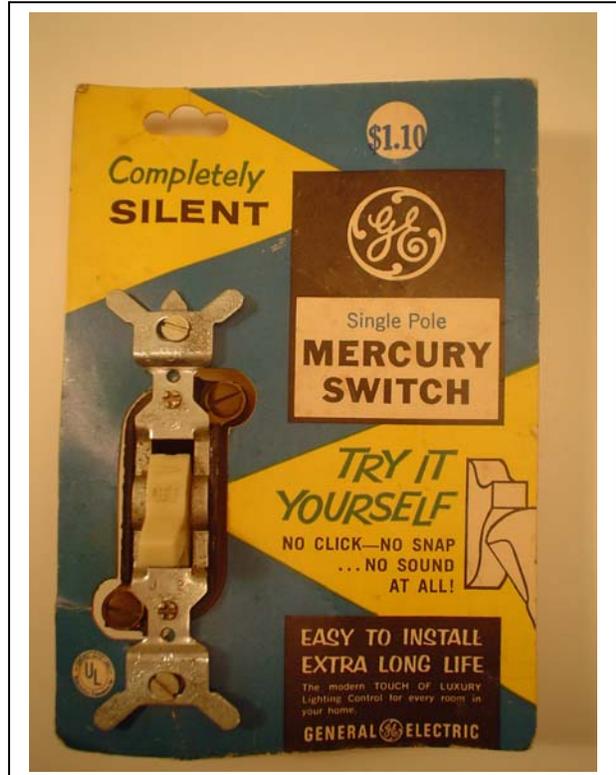
Elemental Services & Consulting, Inc. (ESCO) was retained to assess and remove elemental mercury from a bathroom. The homeowner flipped on the light switch and heard a loud “pop” inside the wall and multiple lights and appliances immediately lost power. Upon checking the fuse box (no fuses were blown), the homeowner removed the switch cover and switch from the wall, and discovered mercury beads inside the wall.

Mercury vapor concentrations within the home were elevated to 6.6 µg/m³ on carpeting adjacent to the bathroom. This was likely caused by tracking of the mercury when the homeowner removed the switch cover and switch from the wall (mercury beads inadvertently fell to the linoleum bathroom floor).
