Mercury Alert

“Silent Switch”

Elemental Services & Consulting, Inc. (ESCO) was retained to assess and remove elemental mercury from a bathroom. The homeowner flipped on the light switch and heard a loud “pop” inside the wall and multiple lights and appliances immediately lost power. Upon checking the fuse box (no fuses were blown), the homeowner removed the switch cover and switch from the wall, and discovered mercury beads inside the wall.

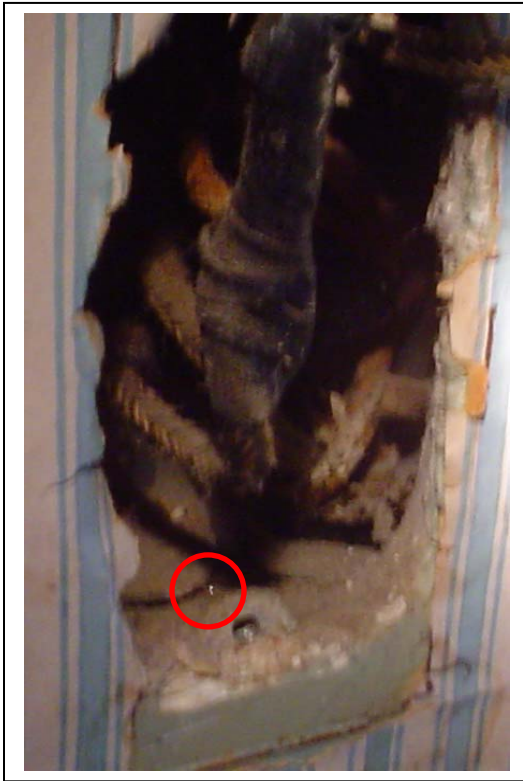
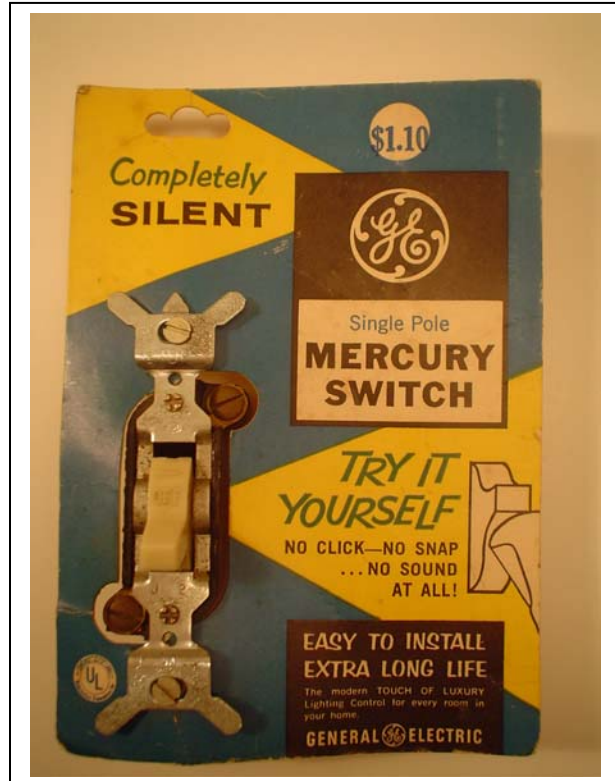
Mercury vapor concentrations within the home were elevated to 6.6 µg/m³ on carpeting adjacent to the bathroom. This was likely caused by tracking of the mercury when the homeowner removed the switch cover and switch from the wall (mercury beads inadvertently fell to the linoleum bathroom floor).
