PART 2 - ISCO

2009 Persulfate Injection

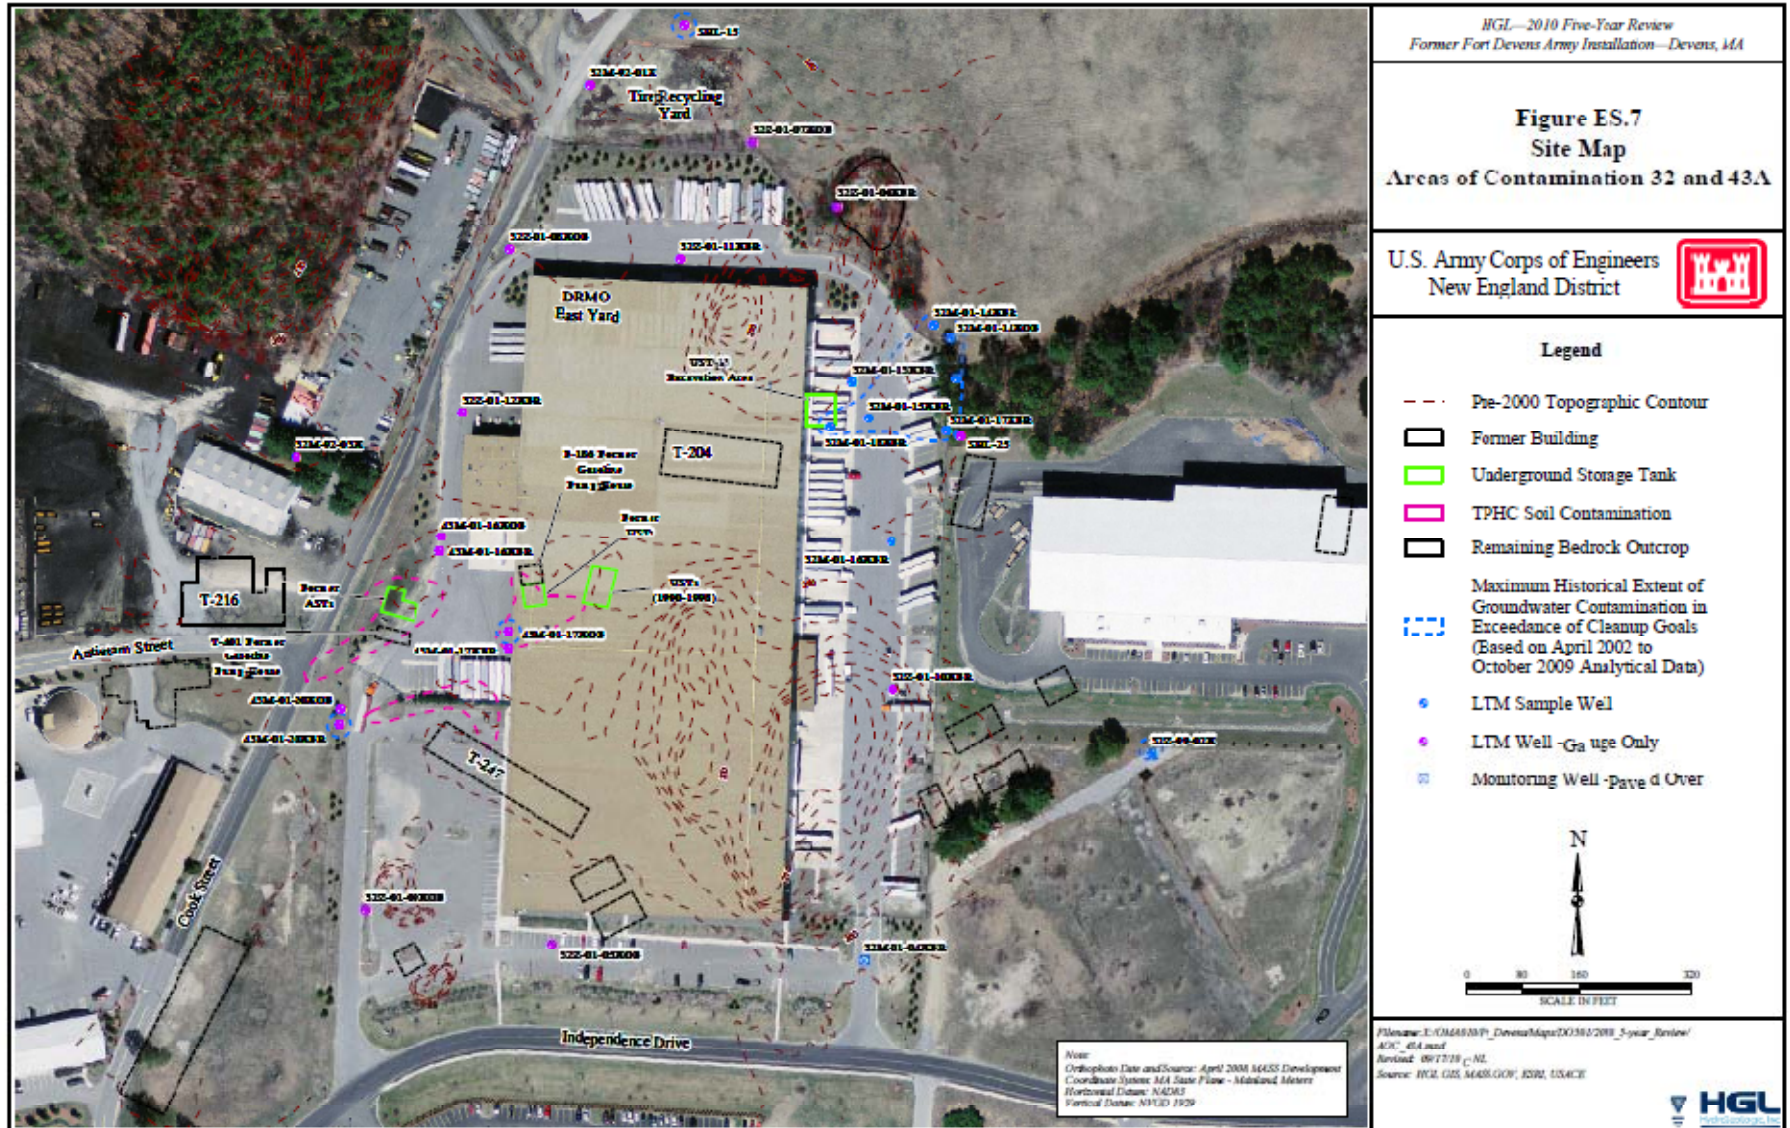
- Focus on “hotspot” near 32M-01-18XBR
 - 50 X 50 X 25 ft (10 ft. Saturated thickness)
 - 3 shallow bedrock injection wells installed around 32M-01-18XBR
- Overburden injection well installed on Top-of-bedrock in former tank grave
- 1800 gallons of water/sodium persulfate solution injected February 2009 (5000 lbs)
- sodium hydroxide used as catalyst
- ~ \$36,000 (Estimate)

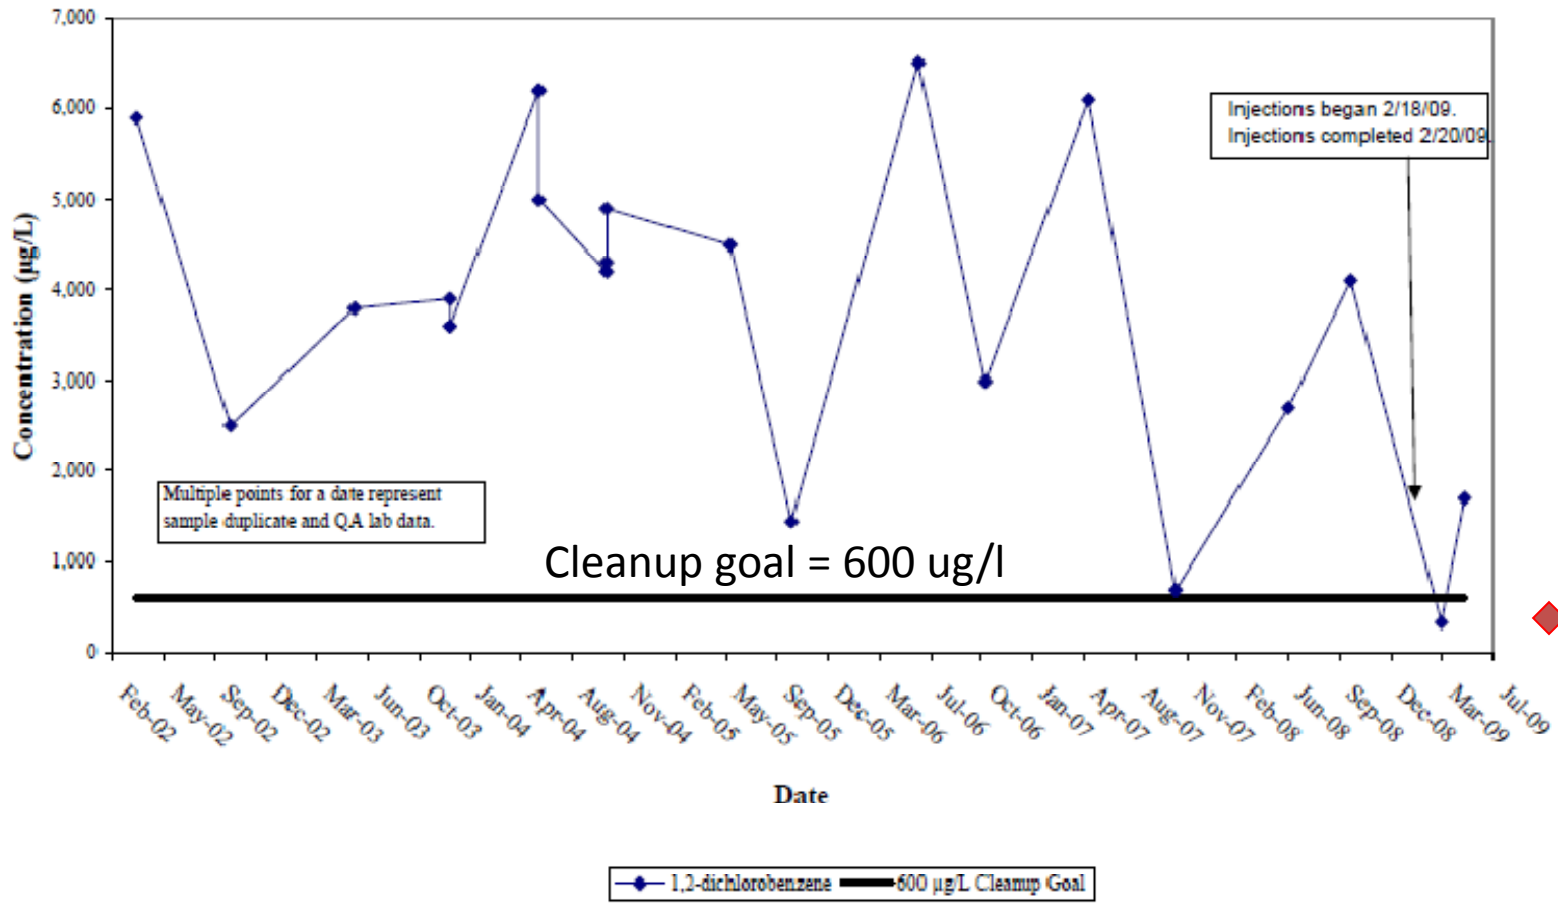
Long-Term Trends
1,2-Dichlorobenzene
Areas of Contamination 32 and 43A
Well 32M-01-18XBR

May 2010
300 µg/l
