Bangor Landing Bangor, Maine

Case Study-Sediment Remediation

Maine Department of Environmental Protection
City of Bangor, with RMT, Inc.

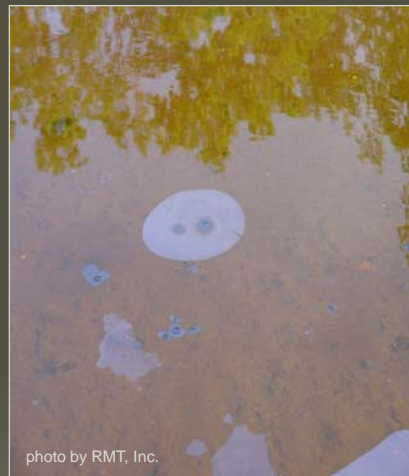
Tar and Sheen on River Surface

At low tide in warm weather, tar moves to surface of the river from tar deposit near the sewer, and is transported by river currents

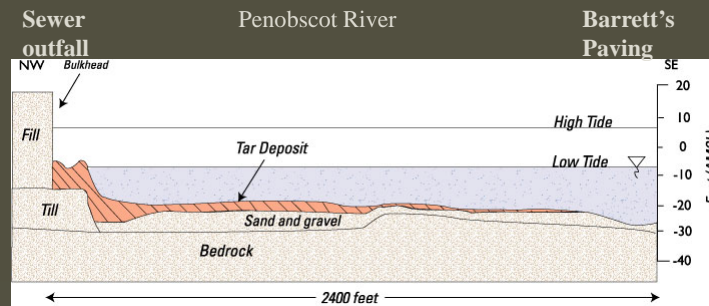
Longitudinal Cross Section of Tar Deposit

Tar deposit thickest near sewer outfall (14 ft) and thins downstream
(4 ft thick 1,000 feet from sewer outfall)

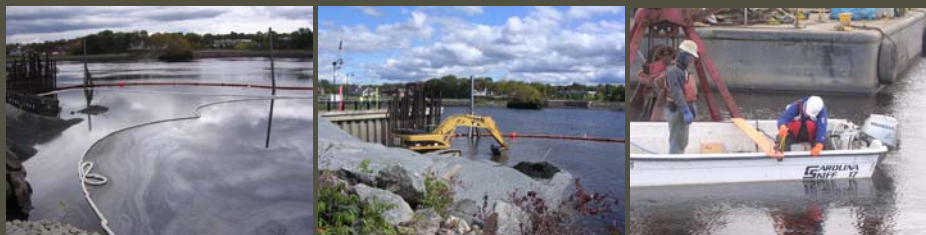
Lessons Learned-Dredging Operation

- Double boom often necessary to contain NAPL, turbidity
- Tide cycle proved very limiting to use of long arm excavator
- Uneven dredge surface made survey difficult
 - In field efforts to smooth cap layers
 - Crane bucket drag
 - I-beam rake

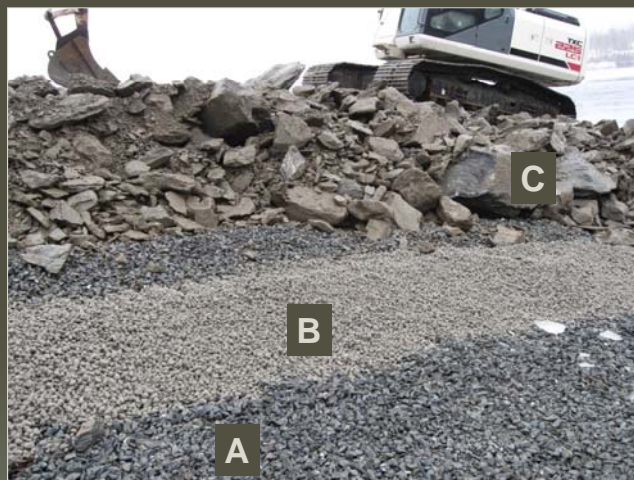
Cap Installation Cross Section

Placing Gas Transmission (A) & Control Layers (B), Armor (C) in Intertidal Zone
Slide content courtesy of RMT, Inc
