Installation of Sub-Slab Depressurization Systems in Stratford, CT

NEWMOA Workshop Providence, RI June 11, 2007 Chelmsford, MA June 12, 2007

Ron Curran Remediation Section, Water Protection and Land Reuse Connecticut Department of Environmental Protection

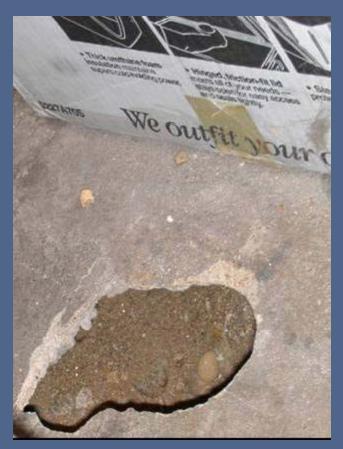
Concrete floors with holes, cracks, and gaps

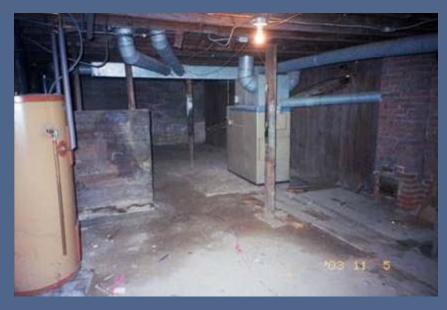
Dirt Floors

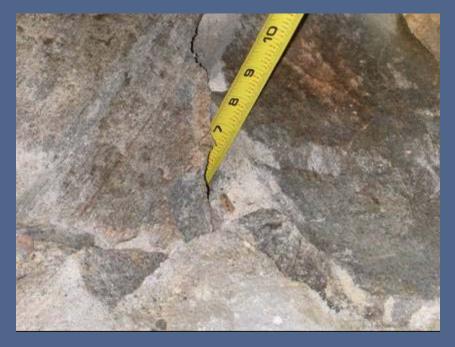
Deep gaps in in the fieldstone walls

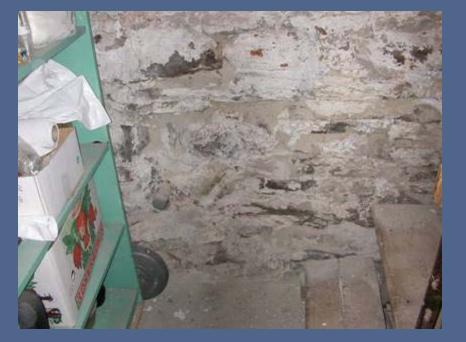
Crumbling high lime mortar in the fieldstone walls

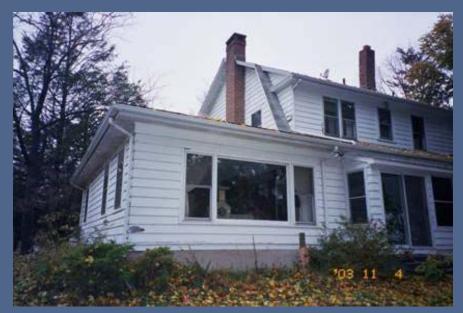
Multiple slabs were encountered at larger homes with additions

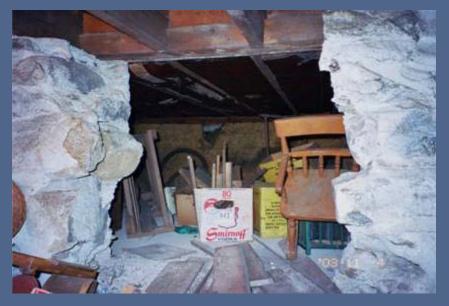
Dirt floor crawlspaces and concrete crawlspaces (as pictured above) were encountered

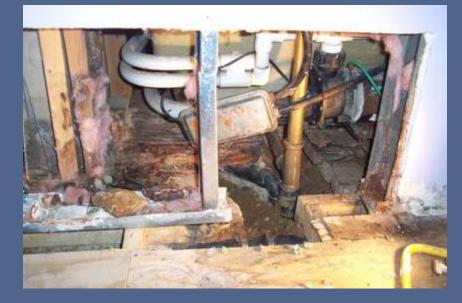
Hidden underneath a tiled floor, a tub was installed over a dirt pit

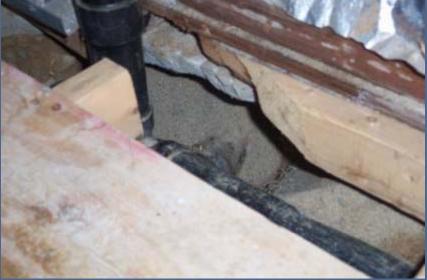
Water line placed in dirt trench located under the finished floor

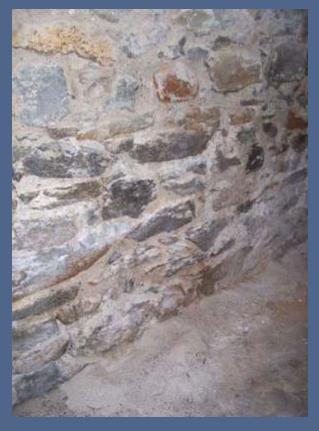
Crumbling high lime mortar fieldstone walls before parge coat

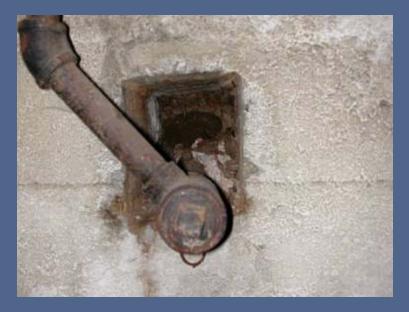
View of a piping penetration in need of sealing
