# Connecticut PCB Case Study

November 8, 2012  
Lori Saliby-Supervising Environmental Analyst  
CTDEEP-Emergency Response and Spill Prevention Division  
Storage Tank and PCB Enforcement Unit  
NEWMOA- Dayville, CT

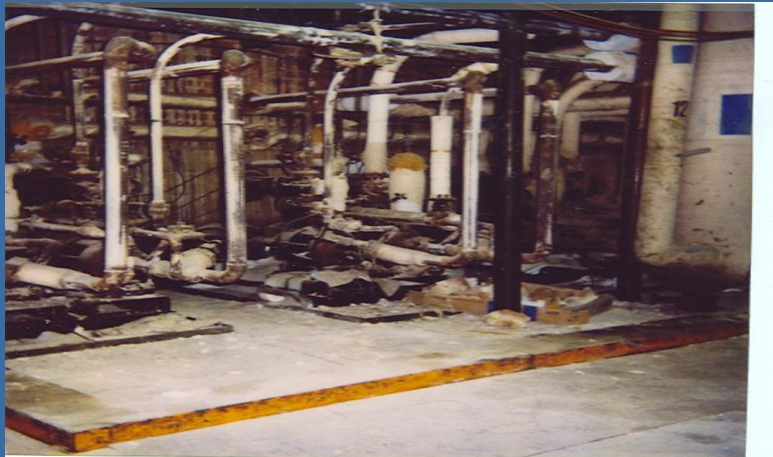
## Heat Transfer Pumps

- PCB heat transfer oil used 1968 to 1972
- PCB Oil leaked from pump seals in basement onto and through concrete floor
- Discovered during routine PCB compliance inspection by CT DEP in 1993
- PCBs concentrations in soil below basement up to 38,000 mg/kg
- Impacted unconsolidated materials and shallow bedrock
- DEP and EPA enforcement actions

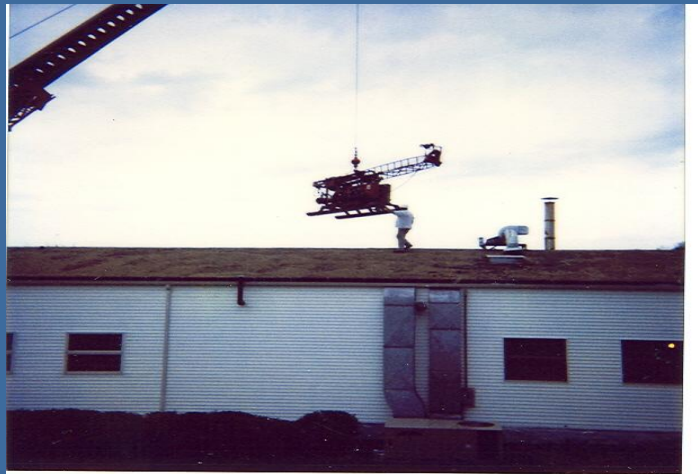
## Groundwater Monitoring Well Installation

- Extensive MW network (>50 wells)
- PCBs documented in unconsolidated deposits and shallow weathered bedrock
- Upward head from deep bedrock
- No PCBs detected in on-site high capacity Bedrock production well.
  - Located approximately 160 feet from source
  - Continued sampling on an annual basis
