Vermont Department of Environmental Conservation

## JARD Bennington, VT

## Brief History of JARD

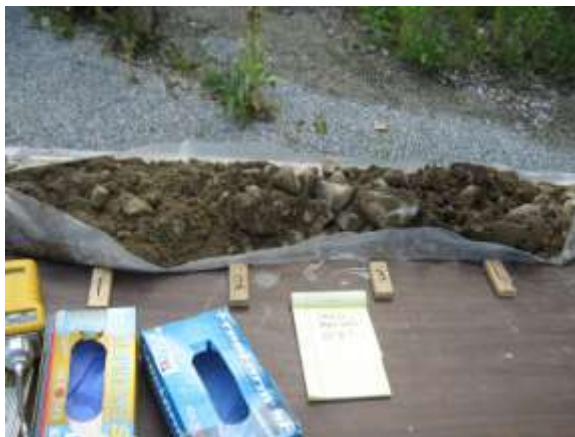
0-5'

JARD Site  
Geology

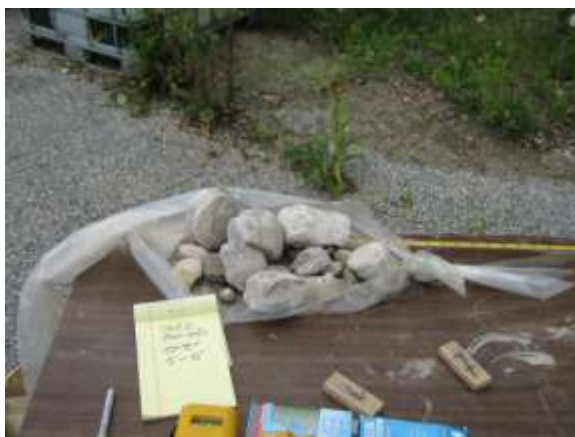
5-10'

JARD Site  
Geology

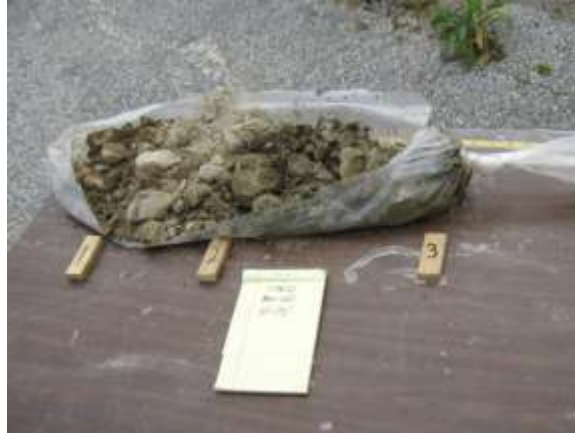
10-15'  
JARD Site  
Geology

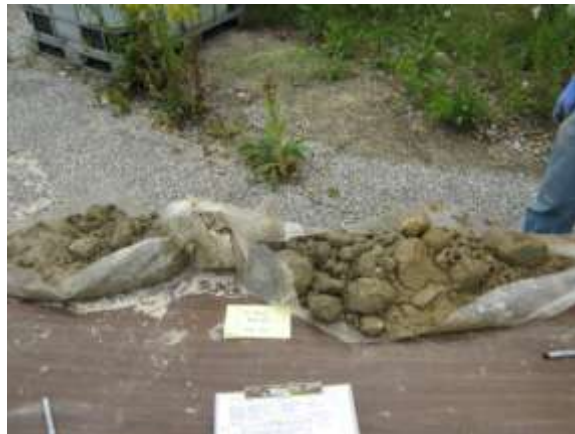
15-20'  
JARD Site  
Geology

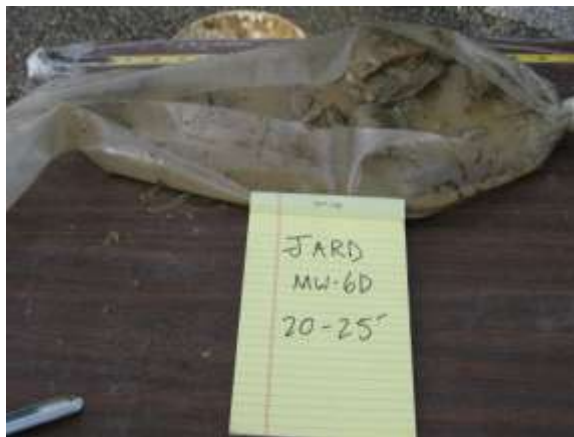
20-25'

JARD Site  
Geology

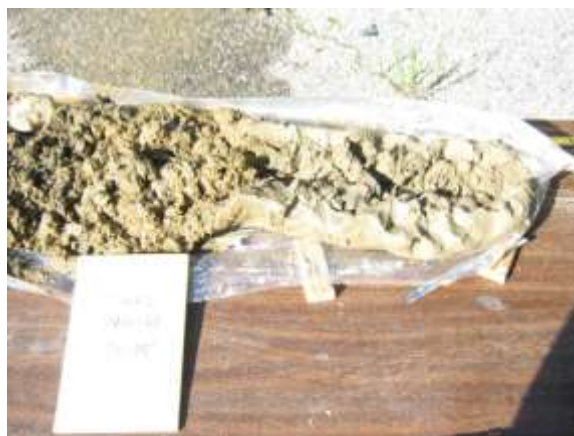
30-35'

JARD Site  
Geology
