## WATERFRONT ACCESS NORTH REDEVELOPMENT CASE STUDY BURLINGTON VT WATERFRONT

WAN Project Done With Resource Systems Group (Prime) And SE Group (Landscape Architects)

#### Project Area 2013 (Pre-Construction)

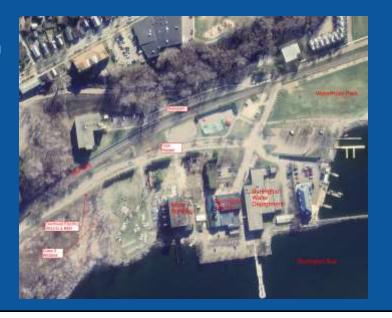
- Flat Site (1% typical)
- Elevation constrained to West, South, and Fast
- Class 3 wetland to North
- Groundwater 3'-5' below grade, based on monitoring, seasonally variable
- PAH, Arsenic, some petroleum contamination
- Silty sands, fill soils

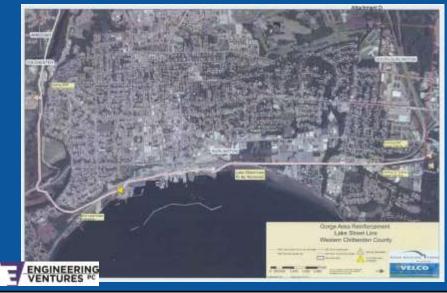
#### **VELCO Gorge Project**

- Public Service
   Board approval
   needed for
   VELCO Gorge
   project –
   needed to allow
   undergrounding
- Potential schedule killer

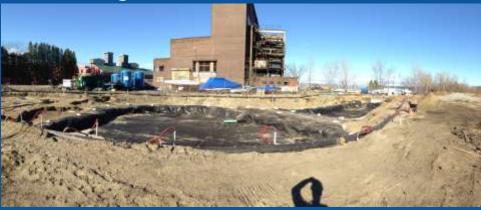
#### Dewatering

- Dewatering: Water removed from excavations shall be handled in one of the following ways, depending on location and field evaluation by the Environmental Project Manager (EPM):
  - Areas of known contamination: Pumped through a 25 micron bag filter, into a fixed axle 21,000 gallon frac tank. Tank to be parked in the fenced yard east of the Moran Plant.
  - Presumed contaminated: Pumped through a 25 micron bag filter, into a fixed axle 21,000 gallon frac tank. Tank to be parked in the fenced yard east of the Moran Plant.
  - iii. Presumed clean: Pumped through a 25 micron bag filter into one of three infiltration areas noted on the plans.
- b) Frac tanks to be pumped to the Municipal wastewater system following 24 hour settling period

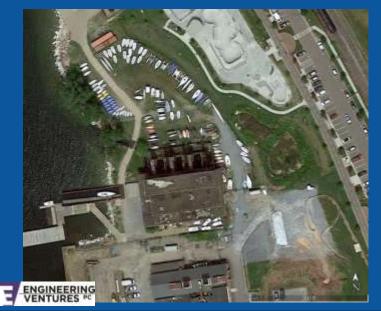
#### Finished Project from Google Earth

Well, not quite finished

- Marina construction underway in photo
- Moran project still under design
