Long Branch Coal Gas Site

◆ Troutmans Creek Remediation

Allan S. Motter
NJDEP/BEERA
609-984-4532
allan.motter@dep.state.nj.us

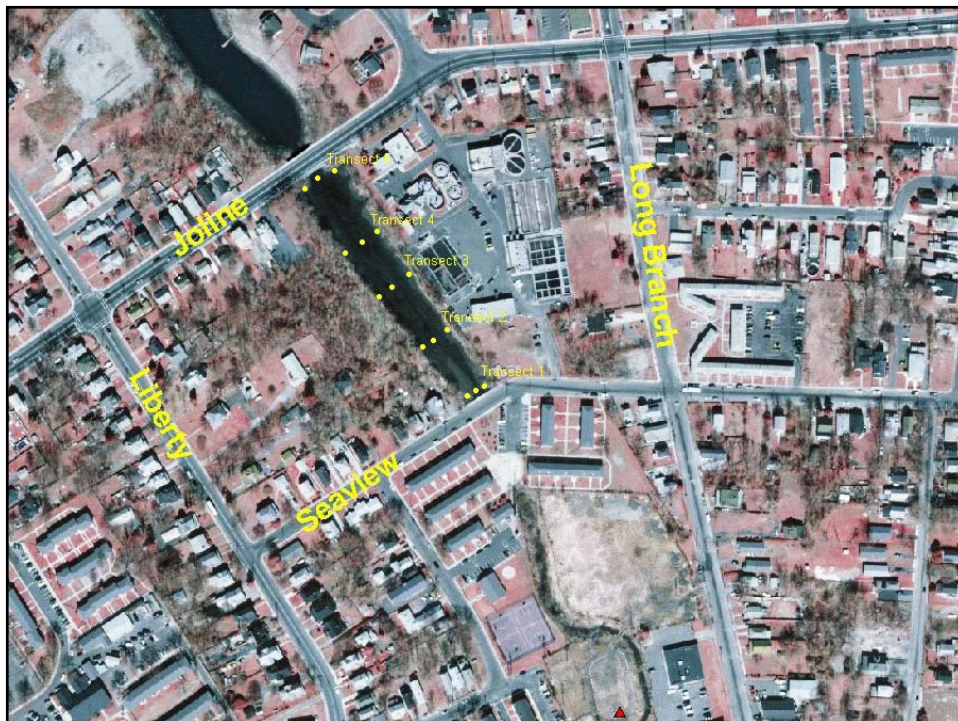
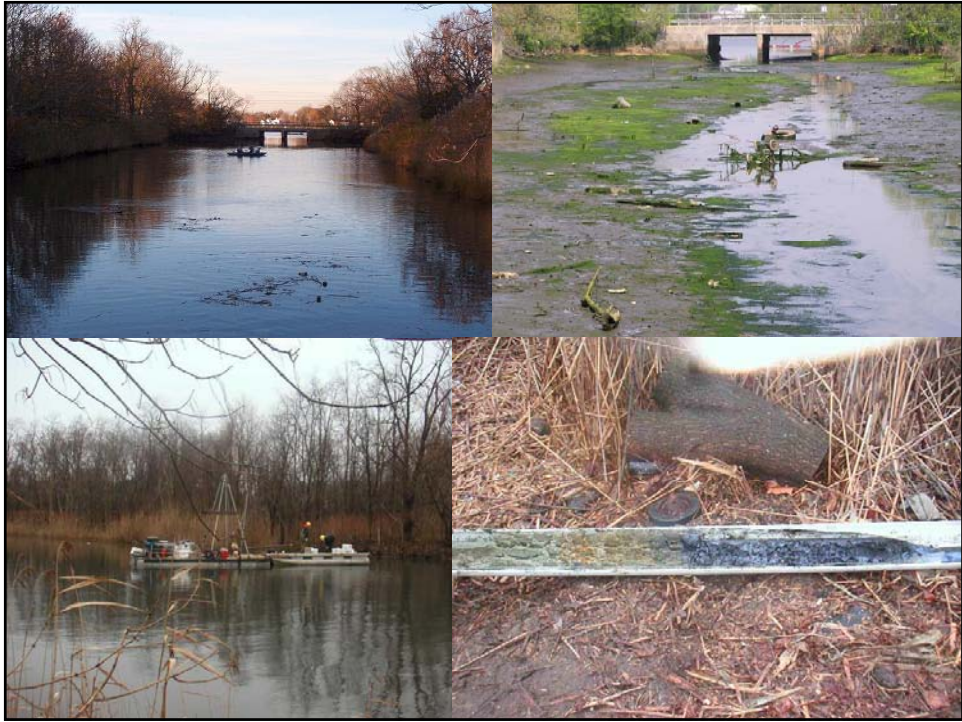
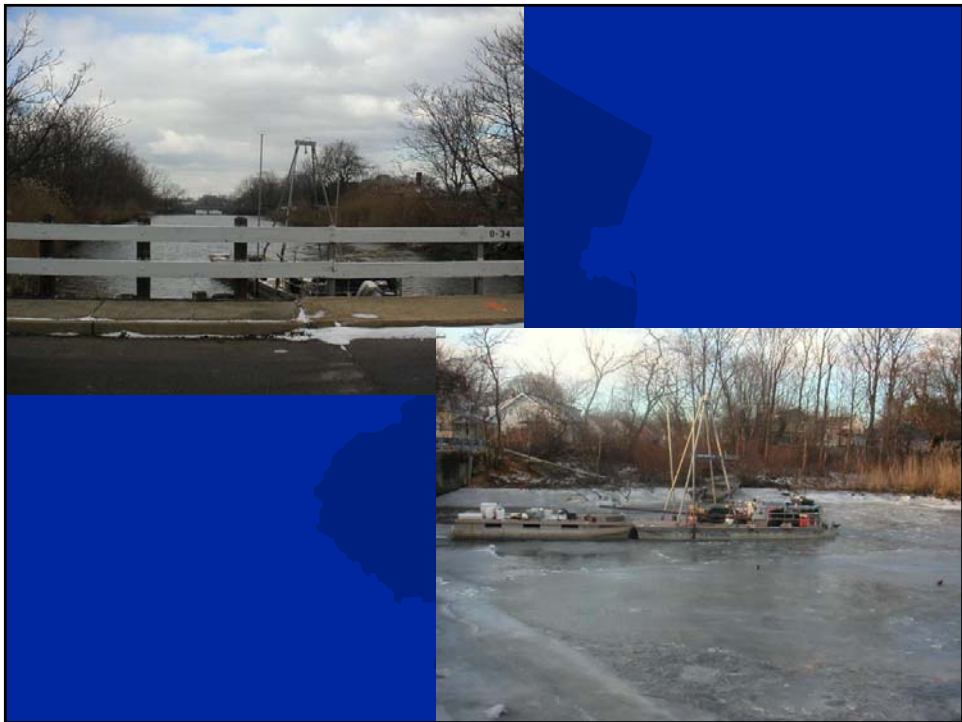
Characterization (Seaview to Joline Avenues)

- ◆ Transect Sampling via Vibracore (five transects, 3 locations per transect)
- ◆ Observation and Mapping of Free Phase Product
- ◆ Sample Collection and Analysis of Surface Sediment (0"-6" below surface debris) and Deep Core (depth based on field conditions)

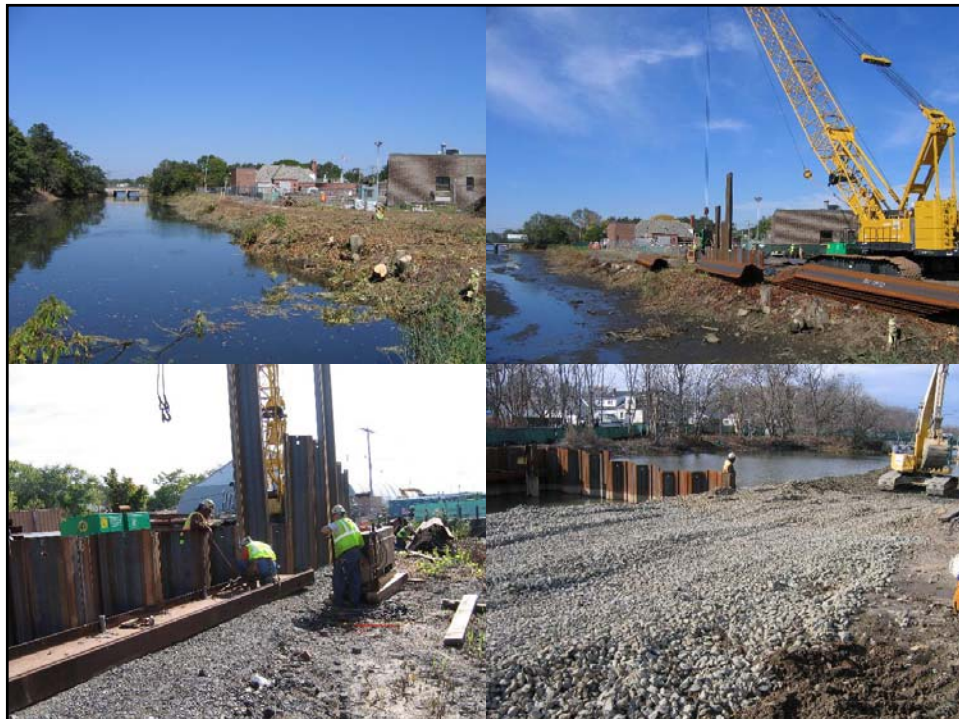
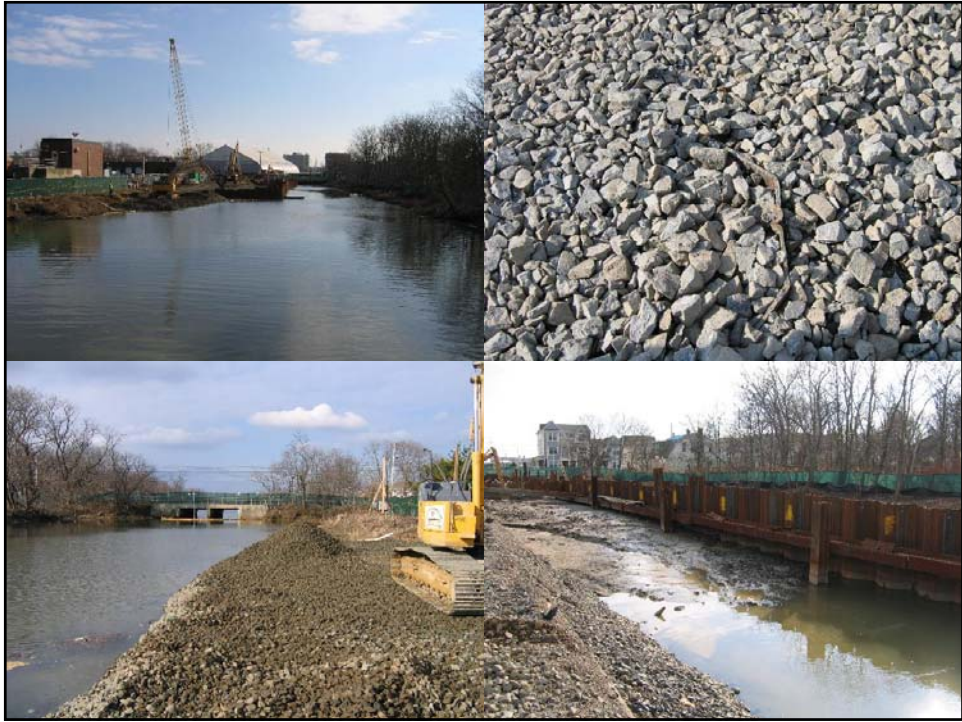
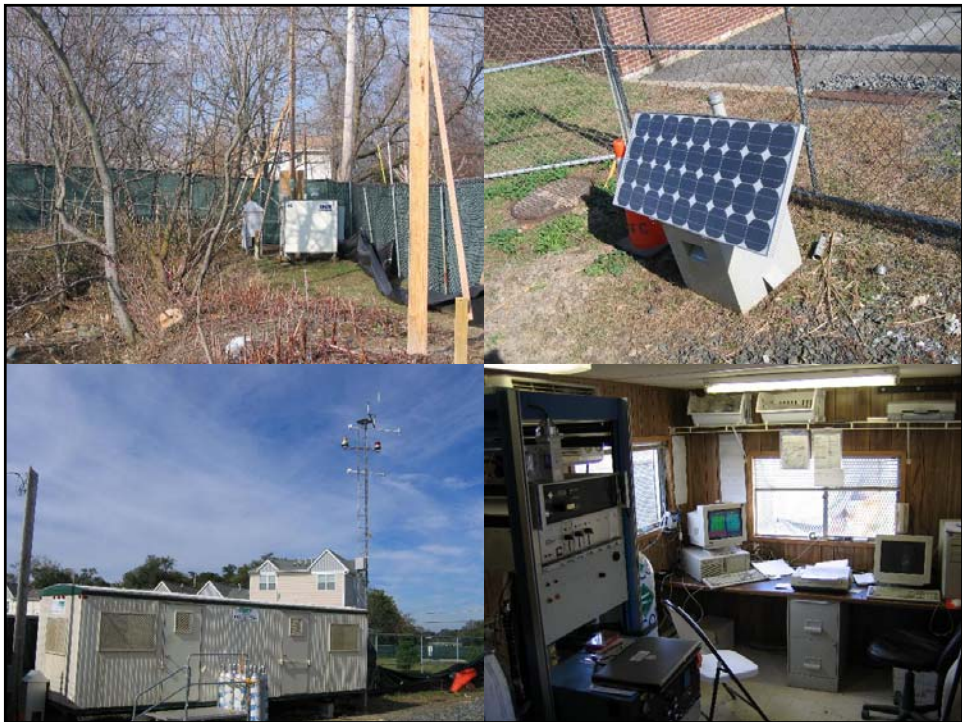
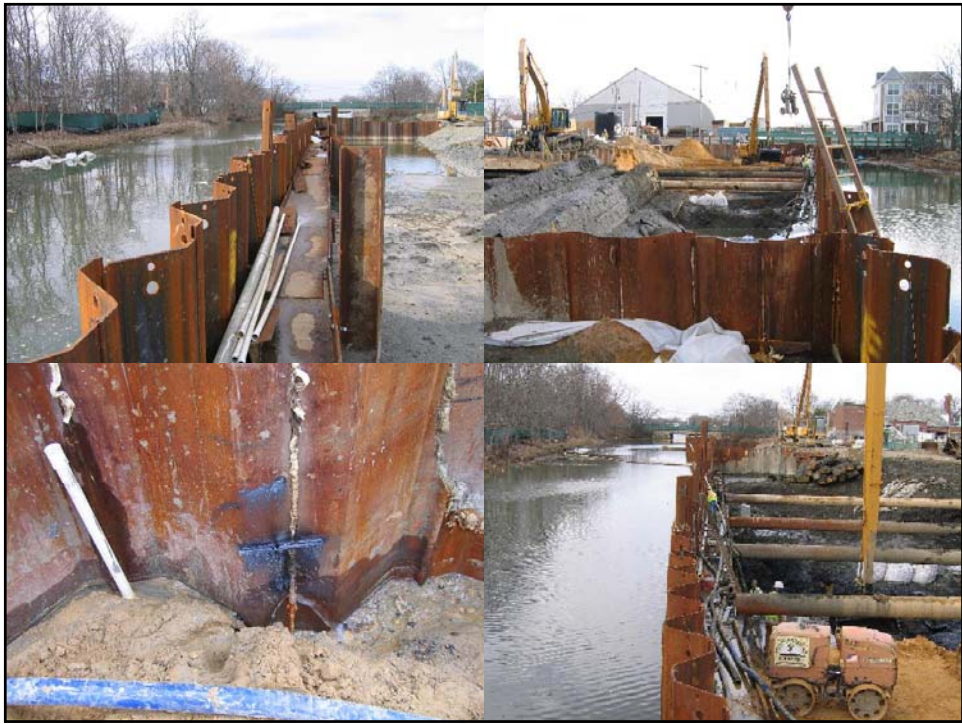
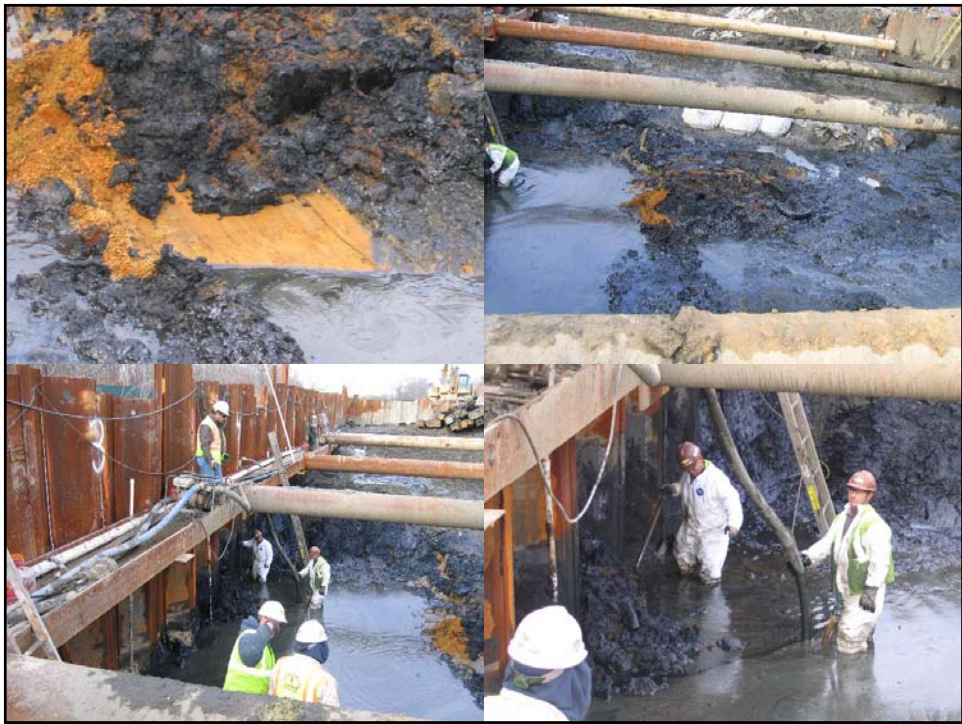
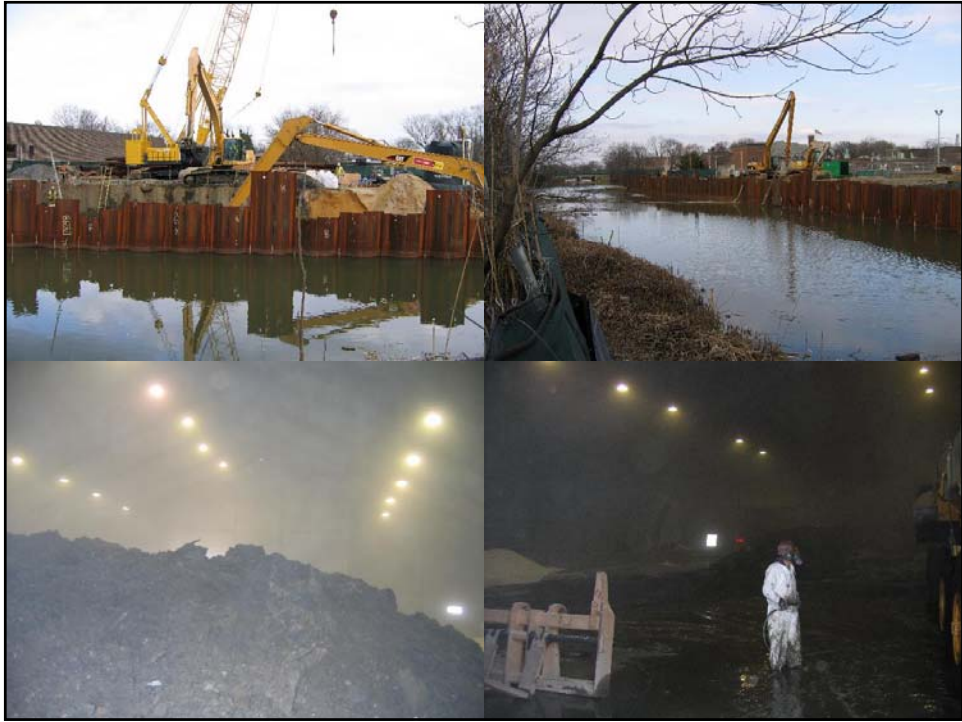
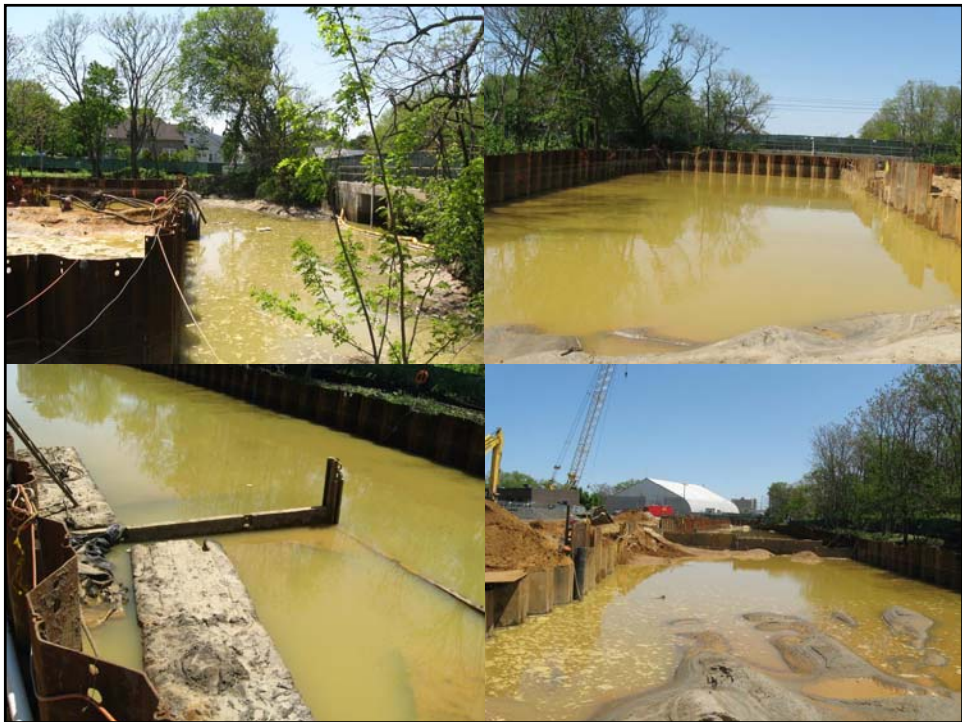
Remedial Strategy

- ◆ Excavation of Free-Phase Product in First 500 feet of Troutmans Creek from Seaview Avenue to Joline Avenue
- ◆ Thermal Desorption and Daily Landfill Cover for Excavated Sediment
- ◆ Removal of Elevated PAHs and Gelatinous Material of last 50 feet of Troutmans Creek up to Joline Avenue
- ◆ Risk Assessment Allowed Natural Attenuation for Area North of Joline Avenue (Contaminants Consistent with Background)

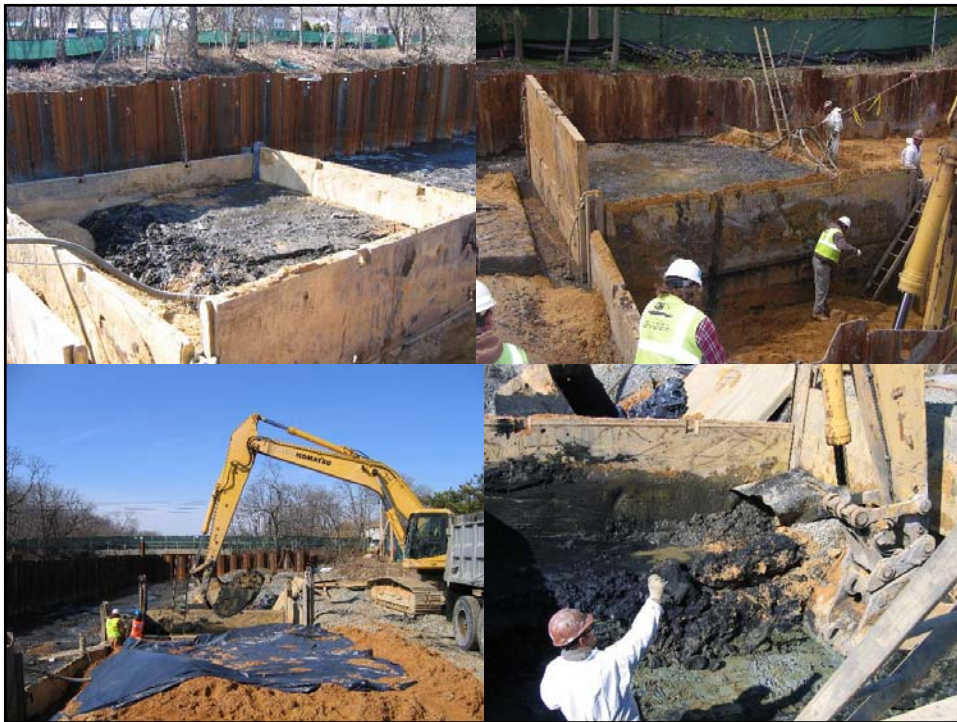
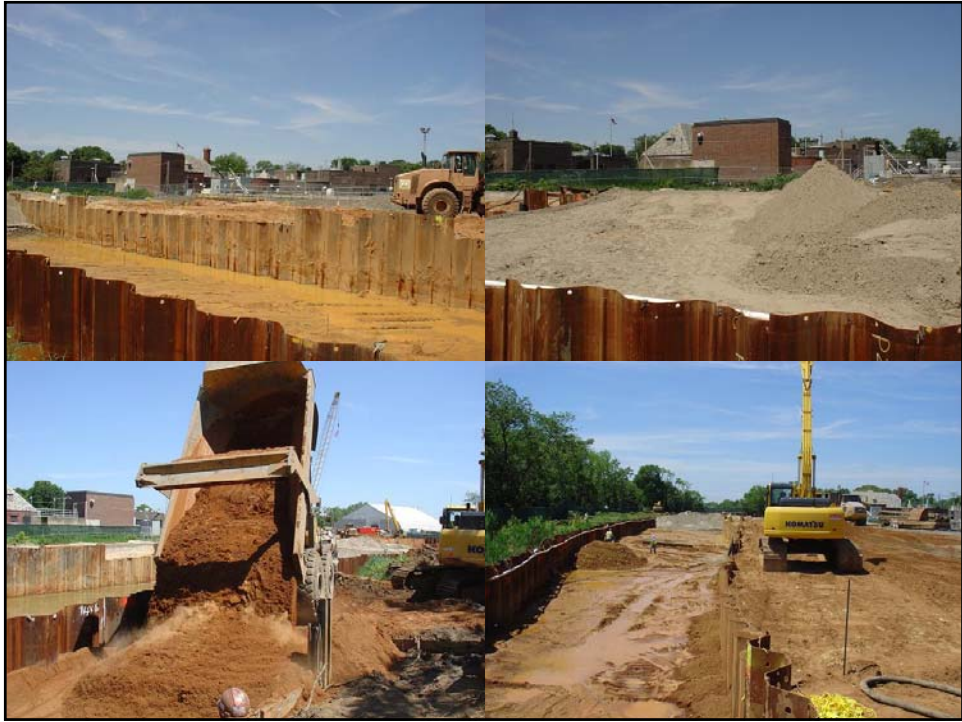
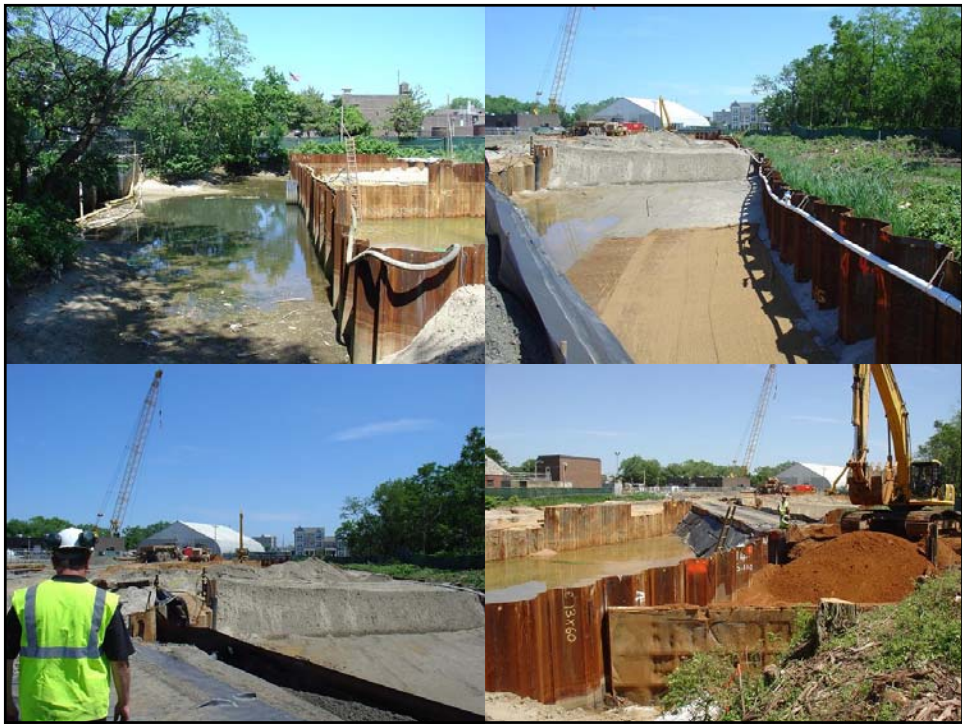
Lessons Learned

- ◆ Sandbags did not hold back product
- ◆ Sandbags became contaminated and had to be disposed adding to waste stream
- ◆ Continued recontamination of backfilled material lead to over excavation
- ◆ Very labor intensive process

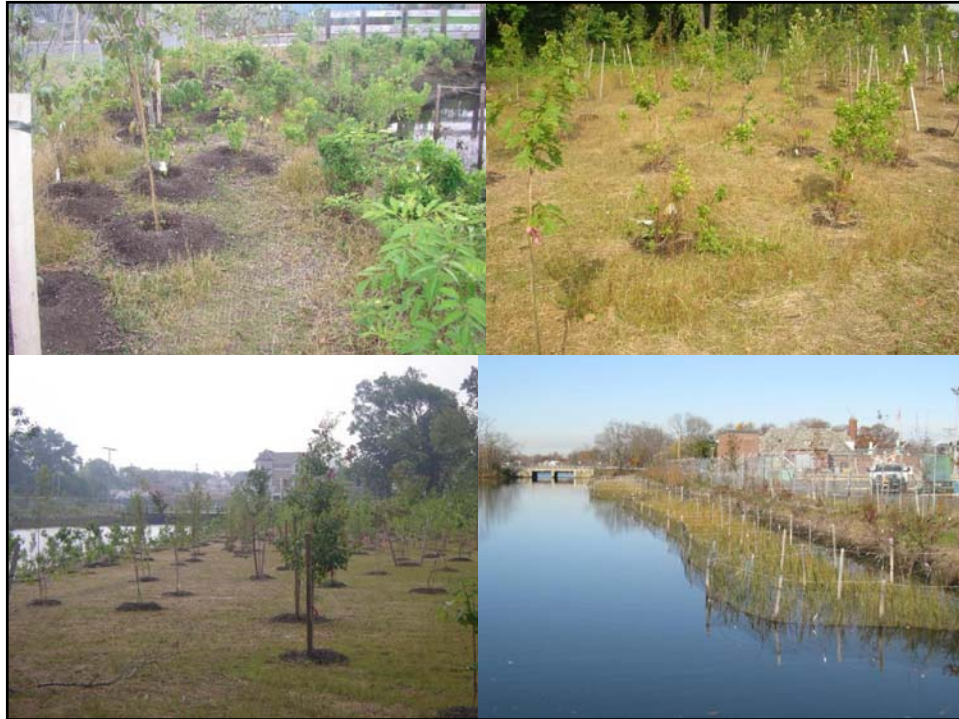
Ecological Enhancements

- ◆ Eliminated Bulkheads and Sloped Western Bank
- ◆ Eliminated Phragmites and Added Spartina Wetland on Eastern Bank
- ◆ Eliminated Invasive Shrubs/Herbaceous Layer and Added Native Species in Upland
- ◆ Resulted in Greater Aerial Extent of Wetlands with Increased Value
- ◆ Upland Habitat had Increased Value
