Stormwater Case Studies in Rhode Island

Igor Runge, Ph.D., P.H.
Senior Consultant
GZA GeoEnvironmental, Inc.

Case Study 1 – South Street Substation

Case Study 2 - Energy Facility Infrastructure Modifications

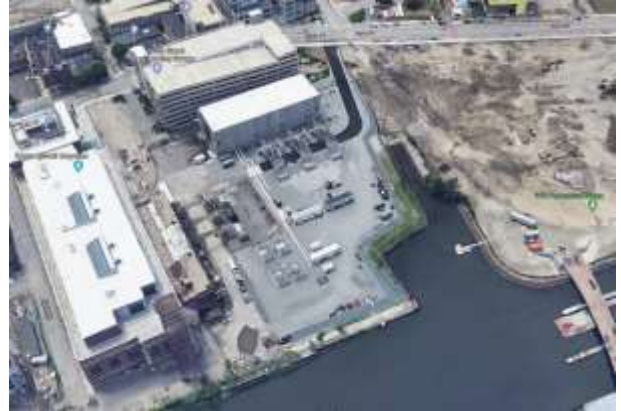
- Located along the Providence River in Providence, RI
- Rebuild of existing substation (5+ acres); included:
 - Demolition of existing substation and control house
 - Construction of new building
 - Relocation of existing overhead transmission line below ground

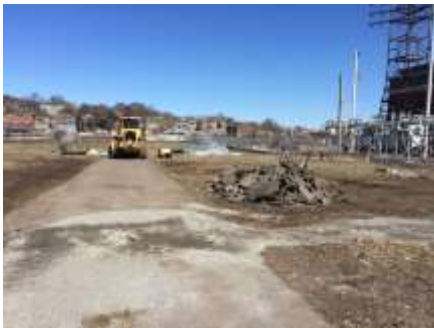
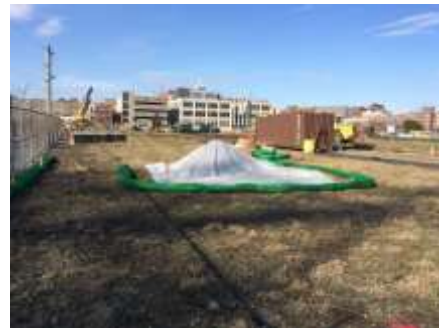
- RIDEM regulated site due to contamination from prior uses - brownfields
 - Excavate/remove certain contaminated soils
 - Install engineered cap (impermeable barrier) – selective?

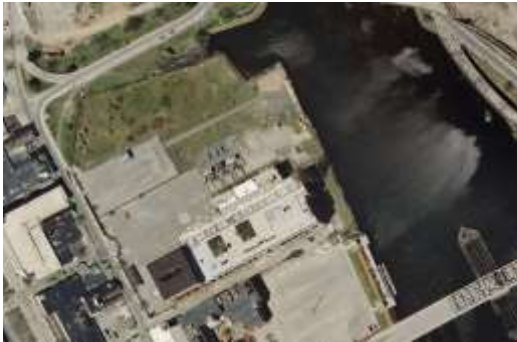
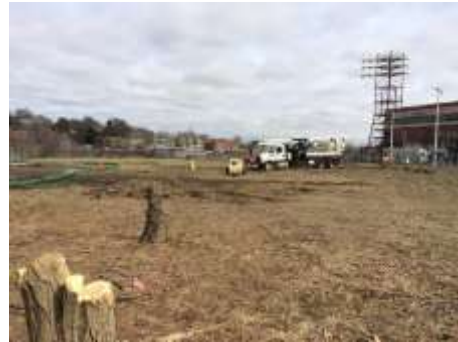
- Infiltration questionable – soil contaminated with various constituents
- Groundwater samples revealed only low-level impacts
- Providence River in this area is impaired water (303d list)
- Limited space

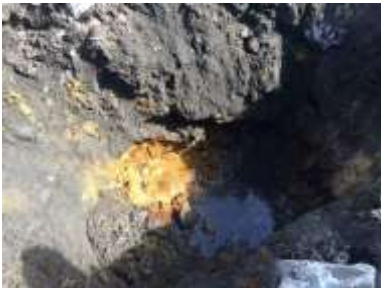
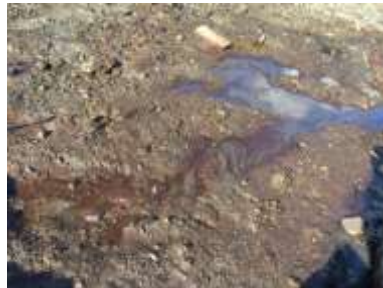
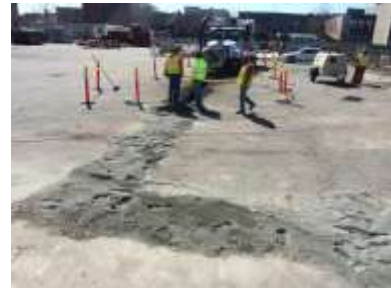
- Underground utilities everywhere
- Limited stormwater allowed in existing municipal system
- Impermeable liner may cause safety issues related to electrical system

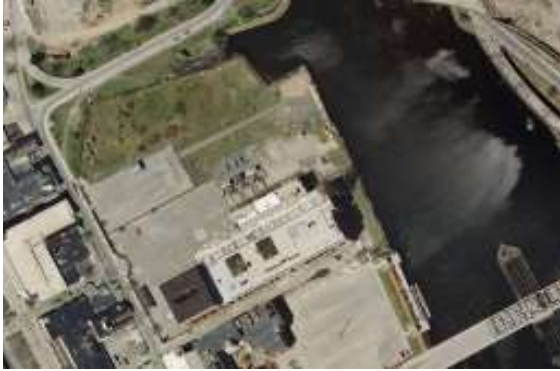
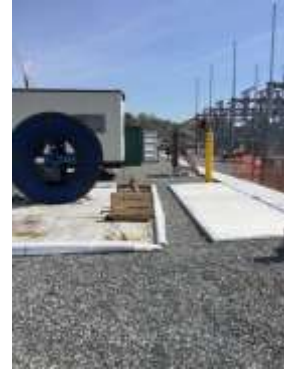
- Completed a Green/Yellow/Red assessment of infiltration suitability of soils
- Roof runoff treated separately (small infiltration basin in green area)
- Transformer area, properly located, allowed to infiltrate (yellow area)

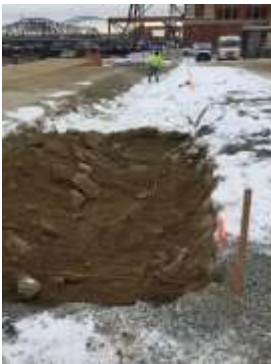
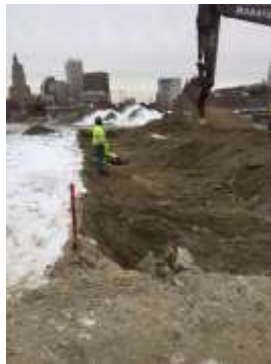
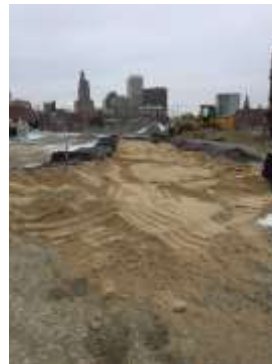
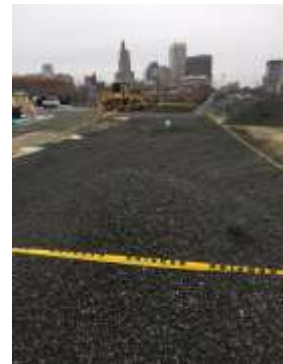
- Additional treatment provided by 2 infiltration trenches (to accommodate WQV) – to capture and treat as much runoff as practicable from paved surfaces

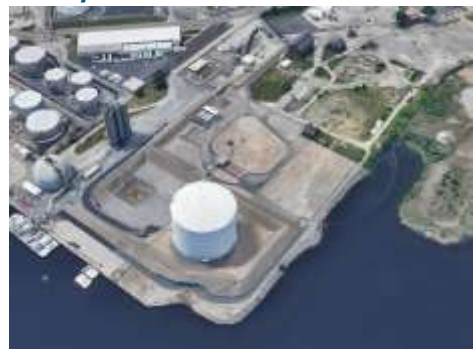
- Work on a portion of a 42-acre parcel
- Located along the Providence River in Providence, RI
- Modifications to an existing facility
 - Construction of a new building
 - Building approximately 11 feet above existing ground level
 - Installation of over 400 piles
 - Considerable existing underground infrastructure
- RIDEM regulated site due to contamination
 - Metals, coal tar, organics
 - Work to comply with Soil Management Plan
