CASE STUDIES

ACCUMULATION OF REMEDICATION WASTE ONSITE

NJDEP

NEWMOA Webinar - January 24, 2019

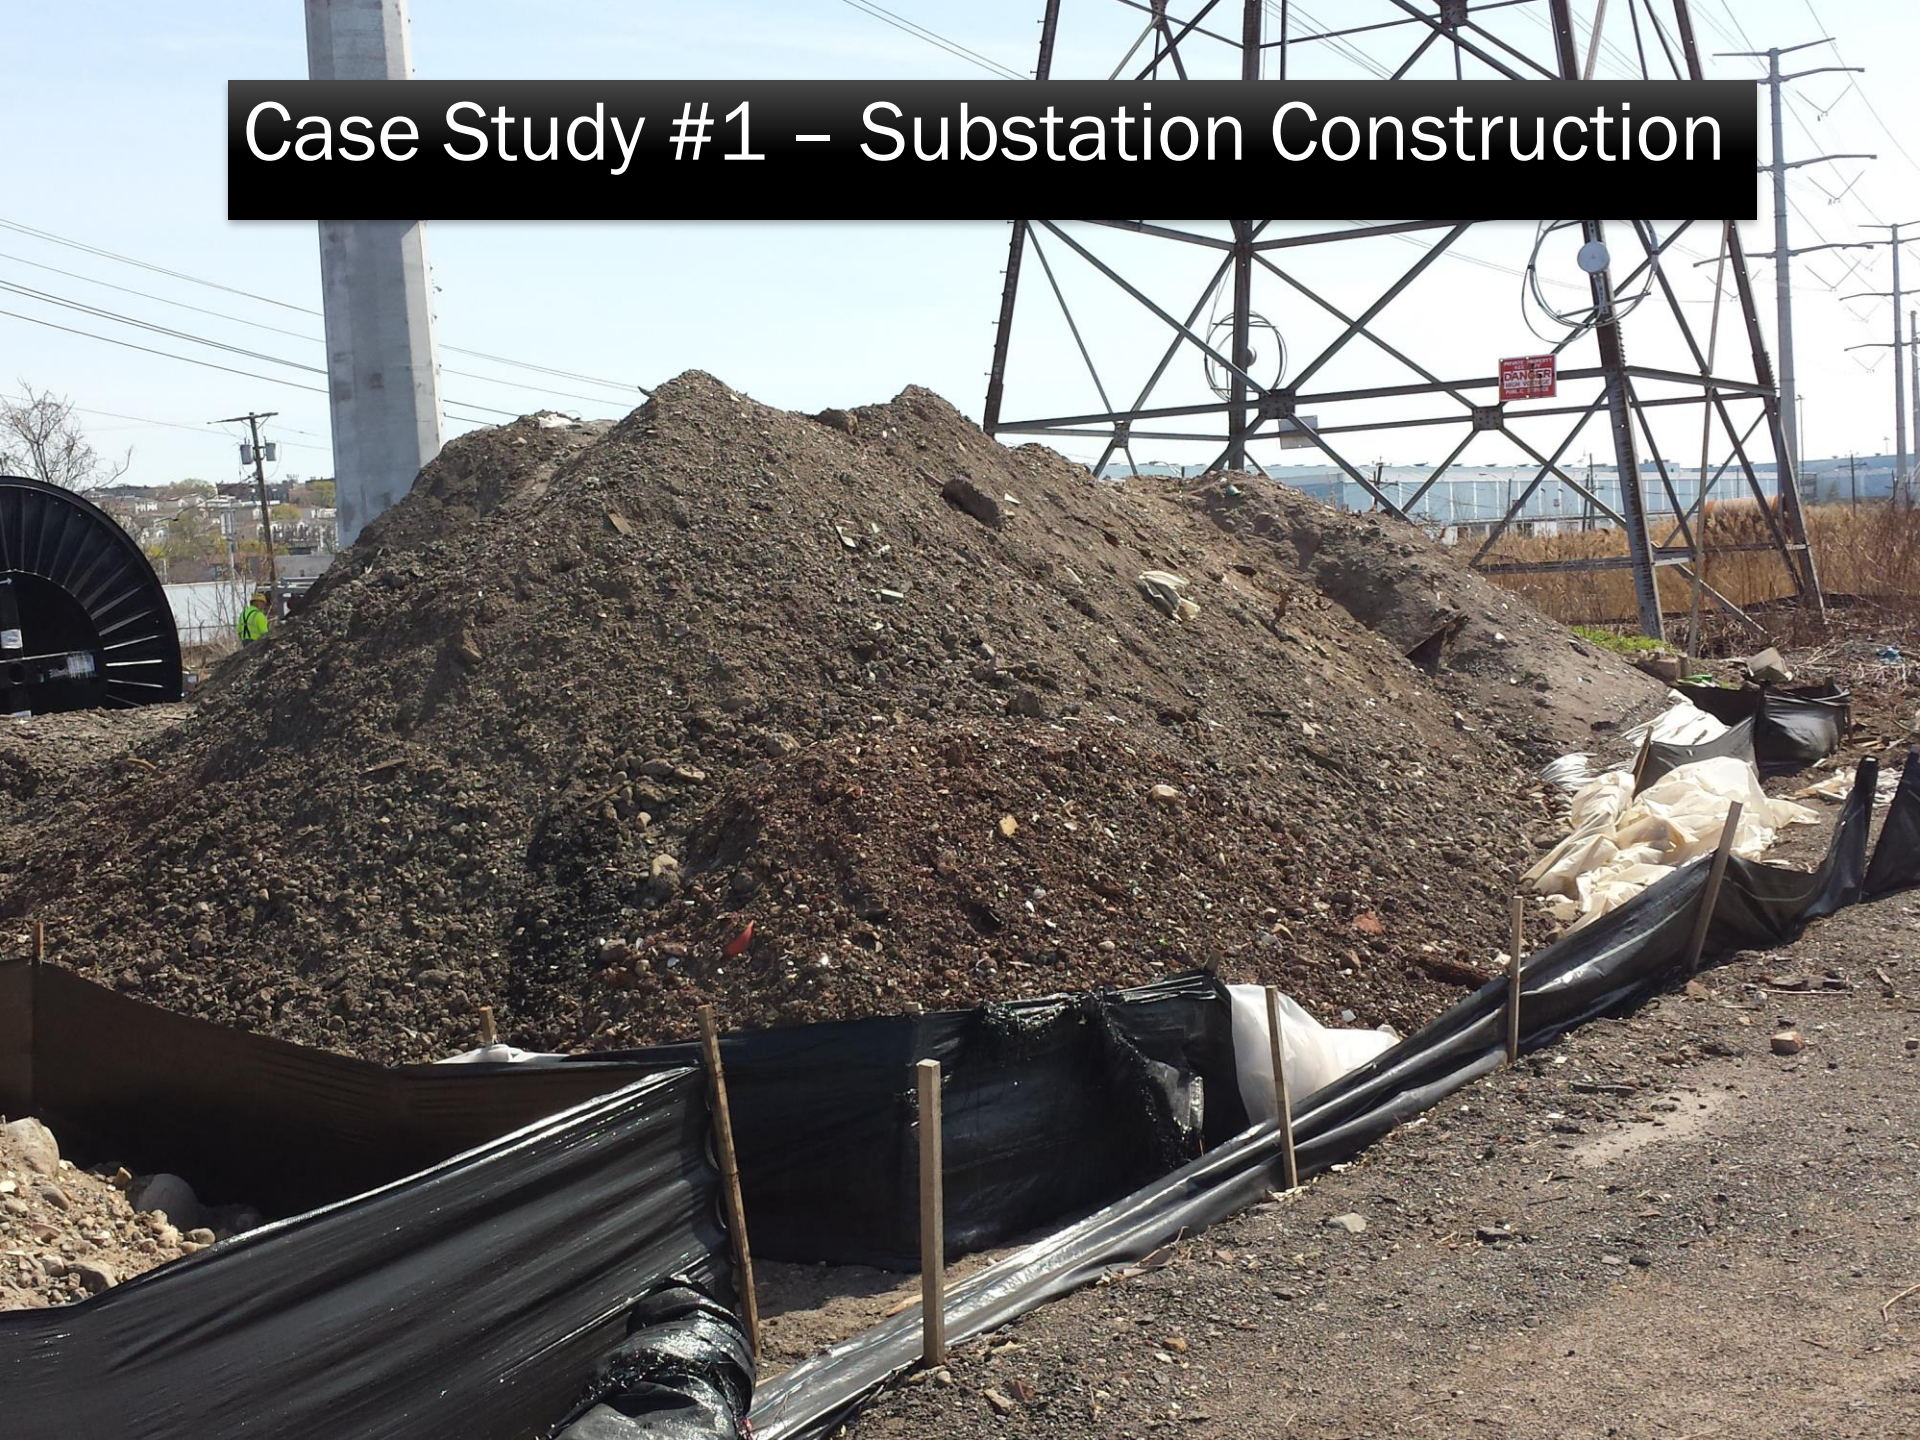
Case Study #1 – Substation Construction

- As a result of upgrading substation, PSE&G generated waste excavated soils.
- The excavated soils were accumulated in piles and then sampled for determination. The soil piles were found to be above RCRA regulatory levels (TCLP) for lead.
- The substation generated Large Quantity Generator (LQG) amounts of D008 hazardous waste (>2,200 lbs./month).
- As per RCRA, LQGs can accumulate hazardous waste for no more than 90 days without applying for Part A/Part B RCRA permit. Generators can only accumulate in containers, tanks, containment buildings and drip pads.
- PSE&G Response: Excavated soil handled in accordance with the NJDEP linear construction guidance document allows soil to be stockpiled and contained while being tested for disposal. Also the site was undergoing remediation and RCRA requirements are not applicable.

- Contamination found must be reported to the DEP Hotline.
- Since excavated soils were found to be above RCRA regulatory levels (TCLP) for lead, the substation is a hazardous waste generator and all applicable RCRA requirements apply.

- Notice of Violation was issued: 1) Failed to determine the waste excavated soils were D008 hazardous waste prior accumulation in waste piles, 2) Failed to place Waste lead contaminated soil (D008 hazardous waste) in containers instead of waste piles & 3) Constructed and accumulated Waste lead contaminated soil (D008 hazardous waste) in waste piles without submitting a Part A or Part B permit application.

- Penalty settlement was reached with Company after the violations corrected.

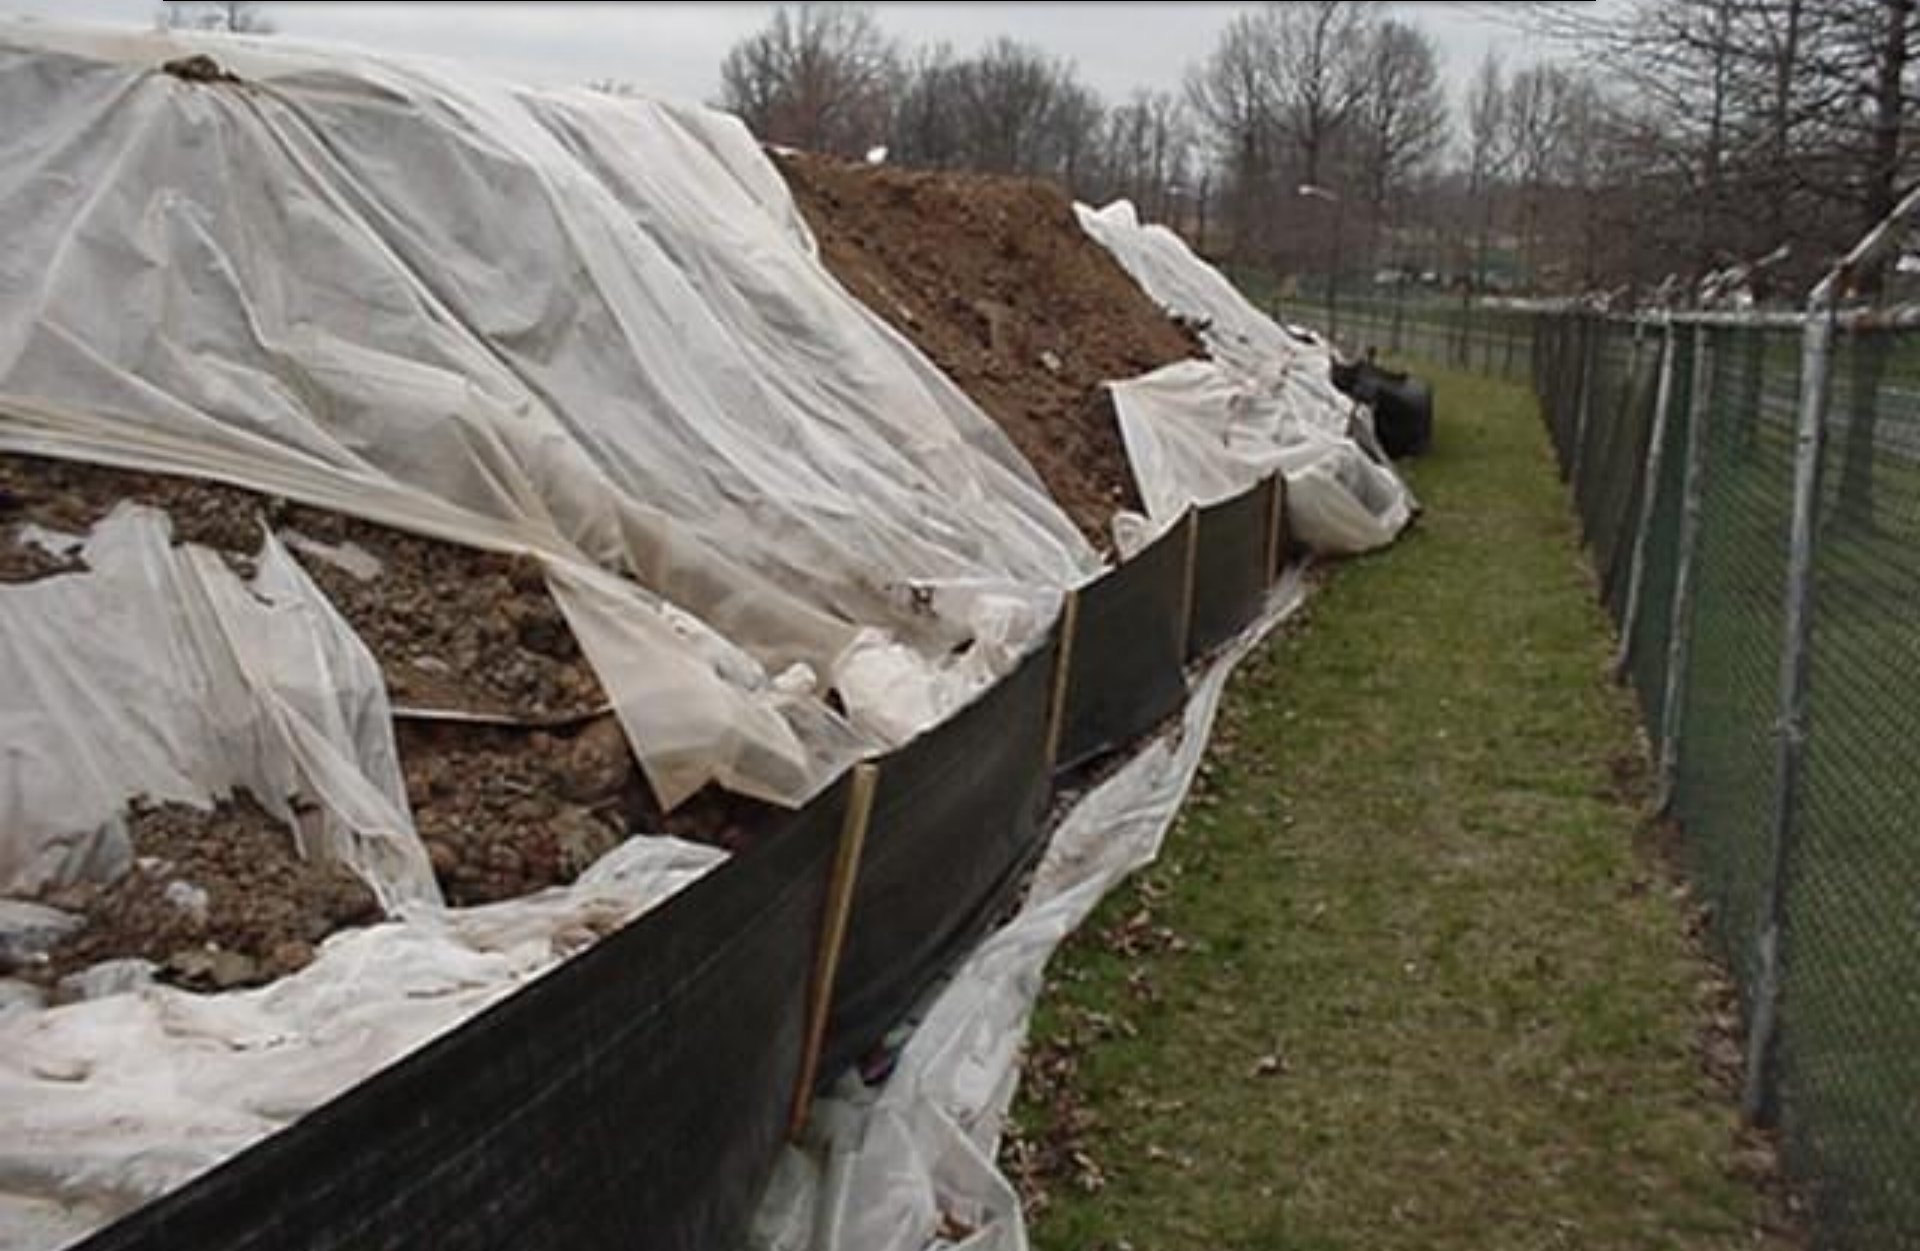
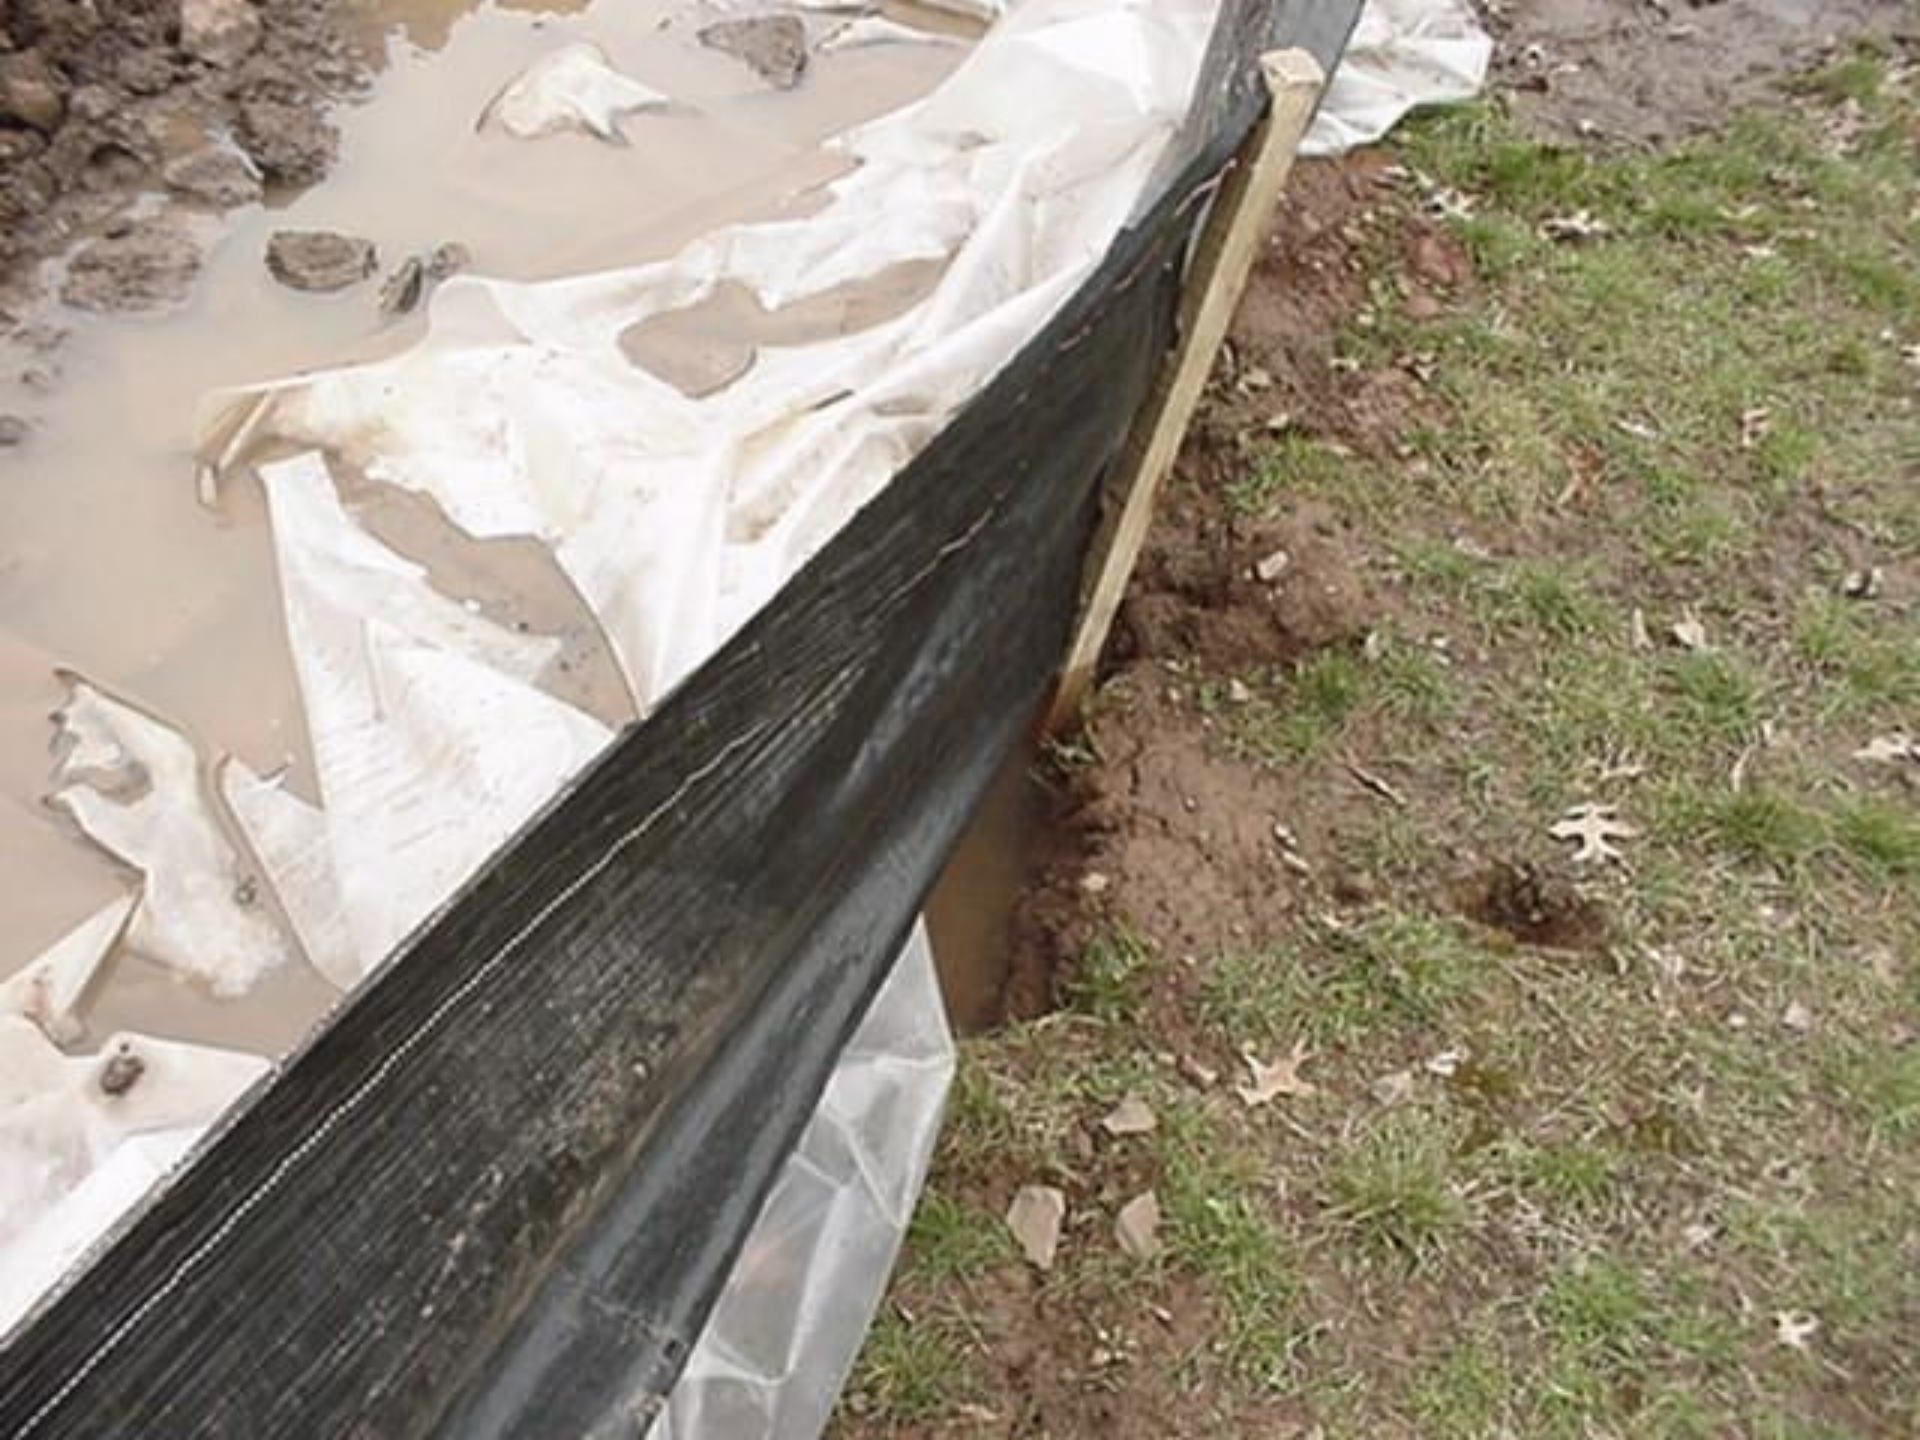
Case Study #2 – ISC Cleanup

- Memorandum of Agreement (MOA) was initiated by ISC & NJDEP-SRP for further remedial activity of the buried wastes at the site.
- On 2/28/00, without notice to NJDEP-SRP, excavation and removal of paint waste, drums, debris and contaminated soils were initiated by ISC and Env. Consultants
- Excavation of the area near the driving range produced seven roll-off containers (varied sizes) holding debris, old paint drums, & soil and approximately 7,500 cubic yards of contaminated soil and placed in a pile.
- The analysis provided by ISC & Consultants (3/27/00) showed that the waste pile and the waste material in the roll-offs failed for TCLP Lead and Benzene.
- On 5/25/00, NJDEP-SRP terminated ISC's MOA. ISC had been managing the remediation wastes in a hazardous waste pile without a RCRA TSD permit.

- A Notice of Violation was issued:
- Failure to design, construct, maintain or operate a facility to minimize the possibility of any unplanned sudden or non-sudden release of D008 hazardous waste accumulated in a pile to soil or surface water which could threaten human health and the environment (40 CFR 265.31); and
- ISC accumulated approximately 7,500 cubic yards of D008 hazardous waste for greater than 90 days and constructed a pile holding the D008 hazardous waste, without submitting a Part A or Part B permit application (40 CFR 270.10(e-f)).
- Penalty settlement was reached with Company after the violations corrected.

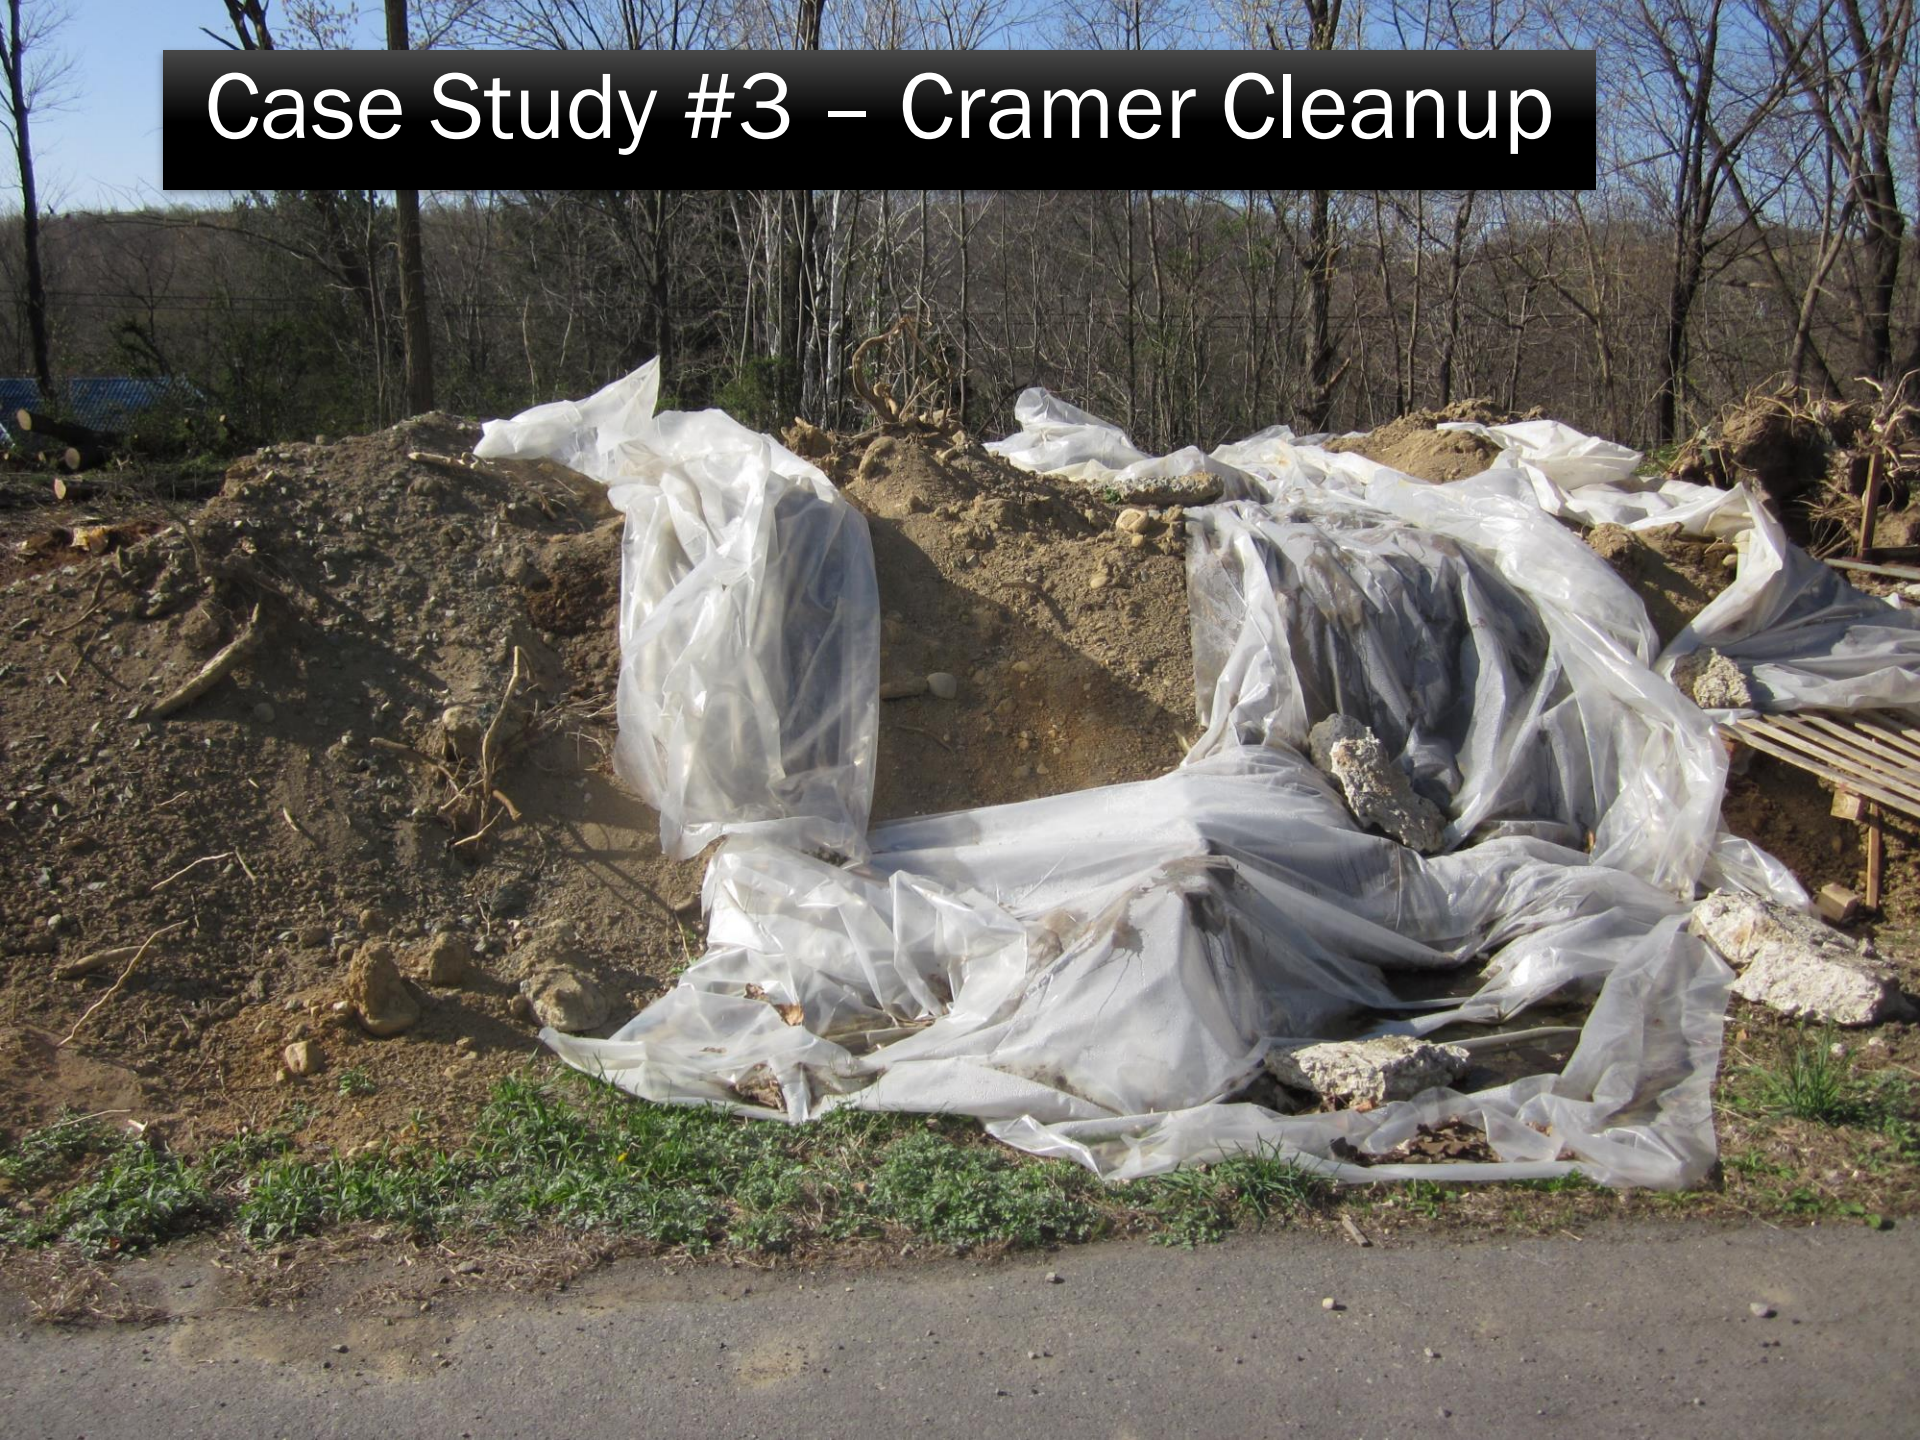
Case Study #3 – Cramer Cleanup

- Cramer was undergoing a remediation of a former unlined lagoon used to collect process sludges, untreated rinsewaters and spent plating solutions (1959 – 1980) and treated rinsewaters (1980-2001).
- NJDEP SRP Investigation Unit (1/24/12) discovered that the area of lagoon was excavated, material stockpiled on-site and later sampled Consultant hired by Cramer.
- The cleanup was initiated without a License Site Remediation Professional (LSRP).
- The excavated material was placed in two (2) piles (approx. 1,381 tons) and each sampled. Both samples were above RCRA regulatory levels for TCLP Cadmium. The pile was uncovered and on bare ground.
- Cramer was Large Quantity Generator of hazardous waste.

- A Notice of Violation was issued:
- Failure to design, construct, maintain or operate a facility to minimize the possibility of any unplanned sudden or non-sudden release of D006 hazardous waste accumulated in a pile to soil or surface water which could threaten human health and the environment (40 CFR 265.31); and
- ISC accumulated approximately 1,381 tons of D006 hazardous waste for greater than ninety days and constructed a pile holding the D006 hazardous waste, without submitting a Part A or Part B permit application (40 CFR 270.10(e-f)).
- Settlement was reached with Company after the violations corrected.
