Case Studies

Vermont Vapor Intrusion Workshop
May 13, 2014

NEWMOA Vapor Intrusion Workshop

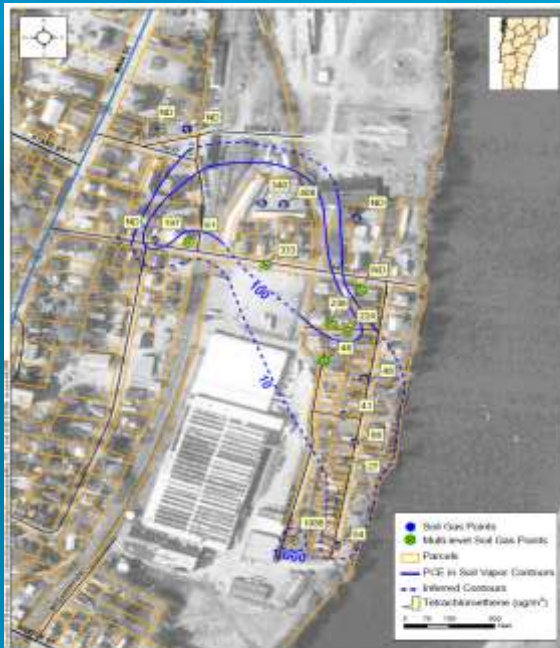
Figure 7: Site Map With Shallow Soil Gas Tetrachloroethene (ug/m³)
Windsor, Vermont

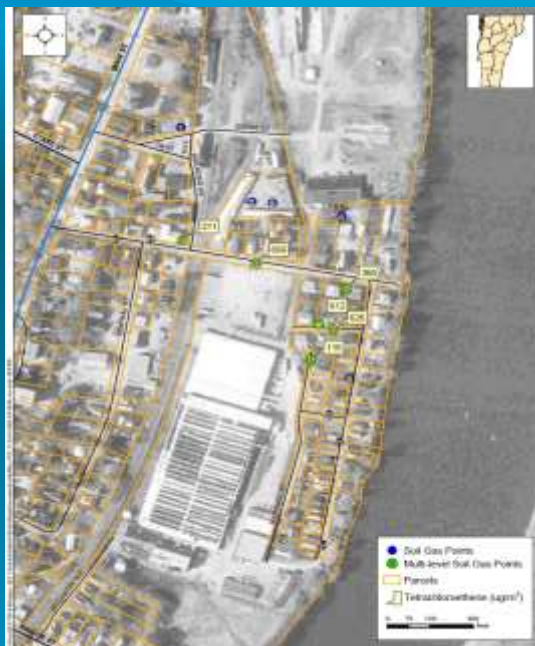
Figure 8: Site Map With Deep Soil Gas Tetrachloroethene (ug/m³)
Windsor, Vermont

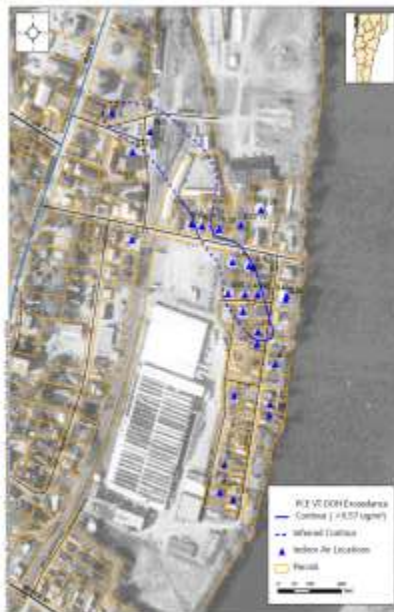
Figure 2: Site Map With Indoor Air Quality Results for tetrachloroethene (aggr)
 Windsor, Vermont
