Bennington Iron Works Site #1998-2482

Monument Plaza Site #2005-3338

NEWMOA ISCO Workshops Westford, MA & Quinebaug, CT March 15 & 16, 2011

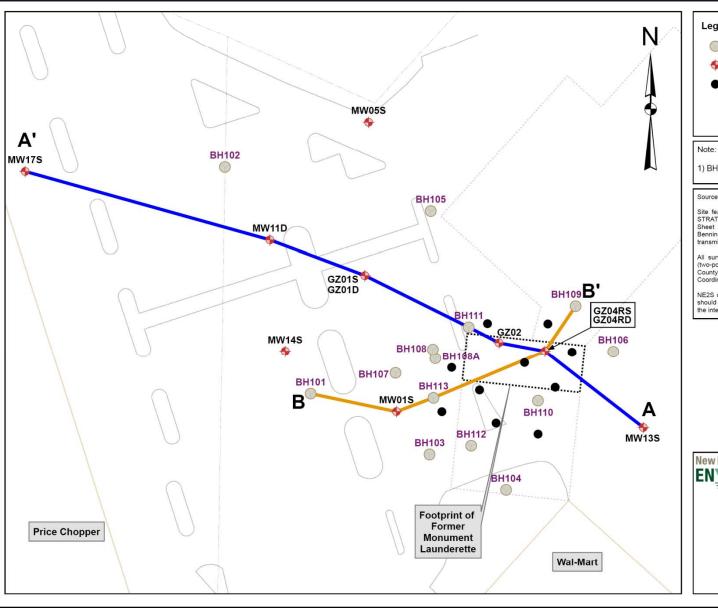
1) BH104 not field located, location is approximate

Site features and well locations from "EXISTING CONDITIONS PLAN, ENVIRO-STRATEGIES WAL-MART, ROUTE 67 A, BENNINGTON' dated 27-May-2008, Sheet Number V-101, scale 1:50, by MSK Engineering and Design, Inc., Bennington, VT, provided as "ACAD-V-SP01-Existing Conditions.dwg2.dwg" transmited 3-June-2008
