# Tracking PFAS in an Island Environment

*Northeast Conference – The Science  
of PFAS: Public Health & the  
Environment*

April 5, 2022

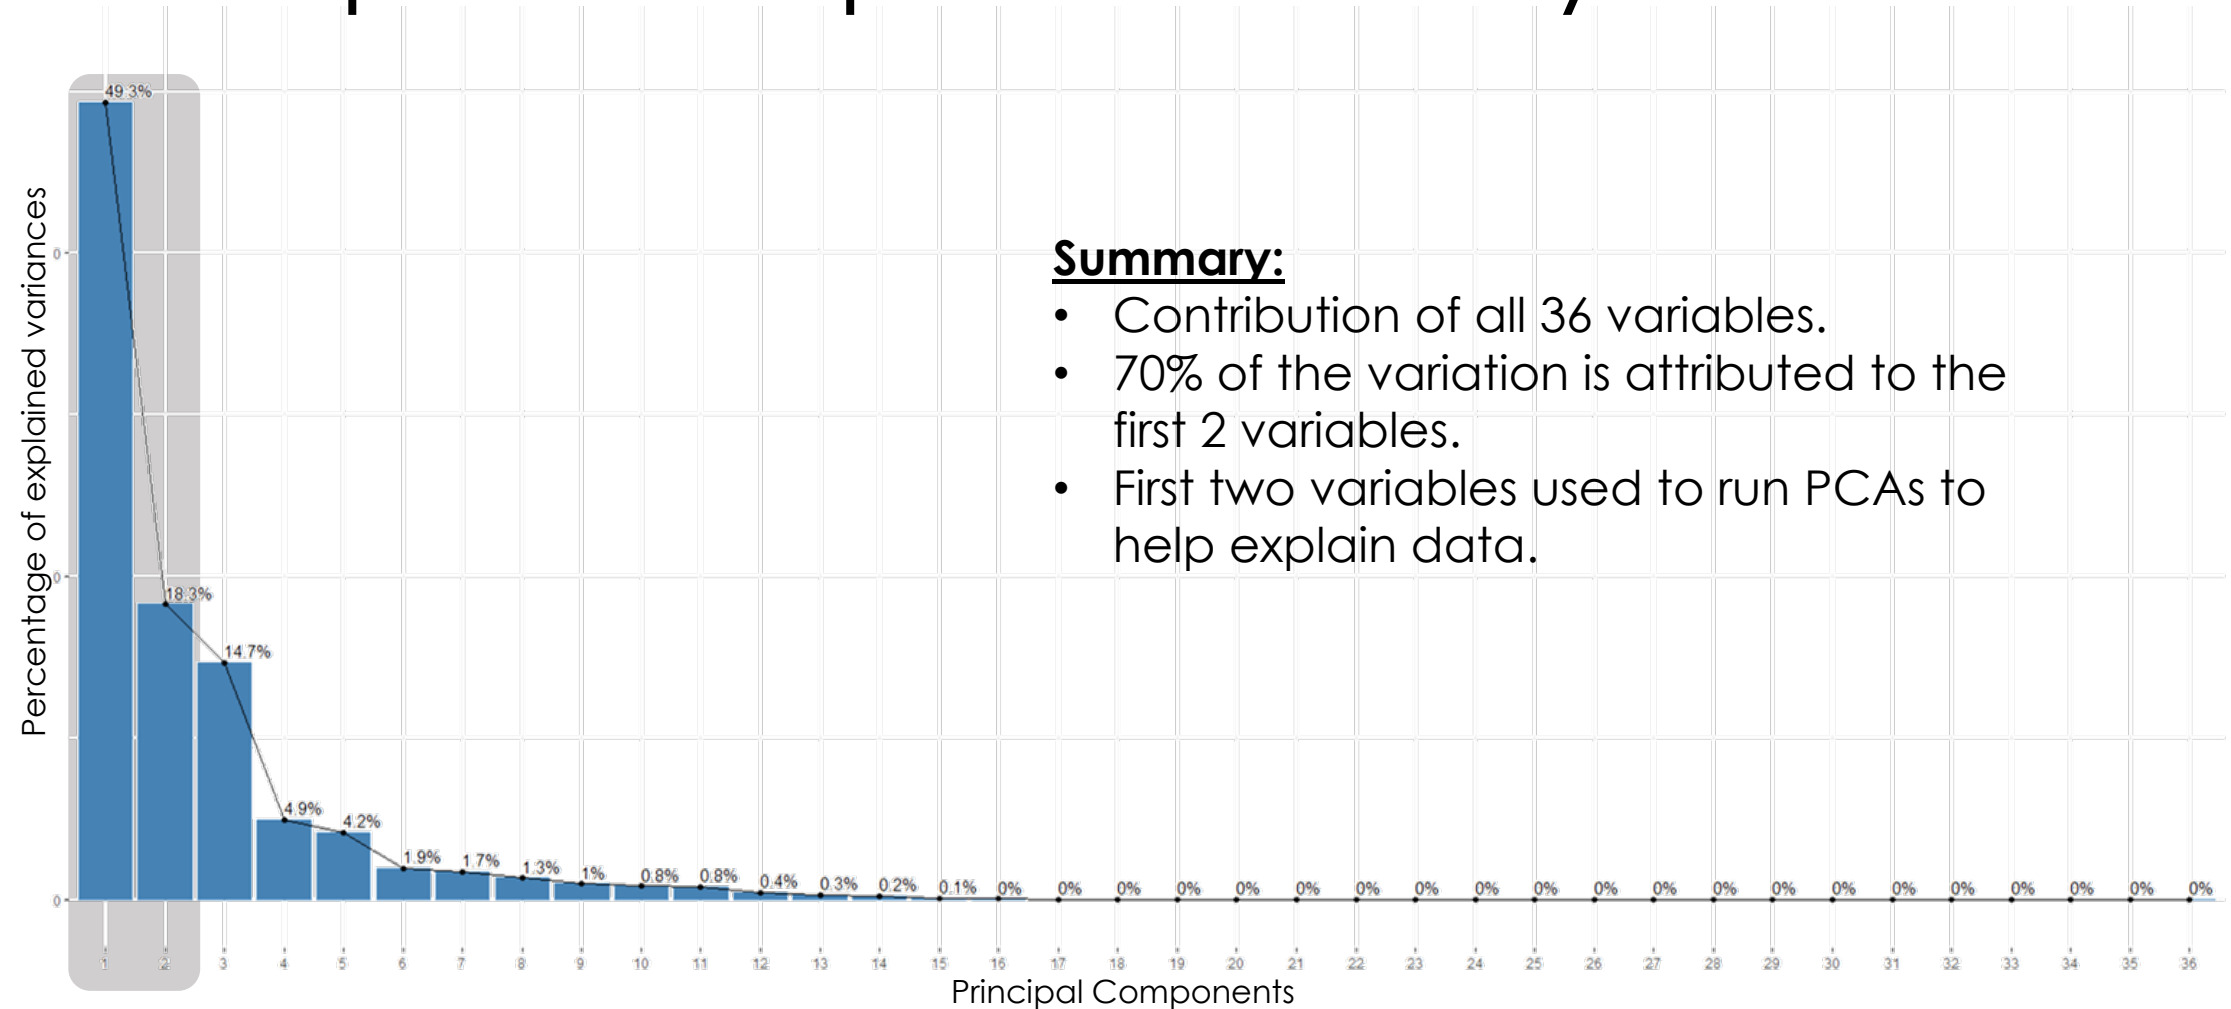
# Principal Component Analysis

## Summary:

- Contribution of all 36 variables.
- 70% of the variation is attributed to the first 2 variables.
- First two variables used to run PCAs to help explain data.

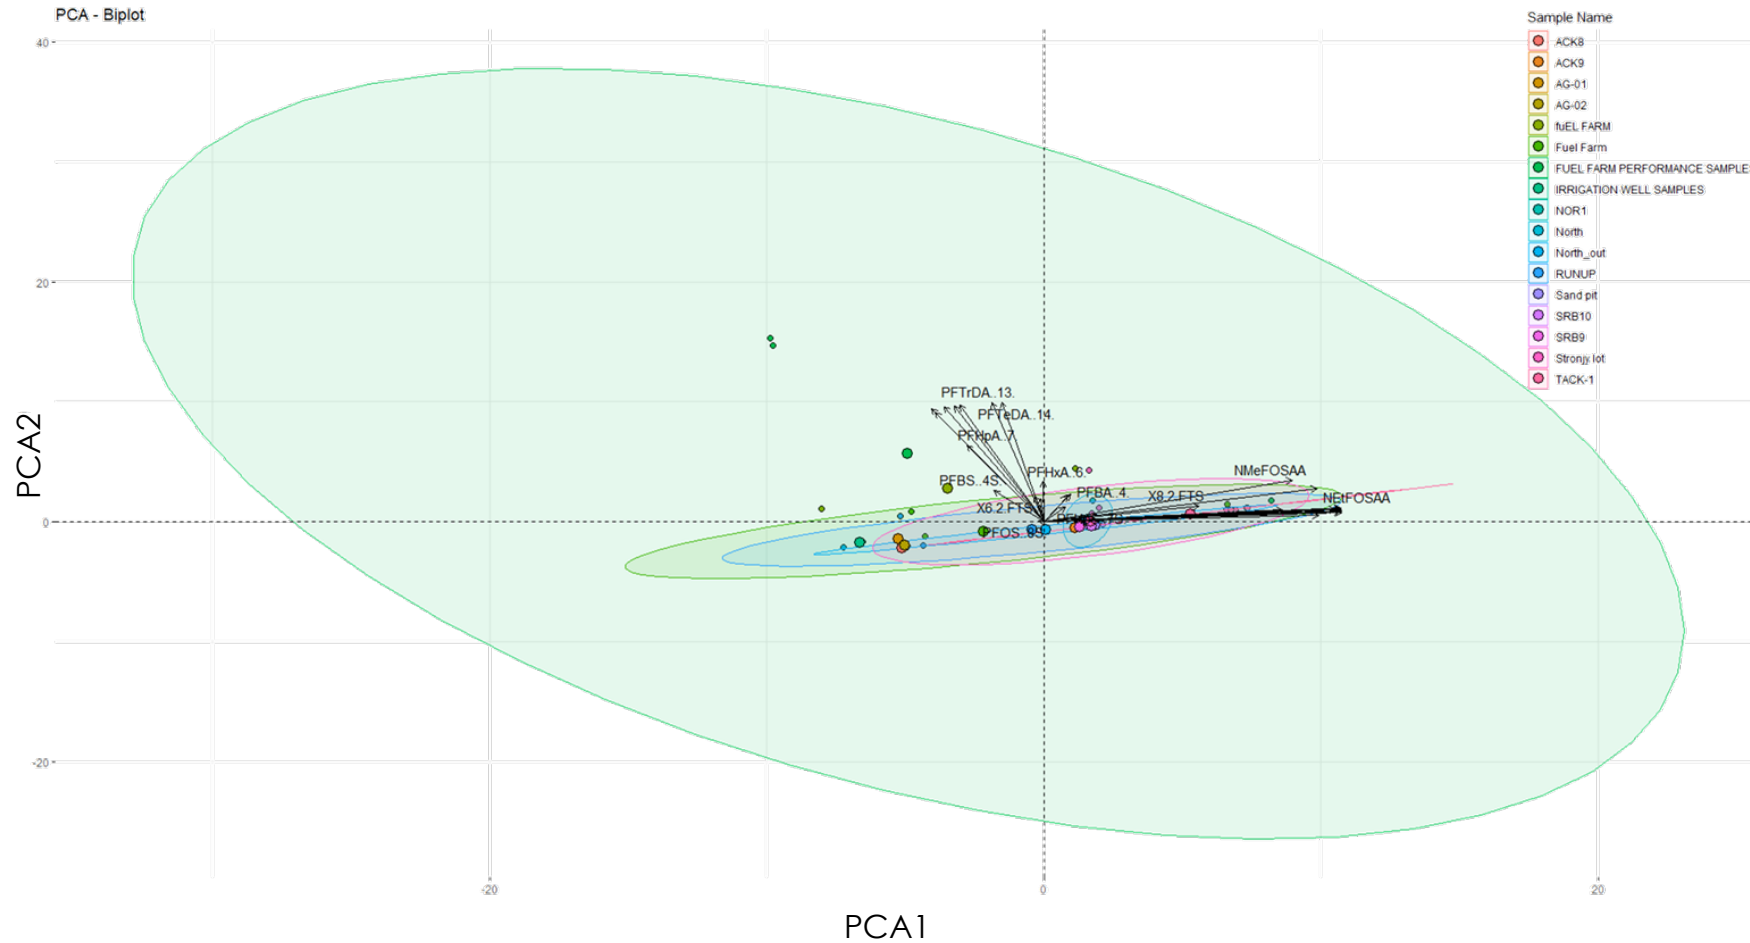
# PCA – Biplot

## Correlation Summary:

- PFCAs correlated with each other.
- Precursors & FTS correlate with PFBA.
- Vector relative distance from center:
  - PCA1 influenced by precursors.
  - PCA2 influenced by longer chain PFCAs.

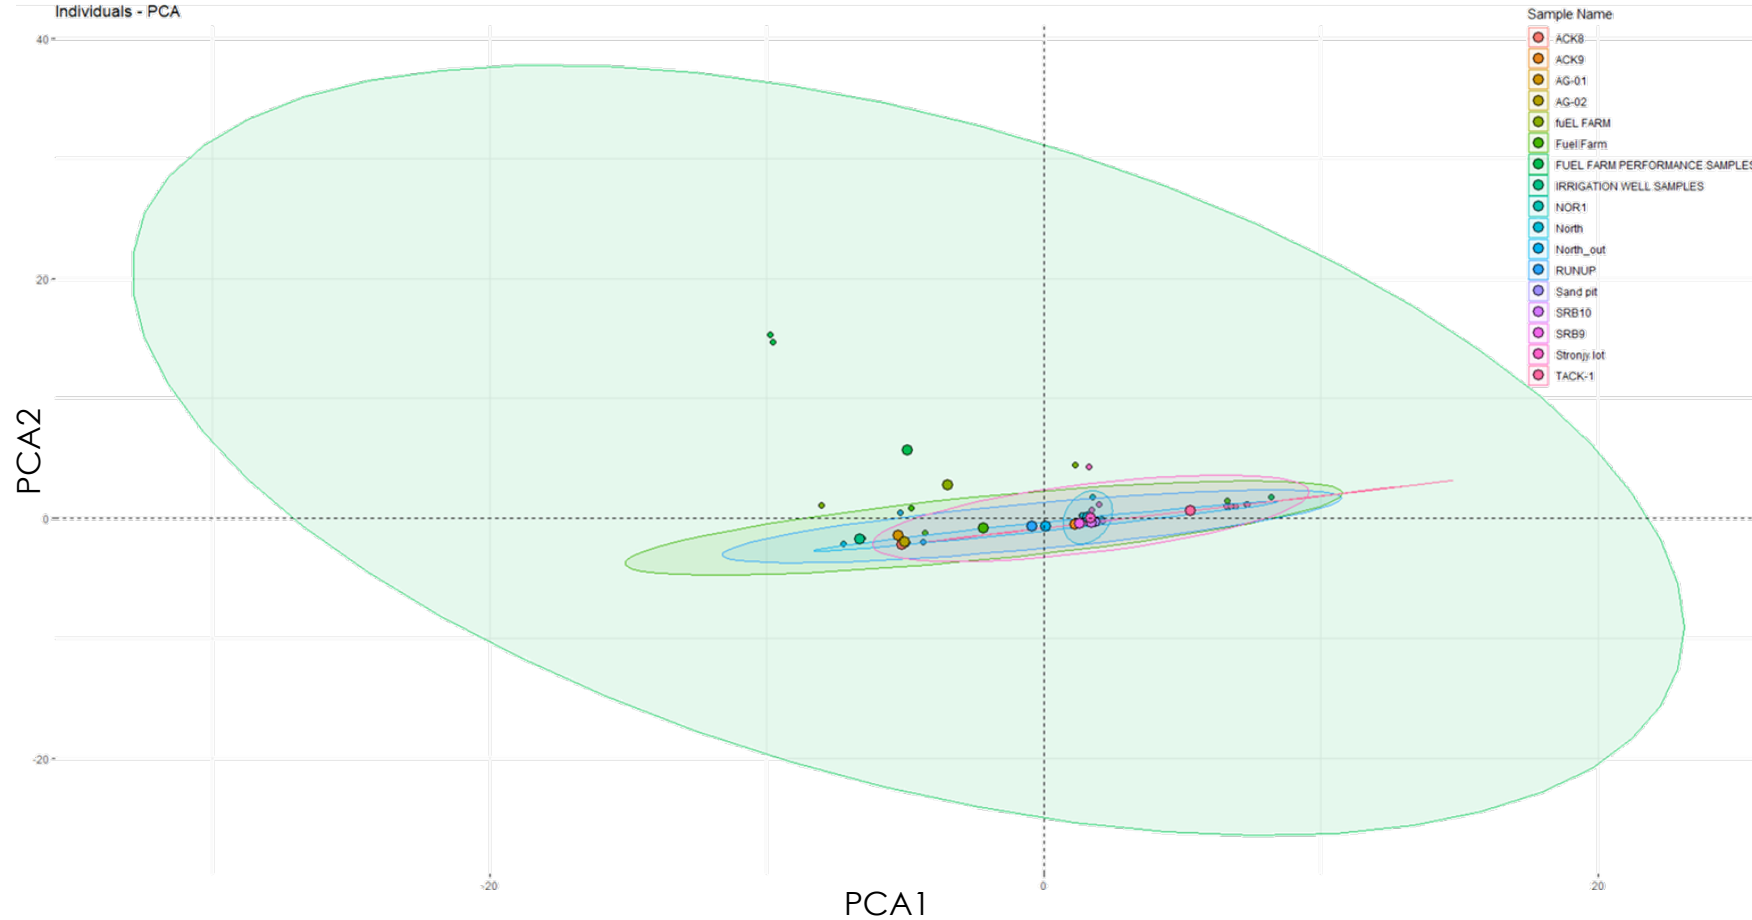
# PCA – Individuals

## Correlation Summary:

- 2 defined groupings.
  - Sand Pit & Strojny Lot
  - Fuel Farm
