PFAS Impacted Residential Wells Near a Closed Municipal Landfill in Central Maine

Jason Langley L.G.
Certified Environmental Hydrogeologist
BRWM Technical Services

MAINE DEPARTMENT OF ENVIRONMENTAL PROTECTION

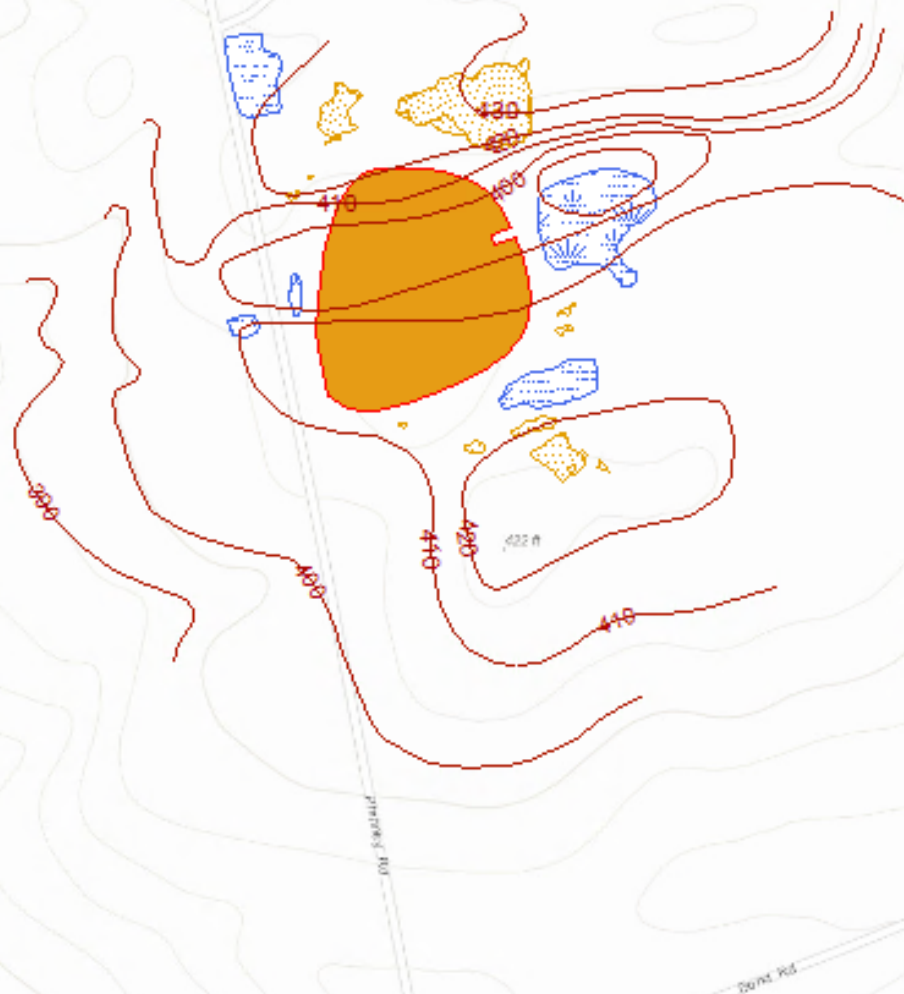
Bedrock Depth Contours from Resistivity Profiles

Top of landfill
+430' elevation

North + South
landfill flanks waste
is very close to or
directly on bedrock

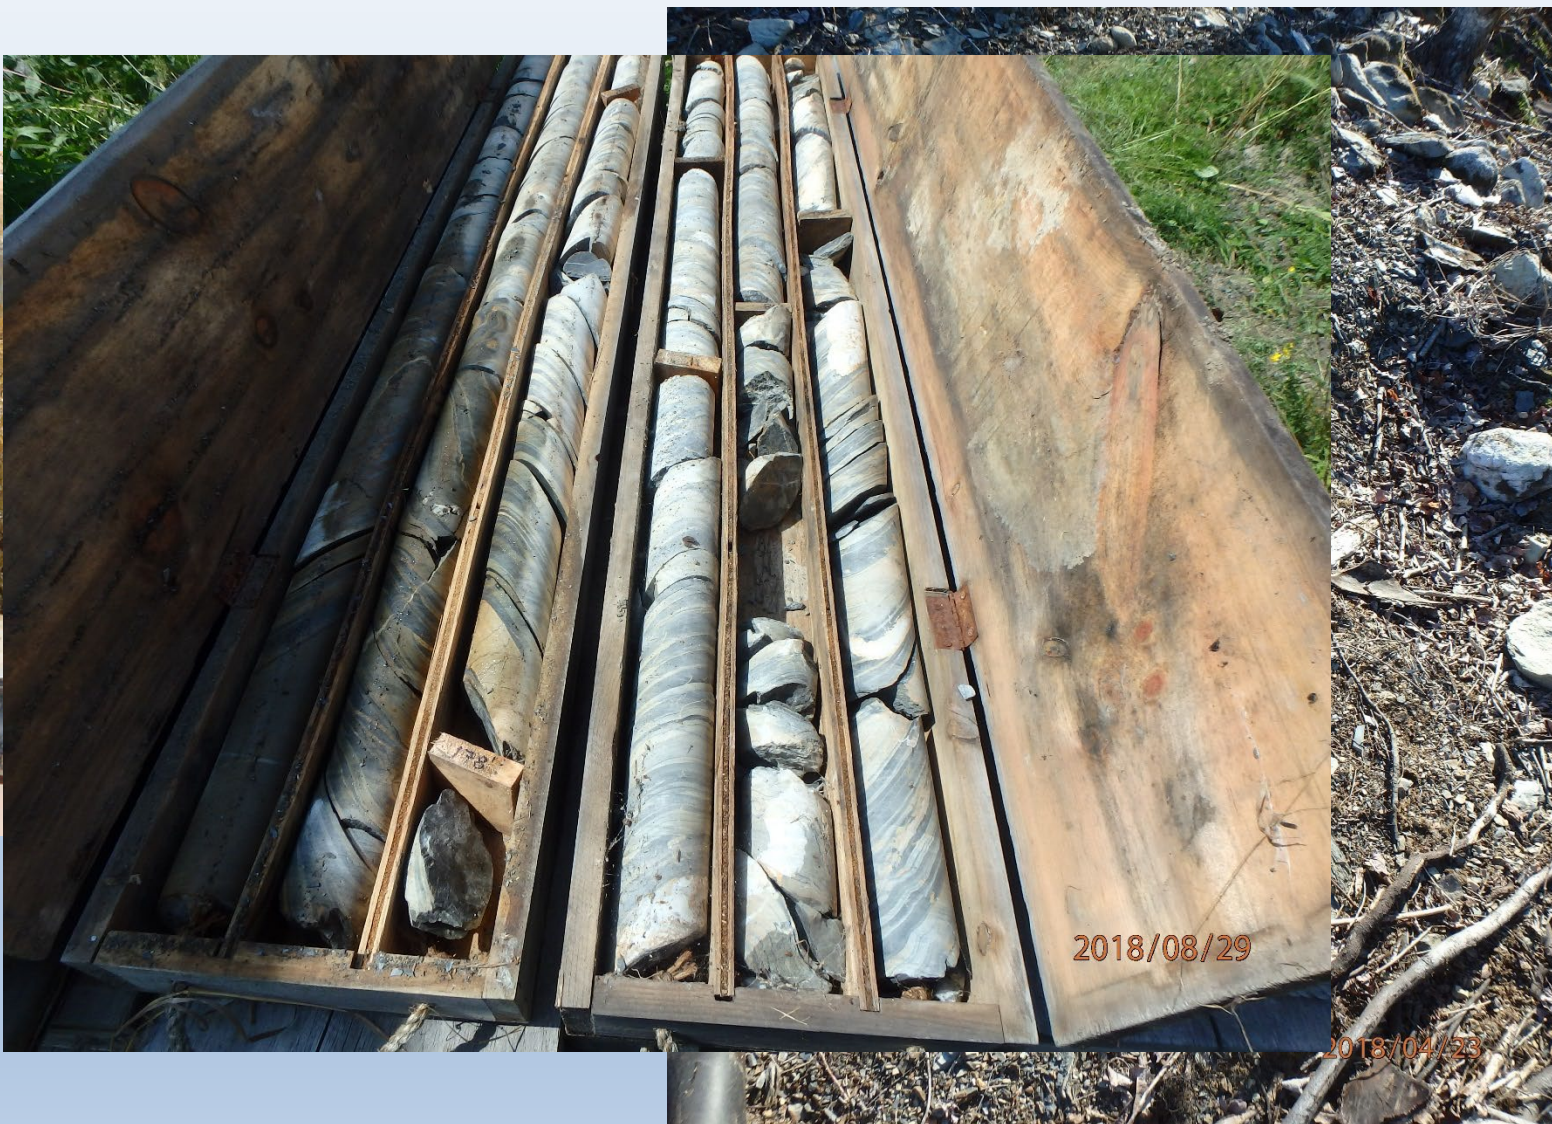
Site Bedrock

- Landfill sited within a bedrock trough aligned with NE-SW strike with topo highs to the north and south
- Bedrock structure fine grained metasedimentary unit with laminar bedding (foliation) planes, NE-SW strike and dipping SE 45-75 degrees
- Leachate impacted groundwater primarily limited to along-strike monitoring wells within 800-900 ft of the landfill, indicating along-strike groundwater flow as a primary pathway for leachate migration
- Residential wells located along bedrock strike and down dip of the landfill considered most likely to be at risk given PFAS persistence and mobility
- PFAS risk drivers to residential wells here are PFOA (8), PFHpA (7), and to a lesser extent PFNA (9) and PFOS (8)

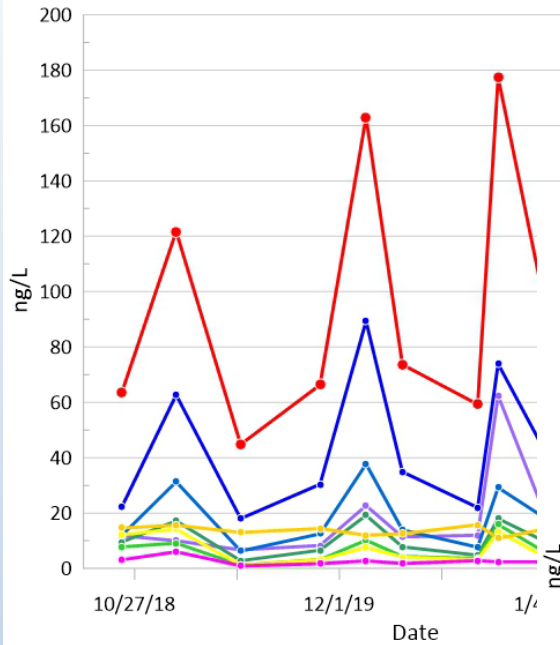
DW-13

Downdip Residential Wells

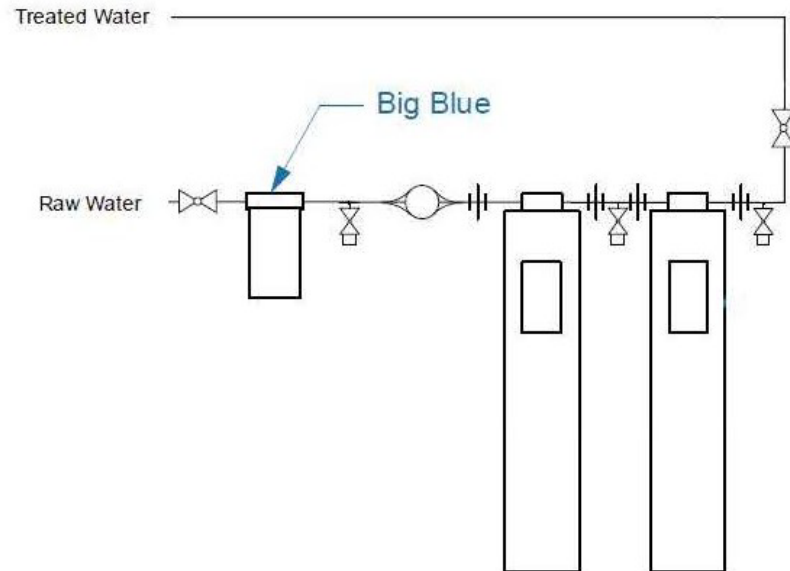
GAC Treatment System

- Point-of-entry GAC filtration
- Big blue to filter sediment
- Two 13" x 54" contact tanks w 2.5 or 3.0 cu ft GAC per tank
- 2 gpm/sq ft loading rate
- Empty bed contact time 10 min
- Samples collected before and between contact tanks

- Changeover when SOS exceeds 20 ppt

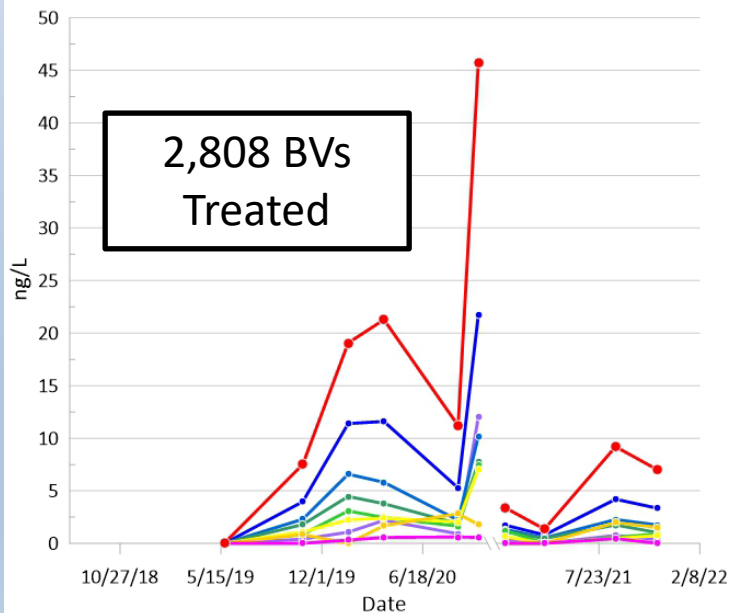
DW-13 GAC

- Legend
- SOS
 - PFNA_9
 - PFOA_8
 - PFHpA_7
 - PFHxA_6
 - PFPeA_5
 - PFBA_4
 - PFOS_8
 - PFBS_4
