TRS Group PFAS and Thermal Remediation

PFAS Projects & Lessons Learned

Thermal conduction heating

- Ex situ soil: Eielson AFB, AK (2021)
- In situ soil: Beale AFB, CA (2022)

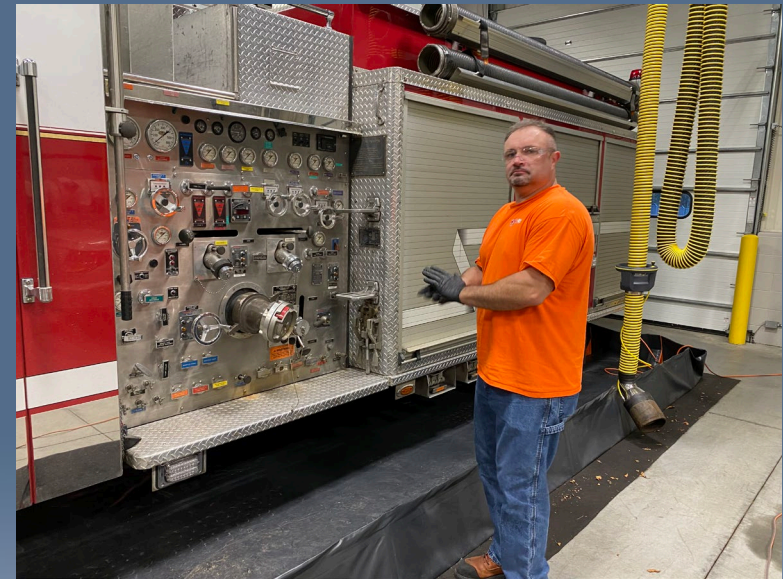
PerfluorAd® technology at Connecticut

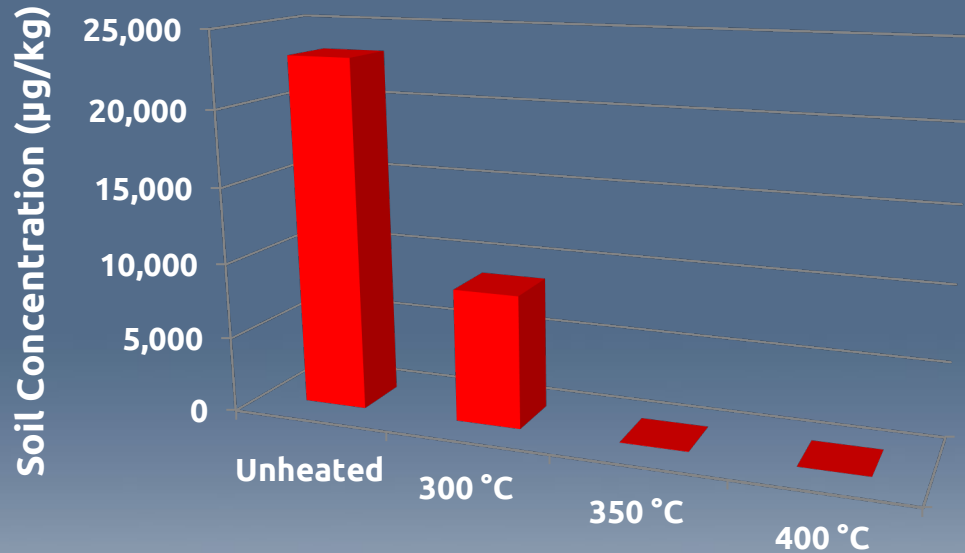
PFAS Removal from Soil

Two Weeks of Heating at Target Temperatures

PFAS	Starting Concentration (ppb)	300 °C % reduction	350 °C % reduction	400 °C % reduction
PFOS	21000	61.90%	99.92%	>99.999%
PFBA	91	93.85%	99.82%	>99.999%
PFPeA	100	92.60%	<99.8%	>99.999%
PFBS	41	58.54%	99.80%	>99.999%
PFHxA	200	95.30%	99.96%	>99.999%
PFHpA	27	86.67%	98.63%	>99.998%
PFHxS	1600	51.88%	99.84%	>99.999%
PFNA	16	96.81%	<98.75%	>99.997%
PFDS	48	75.00%	<99.58%	>99.999%
PFOA	64	92.97%	99.22%	>99.865%

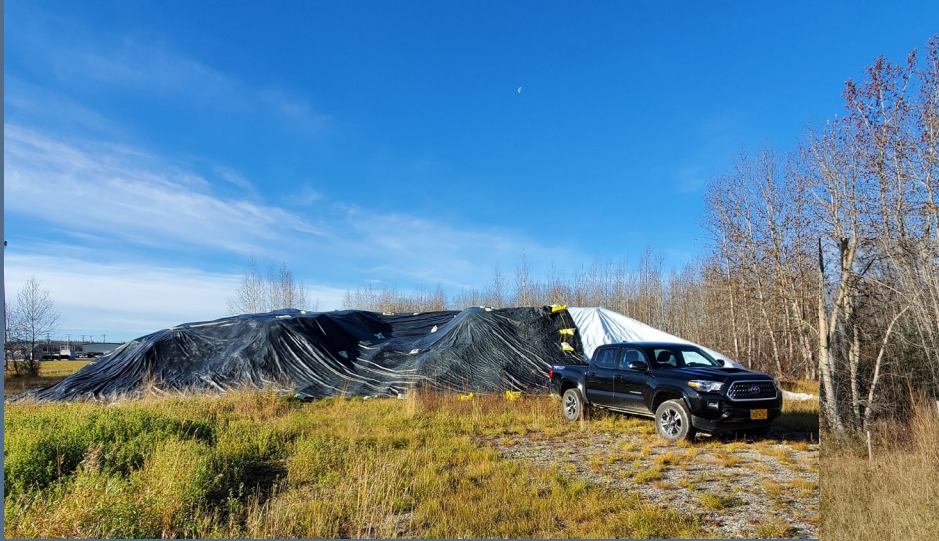
Soil Pile #377-1

1,500,000 cy of PFAS-laden soil in 52 piles

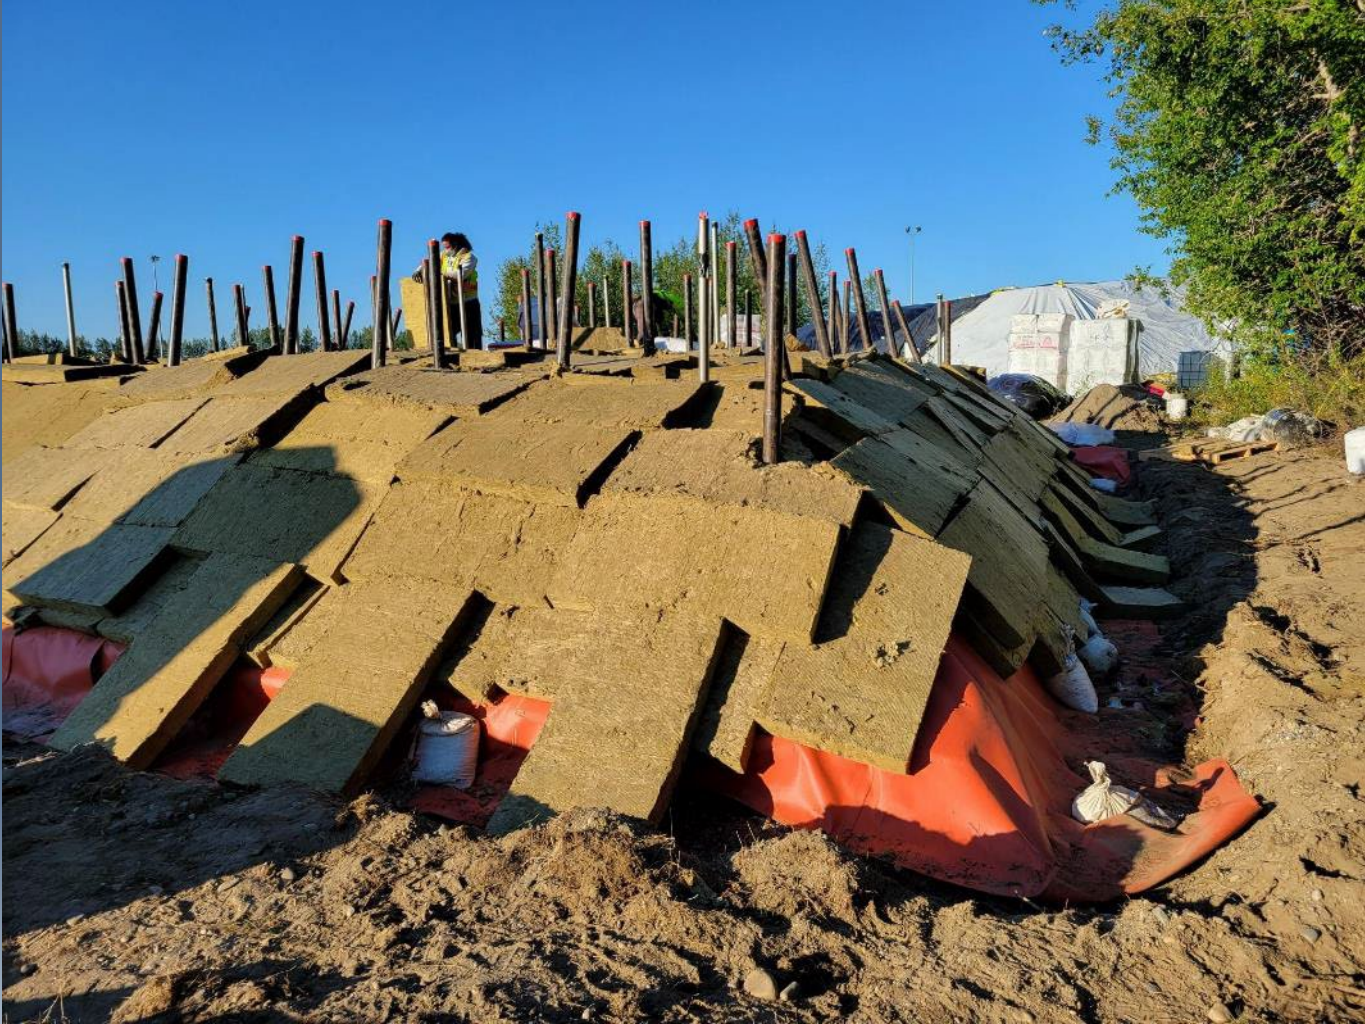
Thermal Barrier Construction

Stockpile covered with impermeable barrier & insulating mineral wool

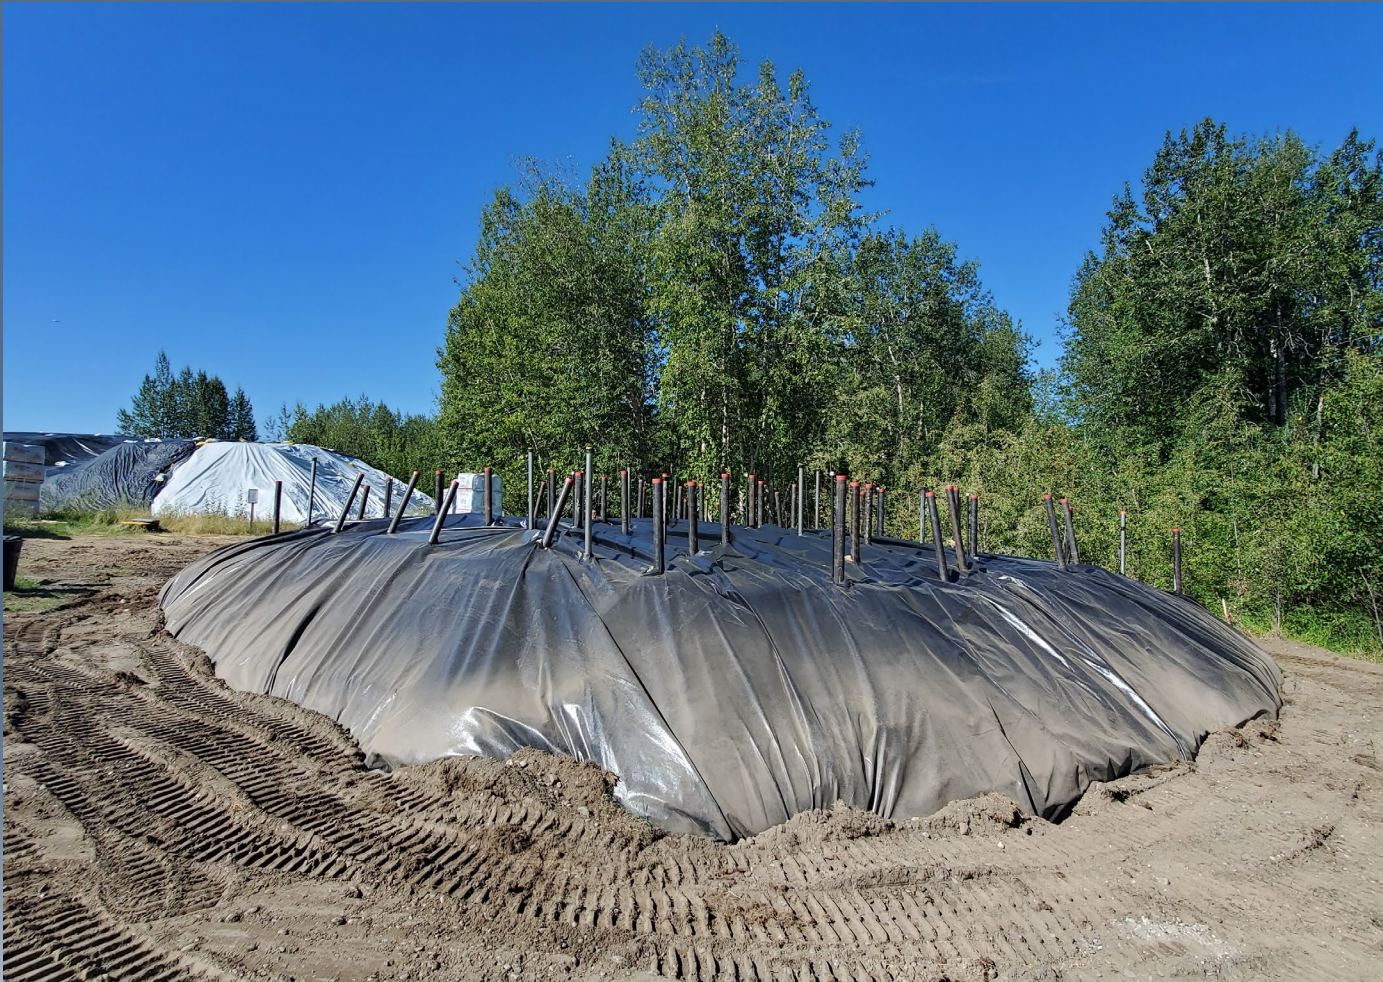
Stockpile Construction Complete

Water resistant outer layer and sealed edges

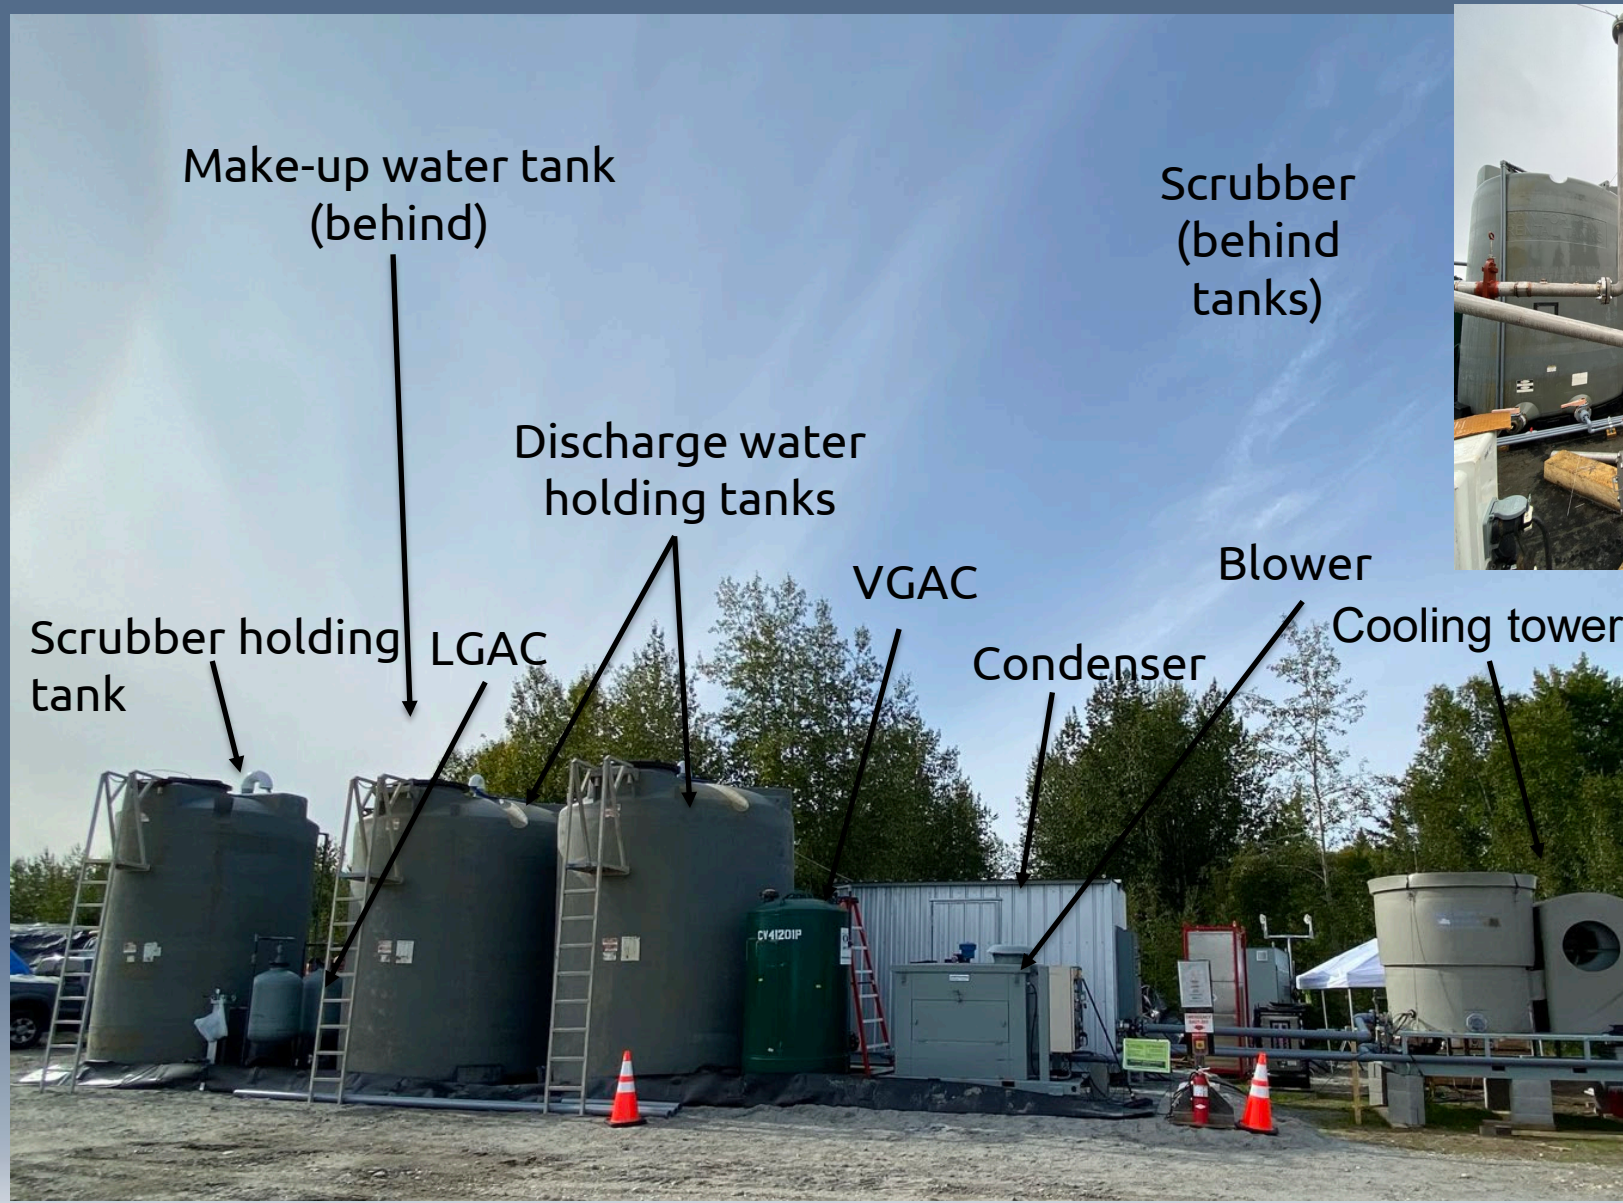
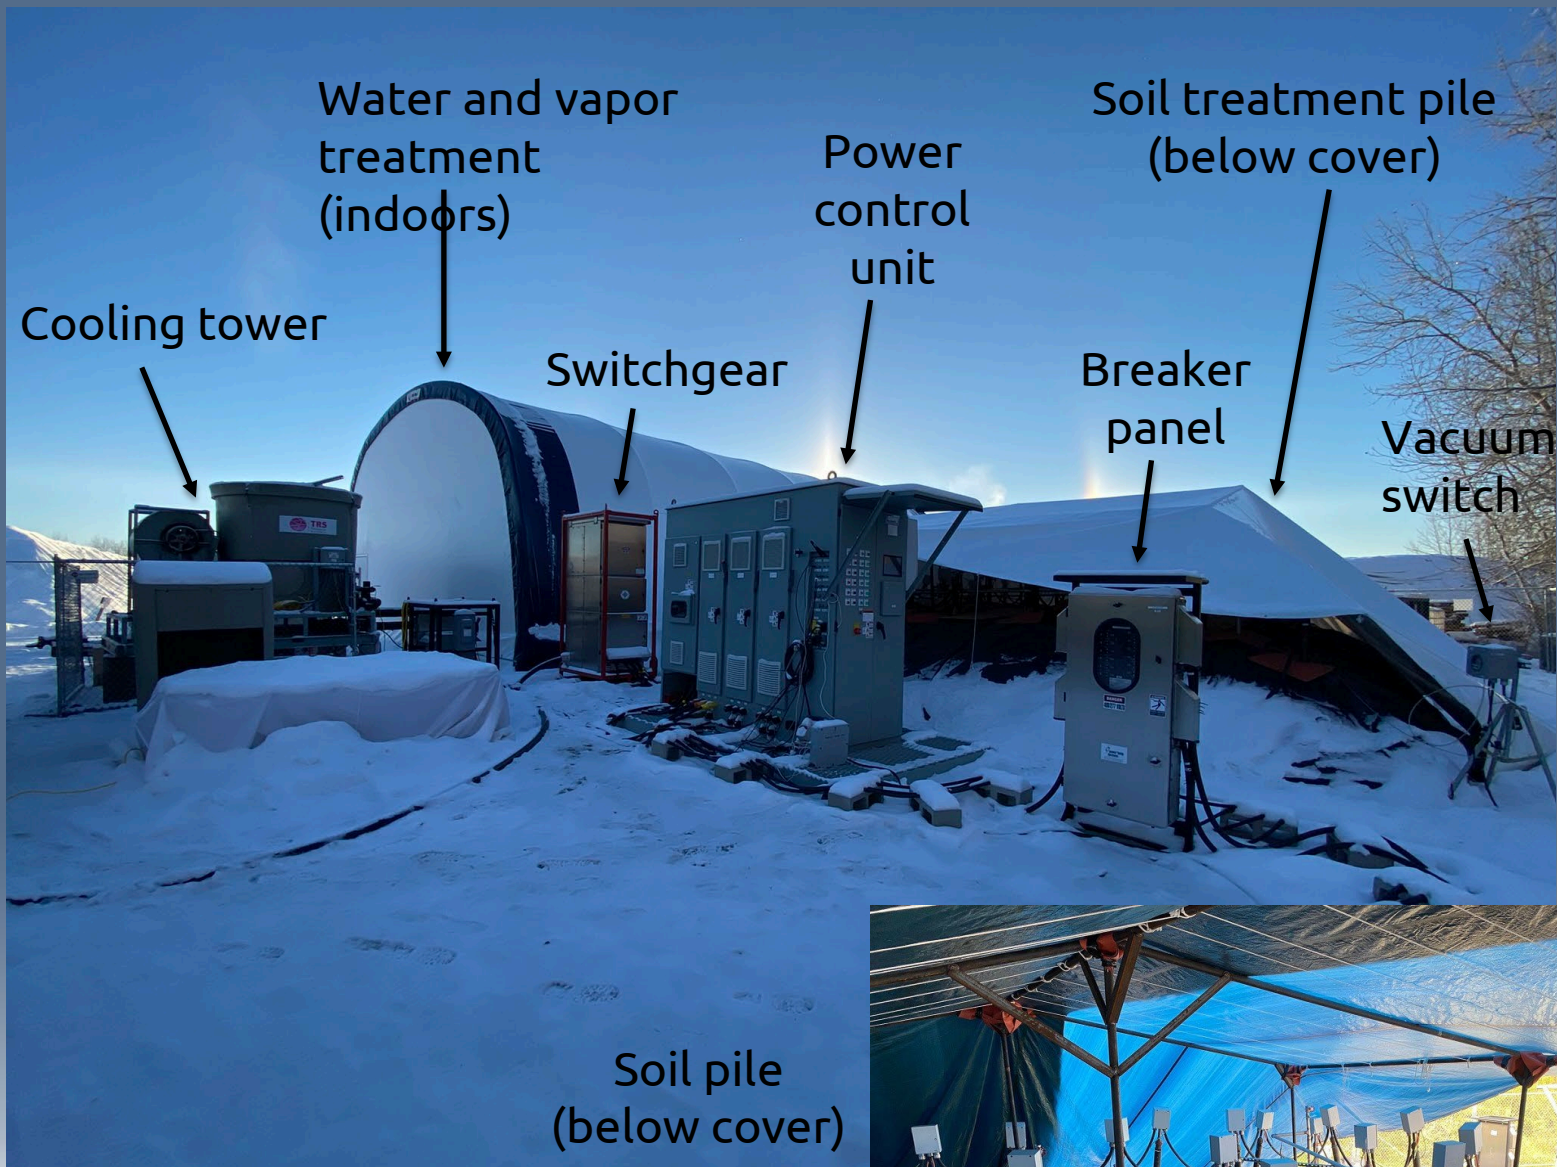
Make-up water tank
(behind)

Scrubber
(behind
tanks)

Discharge water
holding tanks

Scrubber holding
tank

LGAC

VGAC

Blower

Condenser

Cooling tower

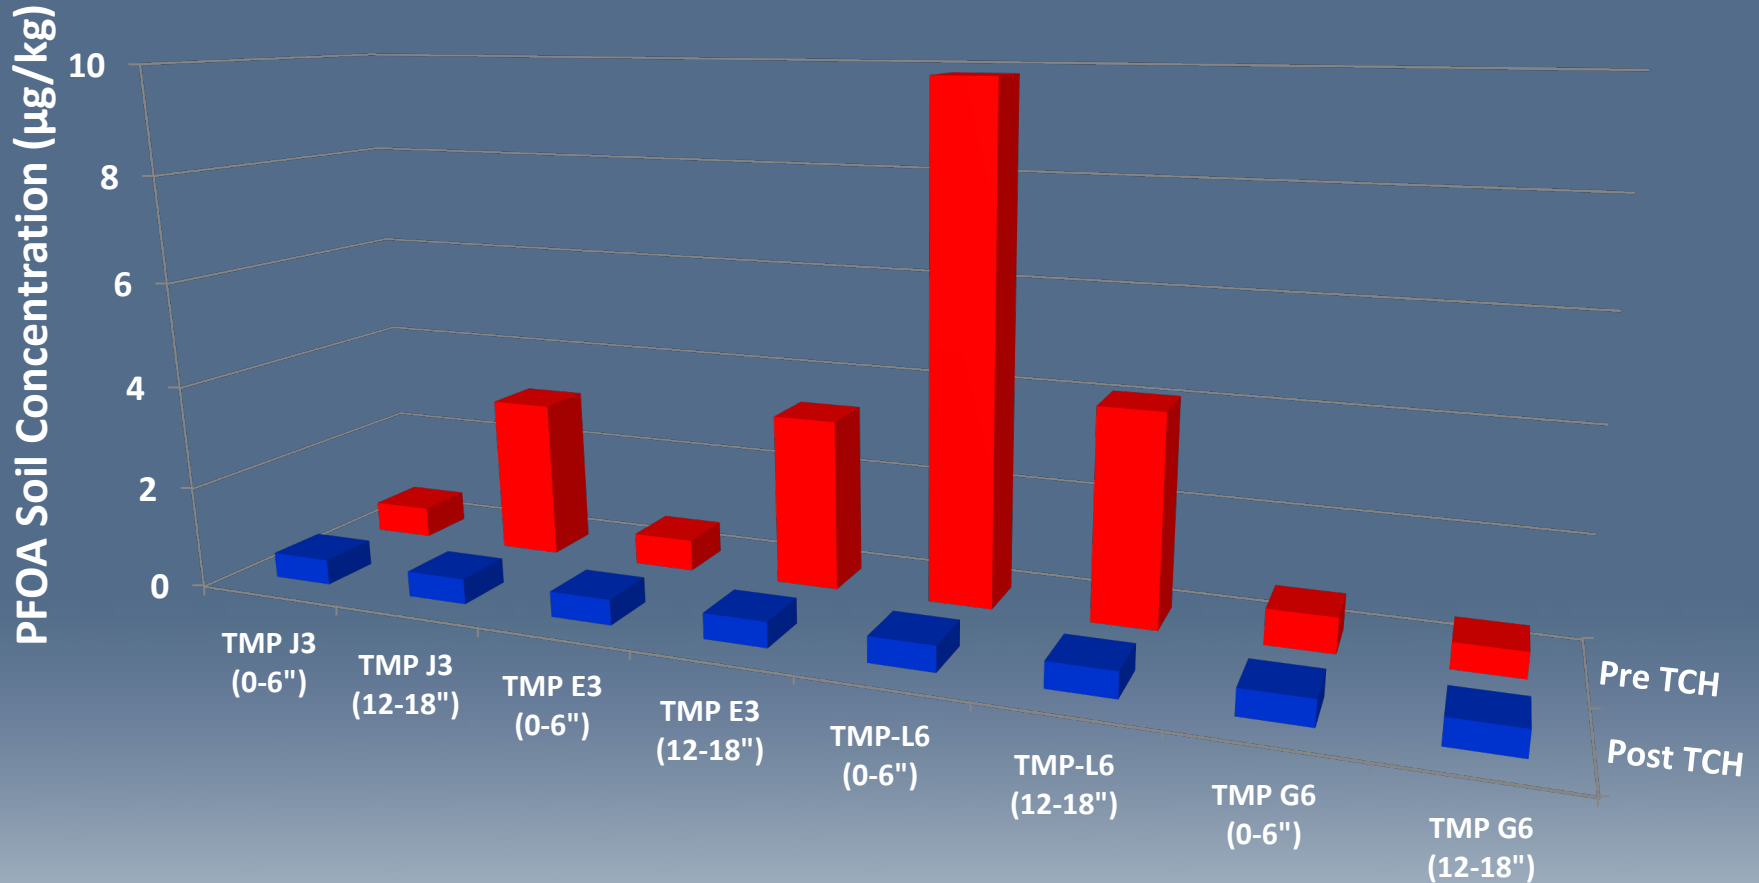
PFOA Preliminary Results

*all post treatment samples below PFOA detection limits

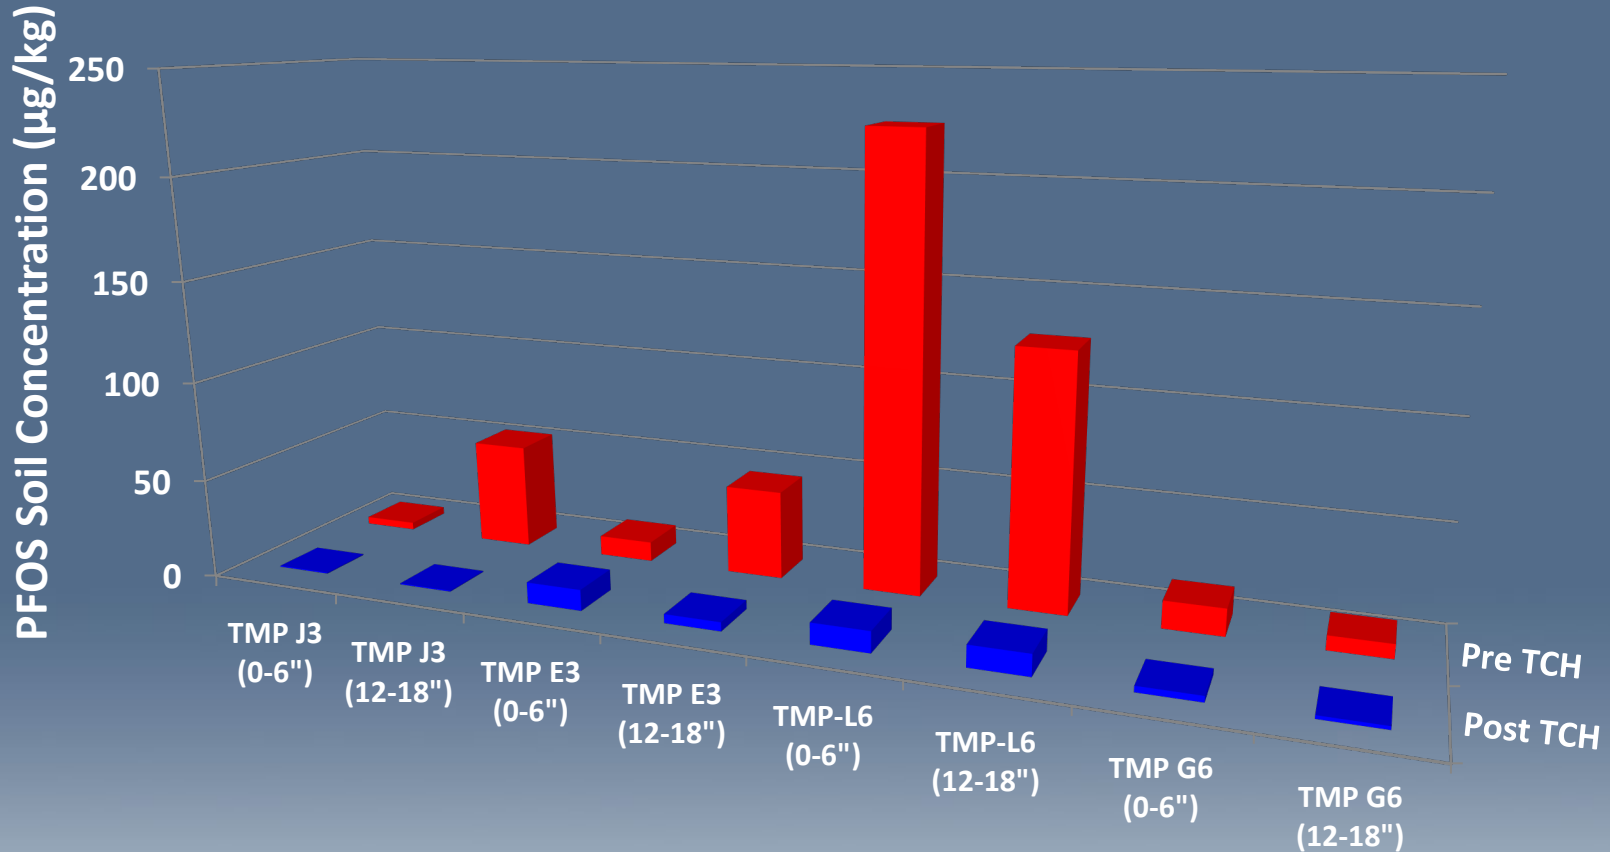
PFOS Preliminary Results

*heating shallow samples to above 400°C below PFOS detection limits
