## Two Case Studies: Exploring commercial, industrial, and wastewater sources of PFAS

**Upstate New York and the Hudson Valley**

**December 11, 2024**

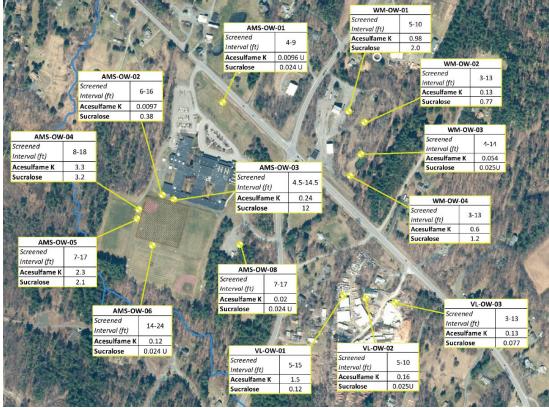
#### 4. Artificial Sweeteners

- Artificial sweeteners are found throughout the Assessment Area including in bedrock wells.
- Presence of sweeteners further supports the connection between the surface and bedrock

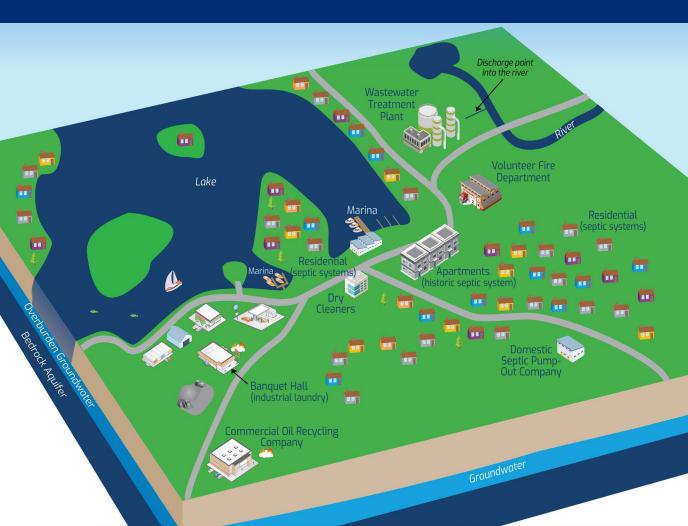
#### Source Investigation Locations

12 Potential Sources Identified:

- Commercial/Industrial
- Waste management
- Areas of known fires
