# EVERY DEMOLITION JOB

Deconstructing 22 Drydock Avenue

HISTORICAL PRESERVATION THROUGH DEMOLITION WITH 10 TWISTS

ARMORY BUILDING ST. JOHNSBURY, VT

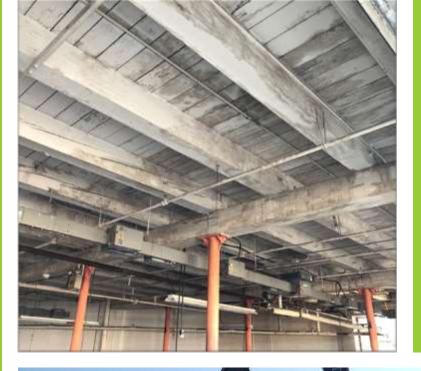
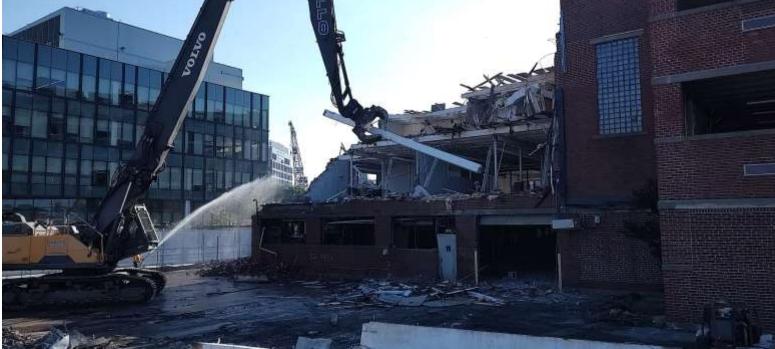
The structural make up of the building was heavy timber framing. We know from similar building types, that we have well honed mechanical capabilities to dismantle this structure safely, with minimal labor exposure and high recovery of delicate timbers, by using one of our high reach excavators equipped with a rotating grapple.

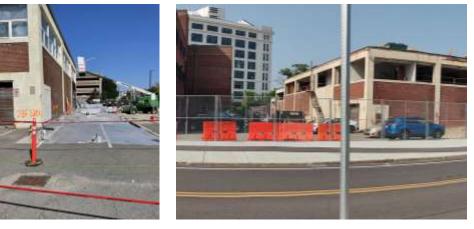
A great deal of planning, sequencing work and site preparation must occur to allow the planned salvage to occur.

First of all, asbestos abatement and haz mat recovery must take place. Only then can any of the dismantling process begin.

#### We had sequenced our work so that all asbestos abatement and an adjacent concrete structure had been demolished, leaving a clean slab for processing and stockpiling the 22 Drydock building material components.

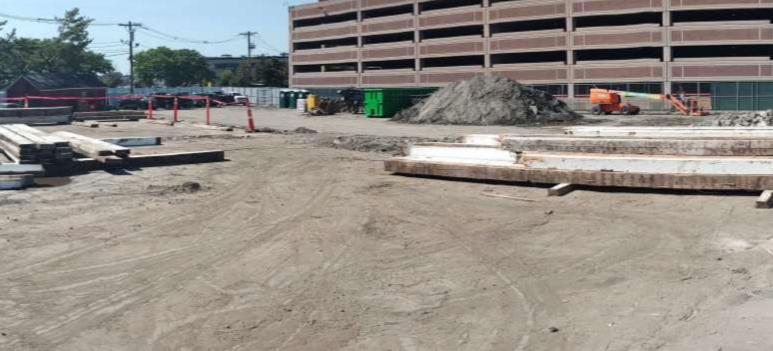
In a very systematic manner, we separate and remove building components to reveal the timbers to be harvested.

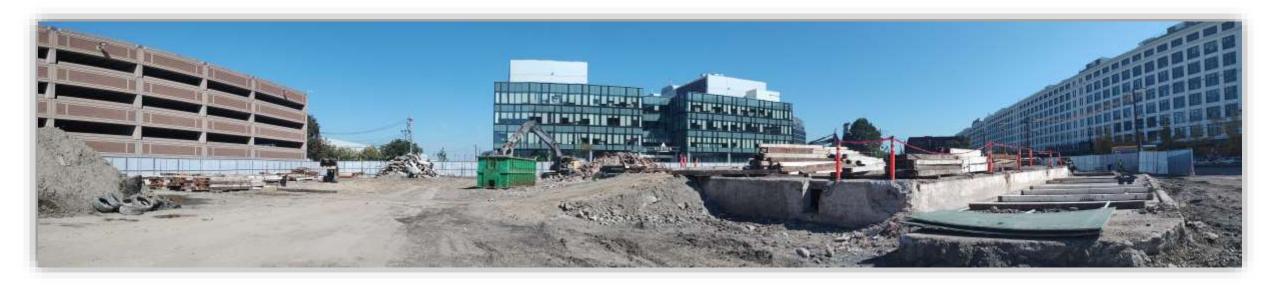
This results in a deliberate, careful source separation of:

- painted and unpainted bricks
- painted and unpainted concrete
- high wood content C&D debris
- mixed unsorted debris
- mixed grades of ferrous scrap metal
- mixed grades of nonferrous scrap metal

We utilize a variation of the source separation theme on every project which we undertake.

Not only is disposal pricing controlled, but we maintain the site in a neat and organized manner which greatly improves site safety and appearance during a demolition project. In a continuous effort of sorting and packaging all salvaged materials, as demolition proceeds, timbers were bundled and loaded for delivery to a local sawmill with whom we have a long-standing relationship.

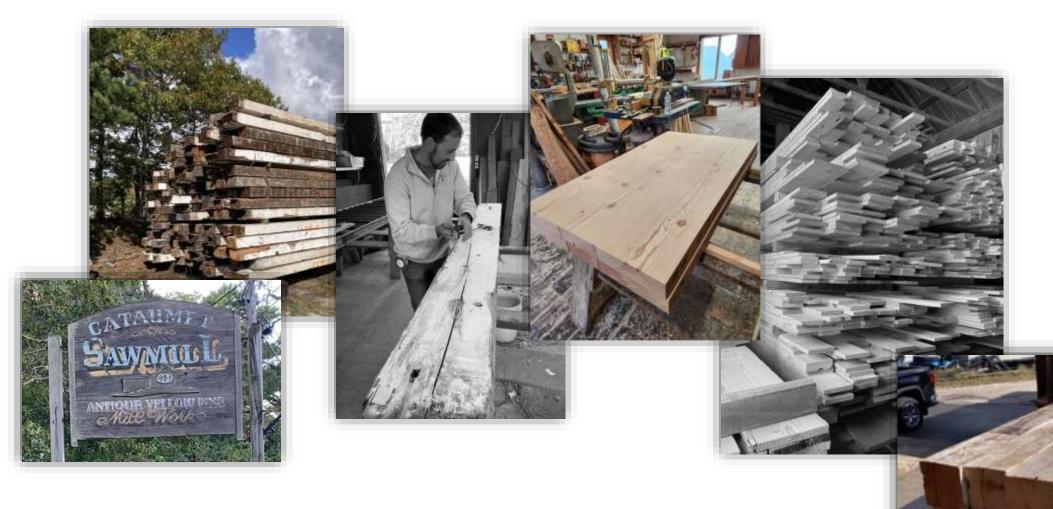
**CATAUMET SAWMILL** further sorts the timbers by species and size.

They conduct extensive denailing before sending any timber through a series of saws, millers, planers, and kiln drying before producing a market ready product.

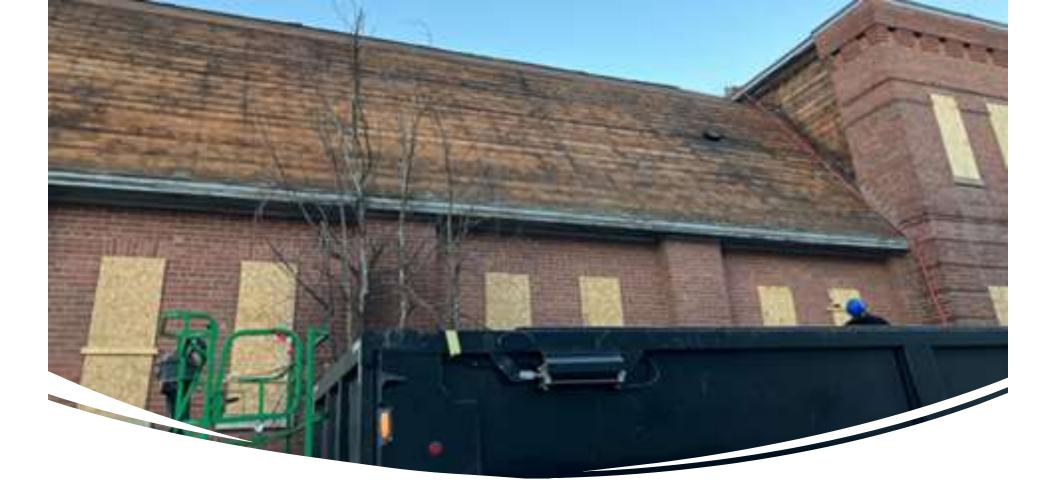
The Armory Building in St. Johnsbury, VT built in 1916 as an armory and was used as such until 1975 then owned by St. Johnsbury and used as a community recreational center until 2009.

The plan calls for preservation of the two-story brick office portion of the building facing Main Street while separating the rear gymnasium portion of the building before dismantling and removing that structure.

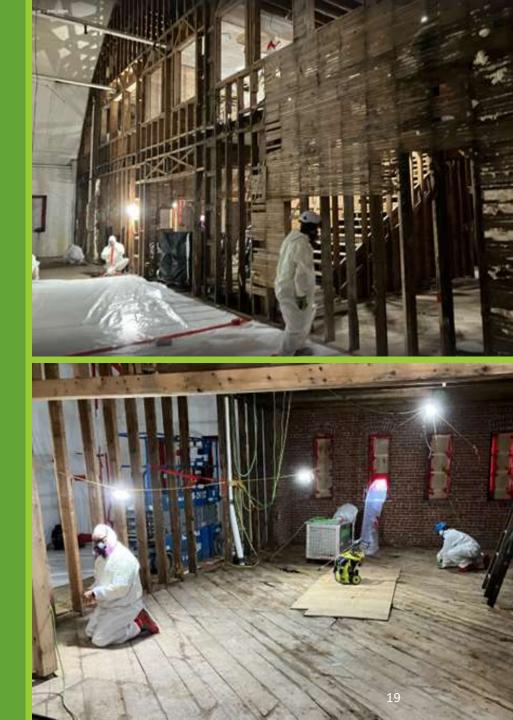
## AN EXTREMELY COMPLICATED DEMOLITION PROJECT

Develop a very technically challenging building separation plan to allow preservation of the historically significant portion of the complex and demolition of the portion of the complex that will become the footprint for new site utilization

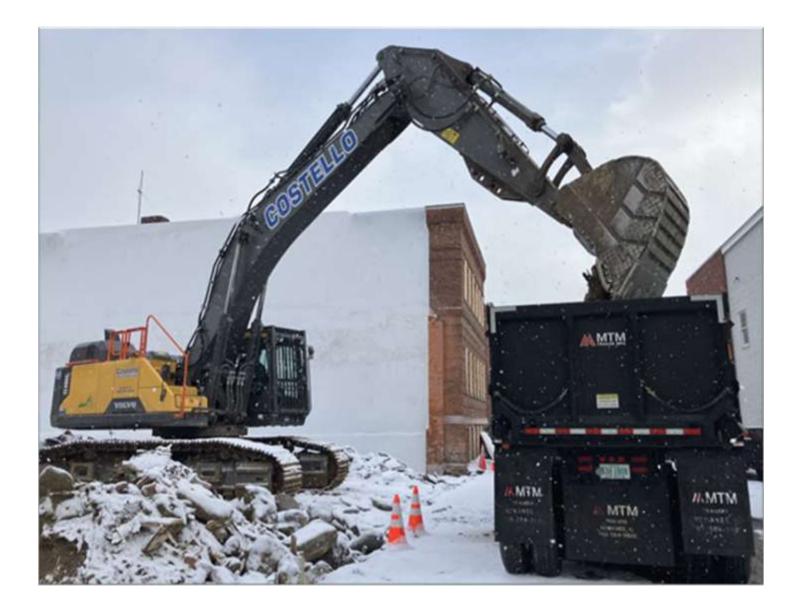
There was pervasive PCB presence throughout this building. Navigating the mine field of PCB TSCA hazardous waste from PCB non-hazardous remediation waste to and through the presence of asbestos the crux of our project management.

Co-mingling of waste streams can be devastating financially and in a regulatory sense.

We chase the path of navigating through ten waste streams because disposal costs of nine of those waste streams is significantly less expensive than co-mingling and shipping out all waste as hazardous waste.

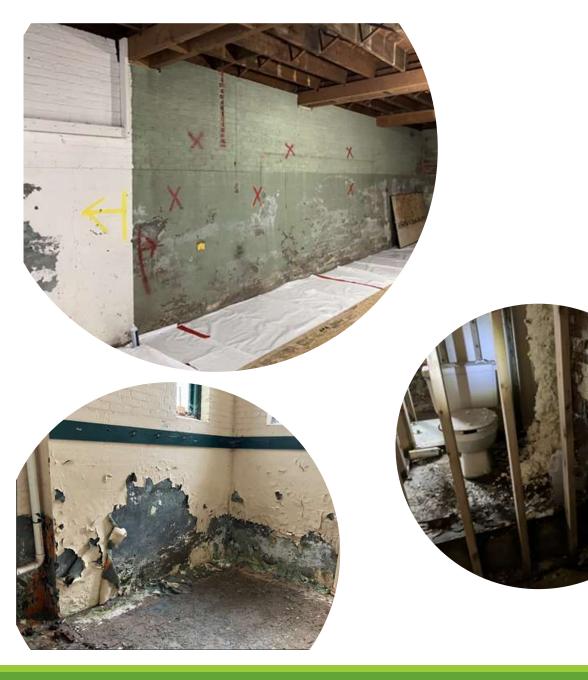
The diversity of contaminants found on a project like this certainly poses some great challenges.

Each waste stream requires very precise testing to allow eligibility, approval and acceptance at each disposal facility long before the first pound of material is shipped.

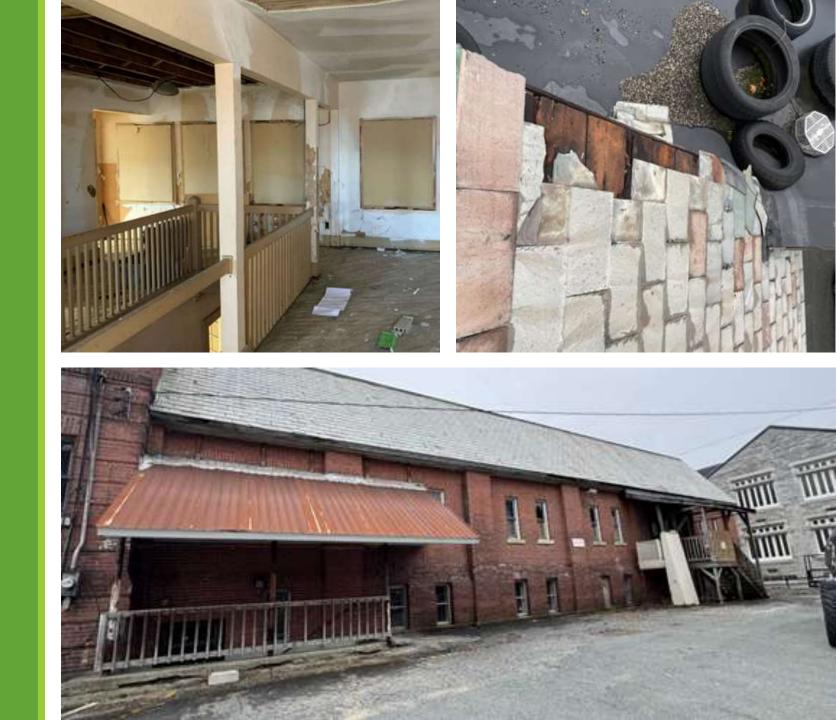
Once the waste streams were identified we started the careful segregation of each material from the rest of the building materials.

Just like a careful deconstruction and source separation project, we utilized all our skills and experience to separate and collect each of the ten material streams.

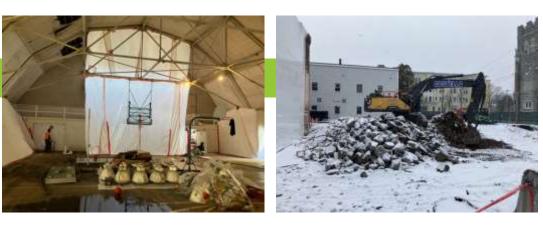
We actually encountered very little non-impacted C&D debris for disposal.
