# Connecticut PCB Case Study

November 8, 2012  
Lori Saliby-Supervising Environmental Analyst  
CTDEEP-Emergency Response and Spill Prevention Division  
Storage Tank and PCB Enforcement Unit  
NEWMOA- Dayville, CT

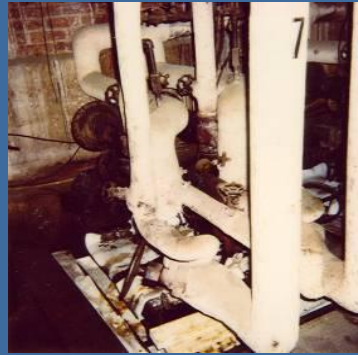
- PCB heat transfer oil used 1968 to 1972
- PCB Oil leaked from pump seals in basement onto and through concrete floor
- Discovered during routine PCB compliance inspection by CT DEP in 1993
- PCBs concentrations in soil below basement up to 38,000 mg/kg
- Impacted unconsolidated materials and shallow bedrock
- DEP and EPA enforcement actions
