Autopsy of a Small UST site in Bedrock: Implications for ISCO Effectiveness *Case Study, Devens, MA*

William C. Brandon, Hydrogeologist, US EPA Region 1

NEWMOA ISCO WORKSHOP

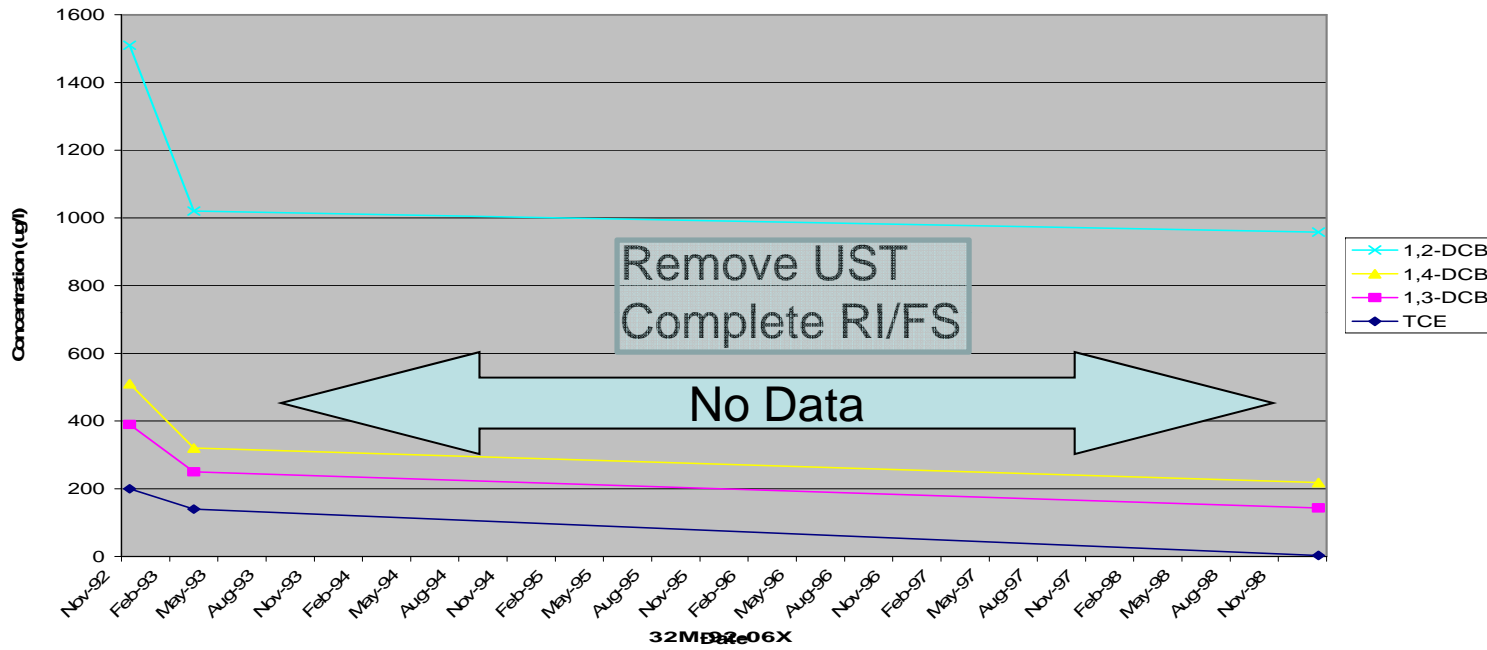
COC Trends (Pre-2000)

32M-92-06X

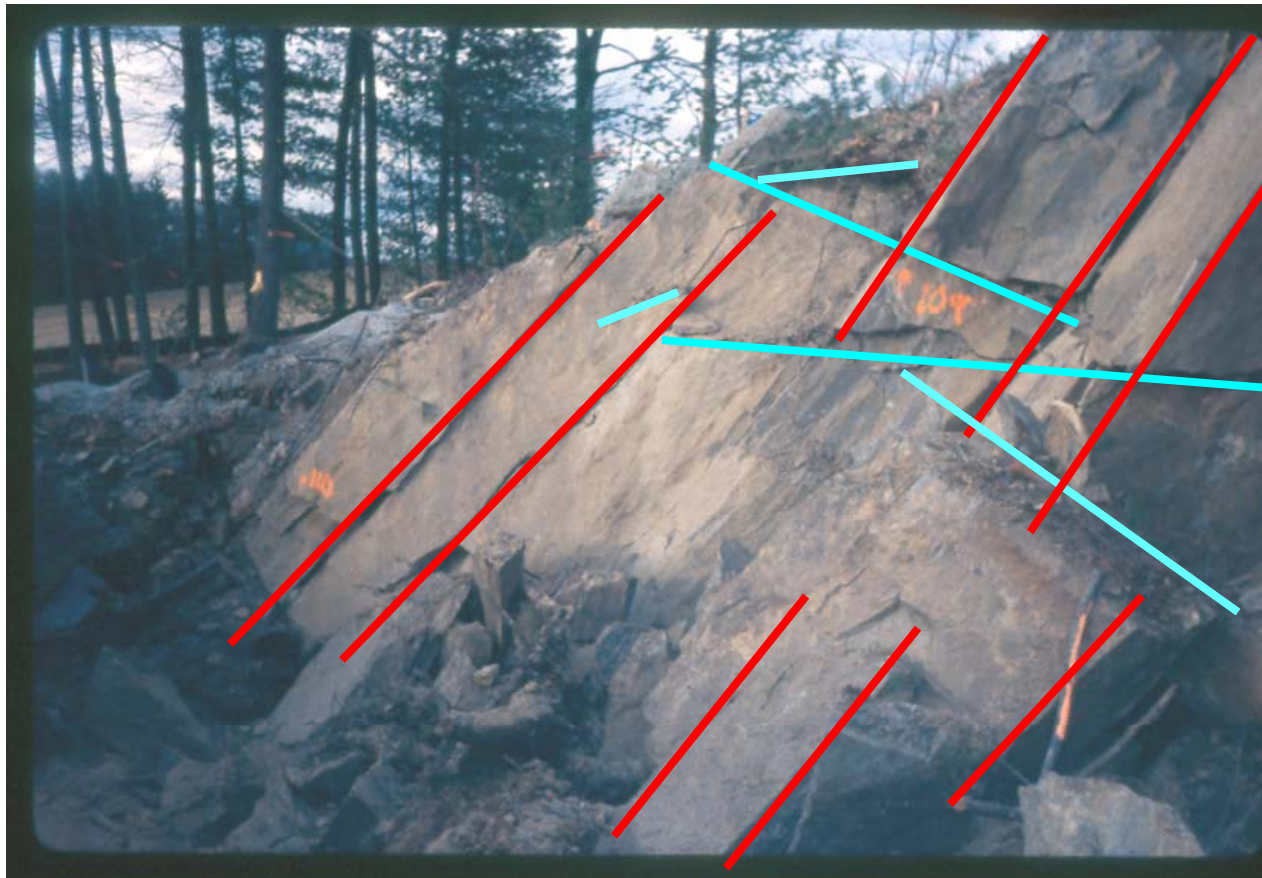
Intersecting Joint Sets

- Generic Term for Planar discontinuity in Rock Mass (e.g., crack)
- Open joints may transmit water (oxidation)
- Greater Variability than Foliation

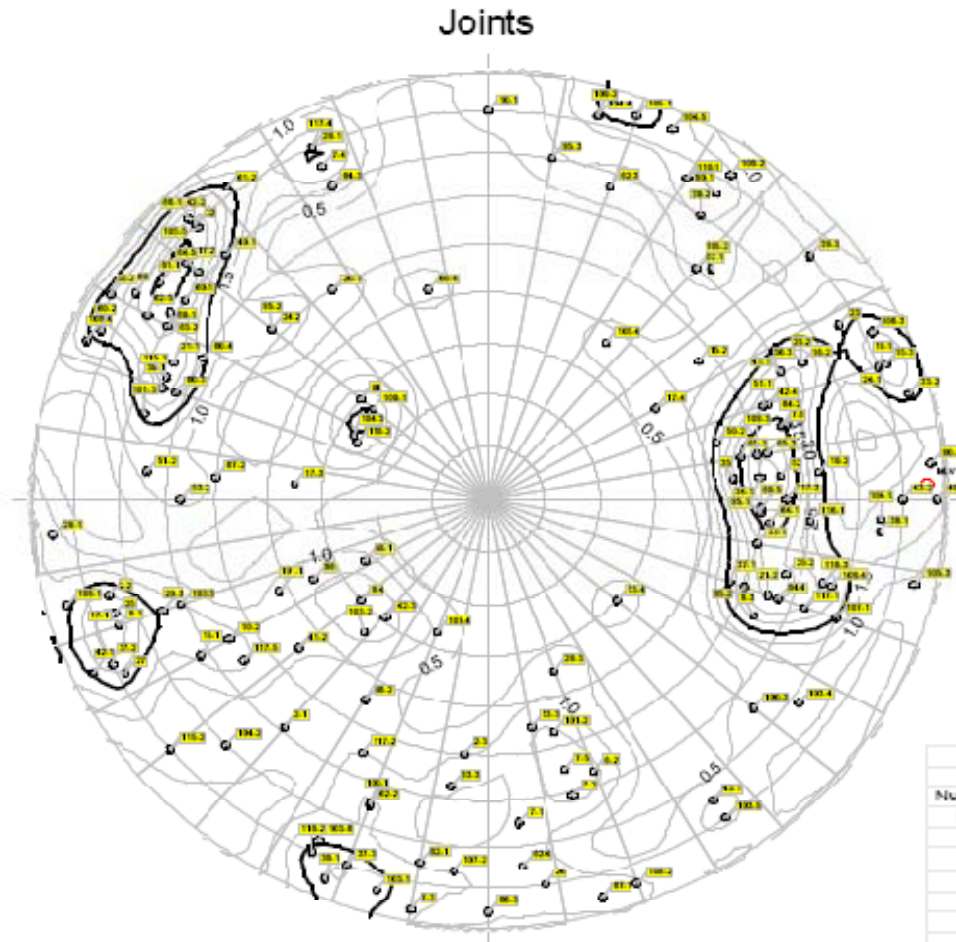
Stereo-plot of Joint Orientations

N=156
66 stations

Statistical Summary	
Projection:	Schmidt (Equal Area)
Number of Sample Points:	166
Mean Lineation Azimuth:	87.8
Mean Lineation Plunge:	4.2
Great Circle Azimuth:	65.3
Great Circle Plunge:	11.1
1st Eigenvalue:	0.452
2nd Eigenvalue:	0.321
3rd Eigenvalue:	0.226
LN (E1 / E2):	0.341
LN (E2 / E3):	0.351
(LN(E1/E2)) / (LN(E2/E3)):	0.973
Spherical Variance:	0.5849
Rbar:	0.4151

- N3E +/-, 50-60 W (parallel to foliation)
- N45E +/-, 65-85 SE
- Near-surface sheeting joints at various orientations, Sub-parallel to former topography
- ~ N70W, Subvertical (weak)
- ~ N30W, > 70-80 SE or SW Dips (weak)
