TCE VI Case Study

Site Overview

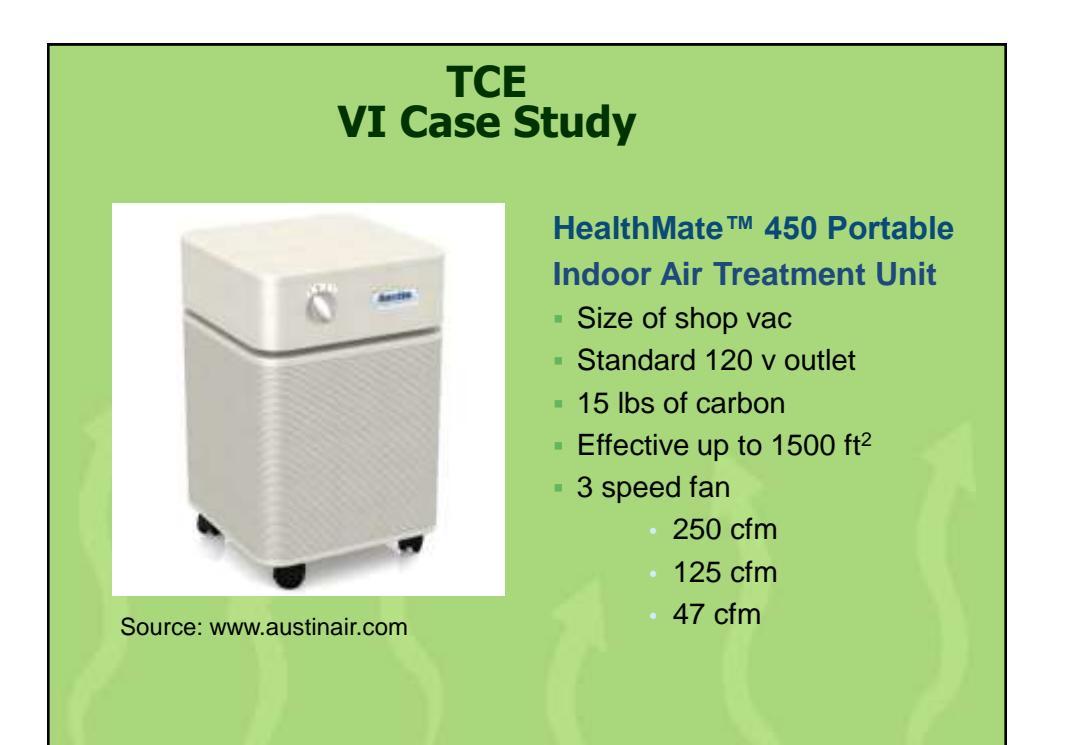
HealthMate[™] 450 Portable Indoor Air Treatment Unit

Assessment

Range of TCE levels prior to assessment*	TCE Baseline 8-hour	TCE after 12 Hours of filtration 8-hour	% Reductions
13 - 210	16	9.1	46%
18 - 61	27	3.6	87%
2.2 - 9.1	2.4	1.4	42%

Concentrations are in µg/m3

*Elevated levels were associated with tropical depression Irene

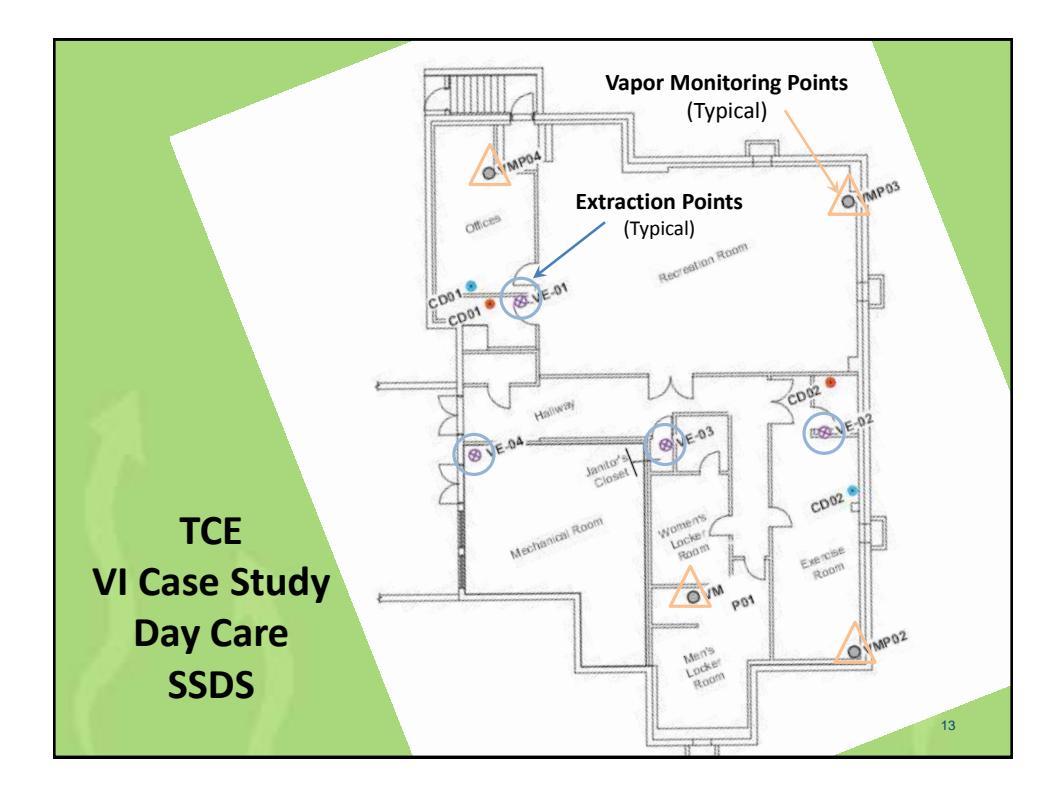
T VI Cas	CE e Study	
y Care SSDS	Effectivenes	SS
Maximum TCE Concentration	Maximum TCE Concentration	
before Mitigation	after Mitigation	% Reductions
before Mitigation 11,000	after Mitigation 1.7	% Reductions
before Mitigation 11,000 140	after Mitigation 1.7 0.27	% Reductions >99.9% >99.9%
	T VI Cas y Care SSDS Maximum TCE Concentration	TCE VI Case Study y Care SSDS Effectivenes Maximum Maximum TCE TCE Concentration Concentration

Day Care

- Sub-slab depressurization system
 - 99.9% reductions
