PASCOAG MOBIL

USE OF REAL-TIME FIELD
CHARACTERIZATION TECHNOLOGIES
FOR REMEDIATION DESIGN

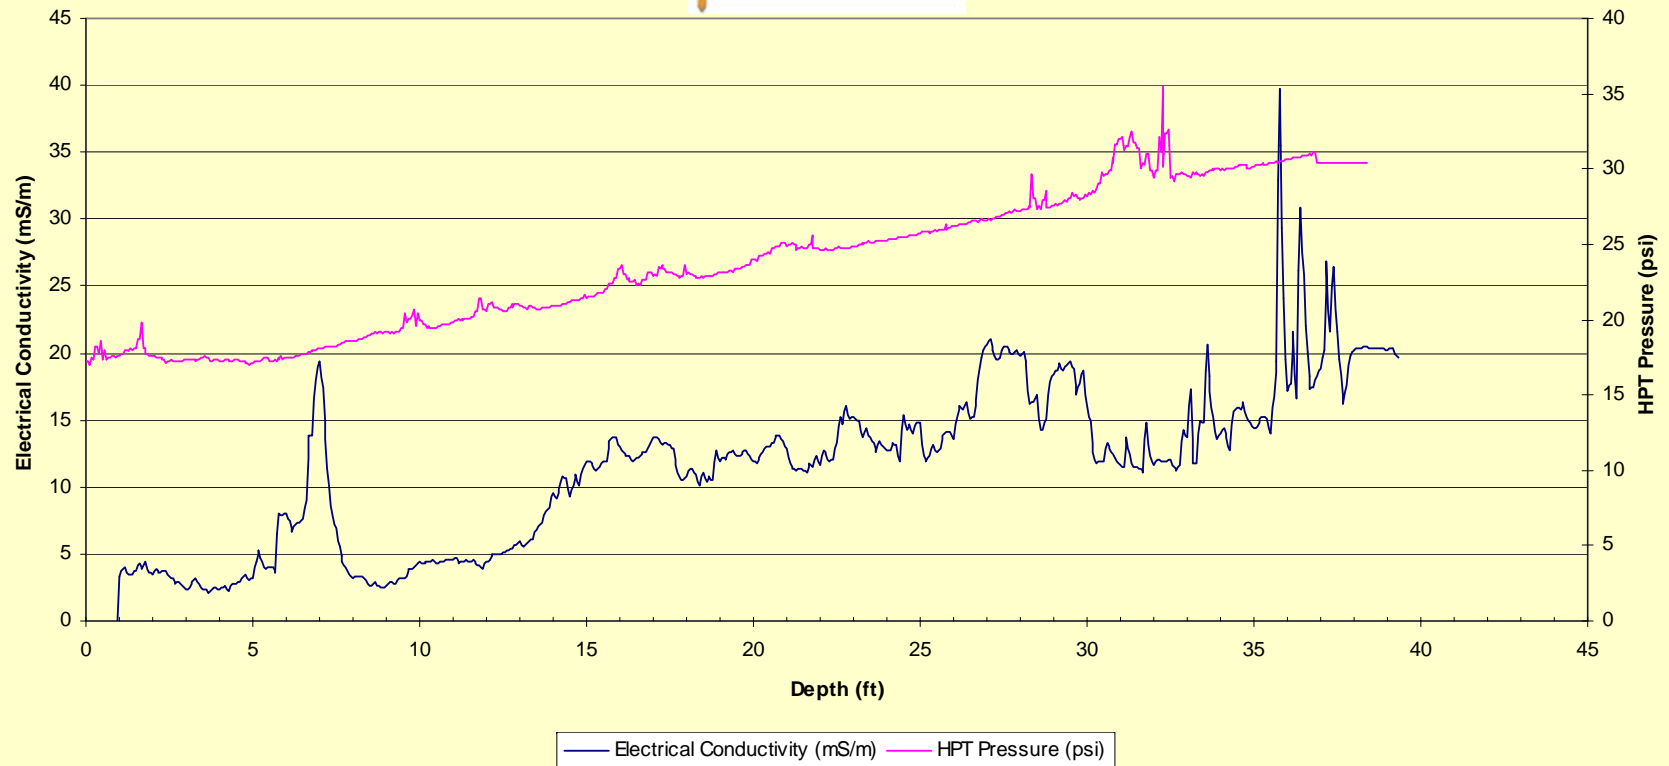
M0505 - (RIDEM12) - Pascoag, RI - 3/7/06

Utilized Geoprobe electrical conductivity and their brand- new hydraulic conductivity logging equipment.

Geology is 20 feet of medium sand overlaying 40 feet of well-sorted very fine sand with highly fractured bedrock
