Case Study: Aladdin Packaging LLC

Facility Information/ Background

Investigative Activities

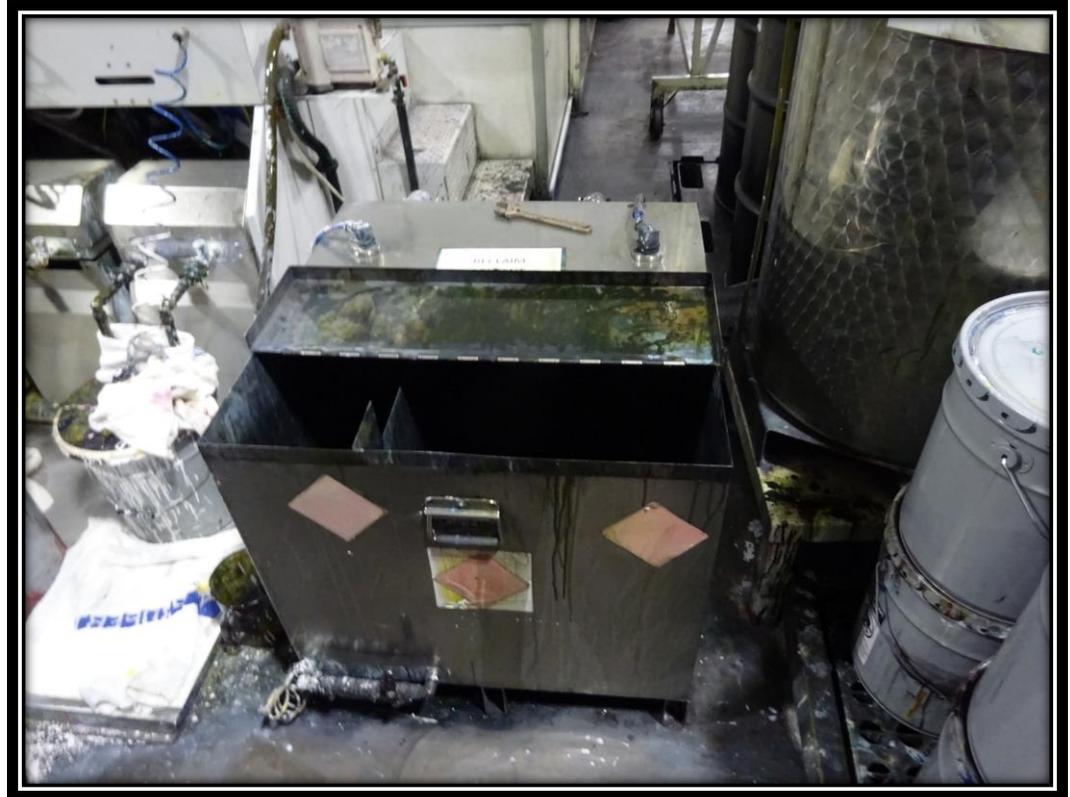
Two-Chambered Tank

- ▶ The biggest issue regarding this case was a two-chambered tank, and how to determine where the hazardous waste is generated, and what is regulated under Subpart BB.
- ▶ The large chamber of the tank was used to cycle solvent through the printing heads until the solvent was deemed spent; spent after 2 cycles
- ▶ The smaller chamber was then used to temporarily store waste solvent to a specific volume; then the waste was pumped to a 55-gallon hazardous waste drum.
